Performance Observations of the Beijing area's Great Wall "Rammed Earth and Rubble Core", (unrestored sections)

David Dark

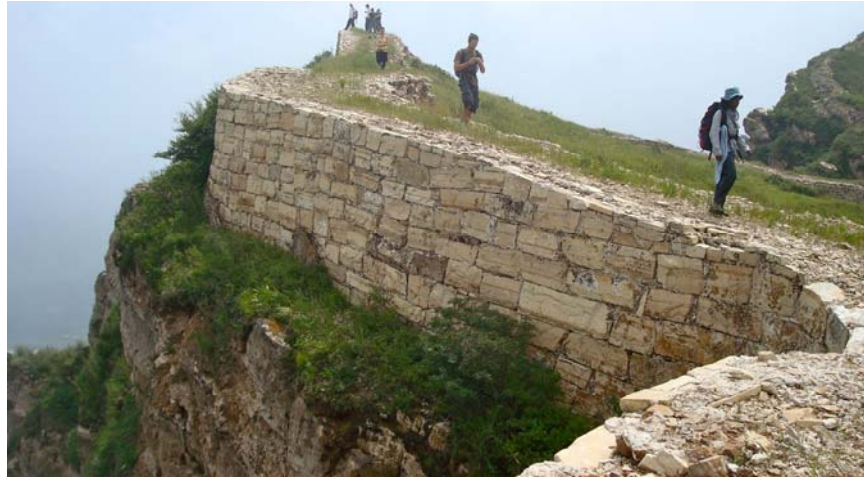
Figure 1. All stone, no brick, but
Rubble Core. #13 and #14

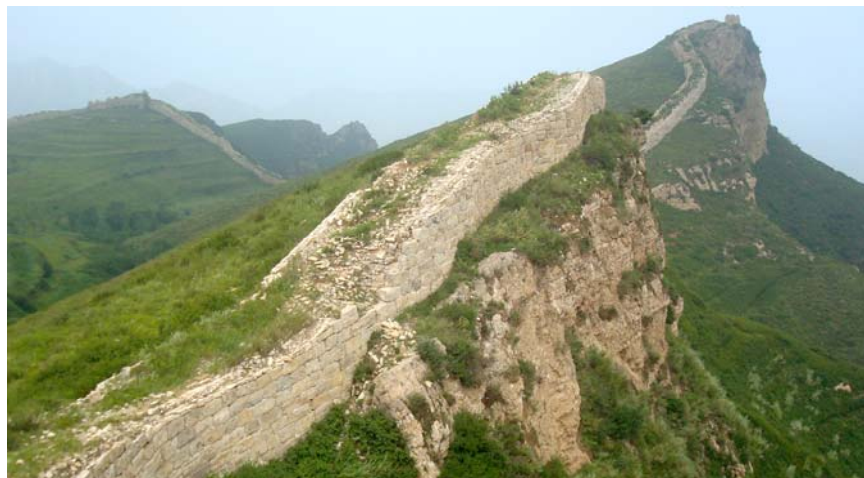
Figure 2. All stone, no brick, but
Rubble Core. #13 and #14

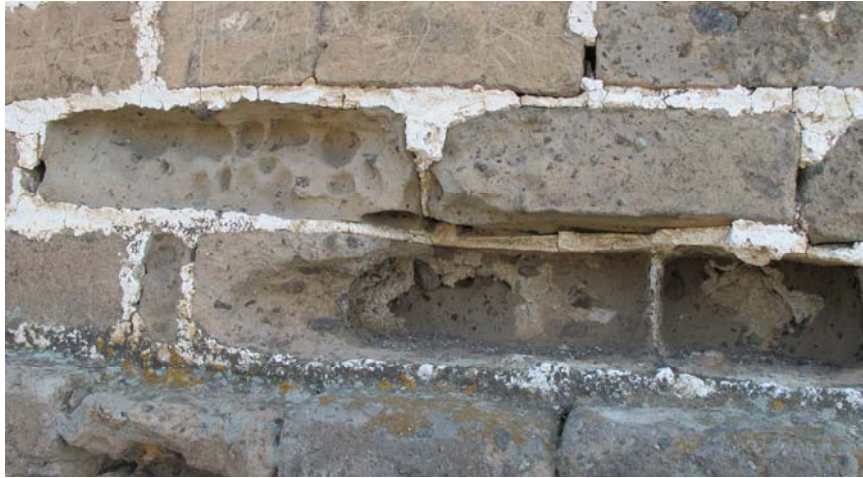
Sticky-Rice and Lime mortar.
Disintegrating bricks. #4

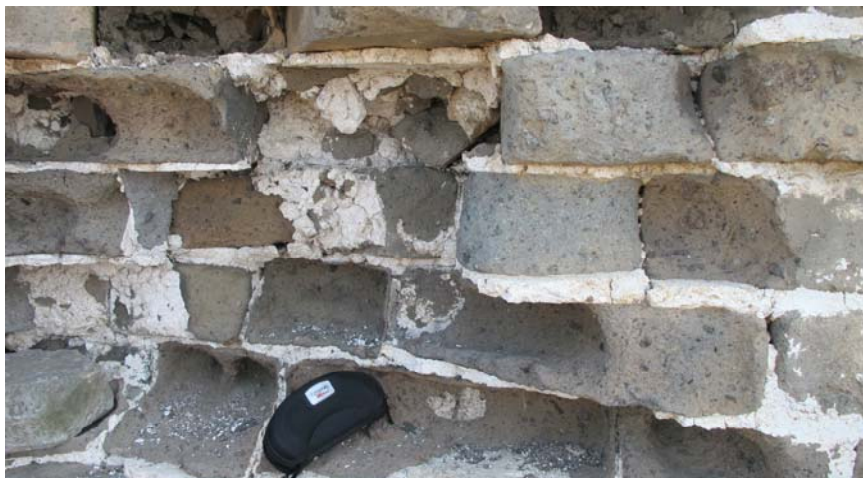
Sticky-Rice and Lime mortar.
Disintegrating bricks. #4

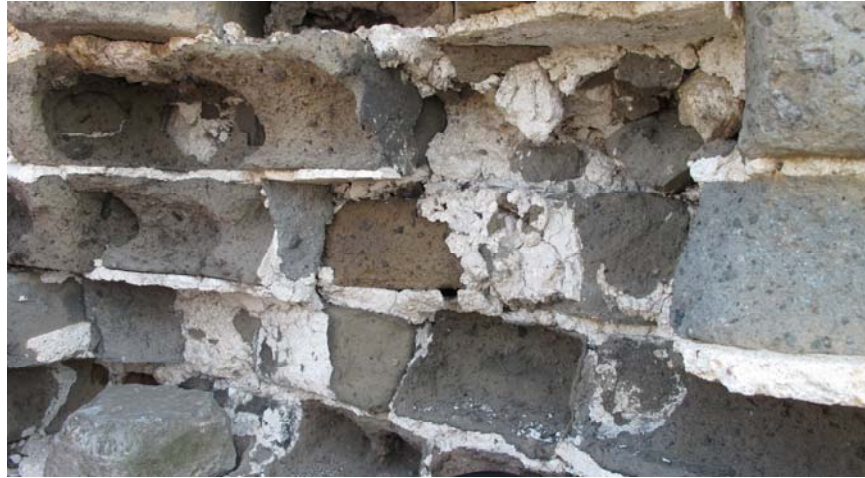
Sticky-Rice and Lime mortar.
Disintegrating bricks. #4

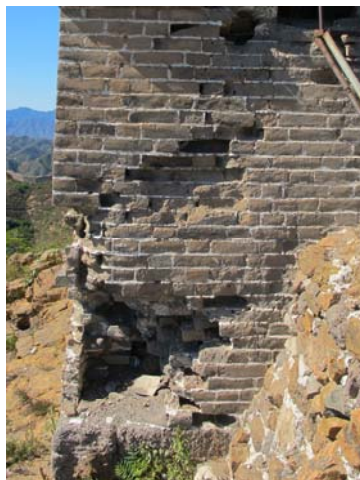
Sticky-Rice and Lime mortar
Disintegrating bricks. #4

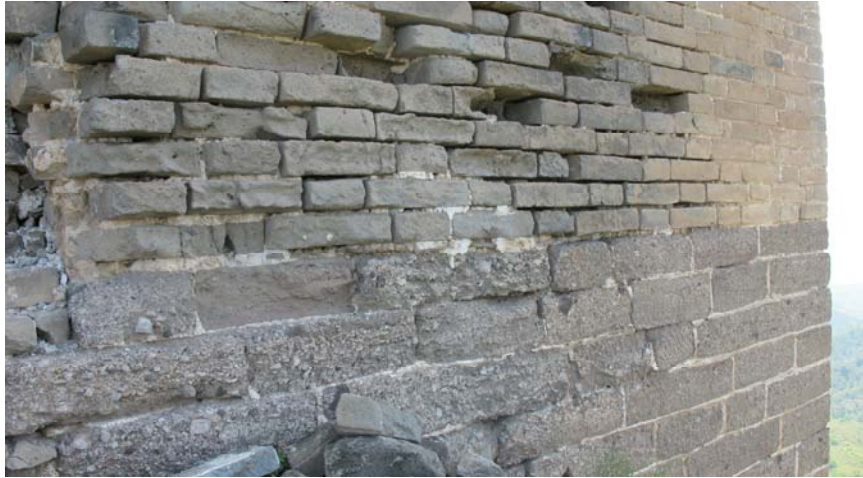
Disintegrating Sticky-Rice and Lime mortar. #4

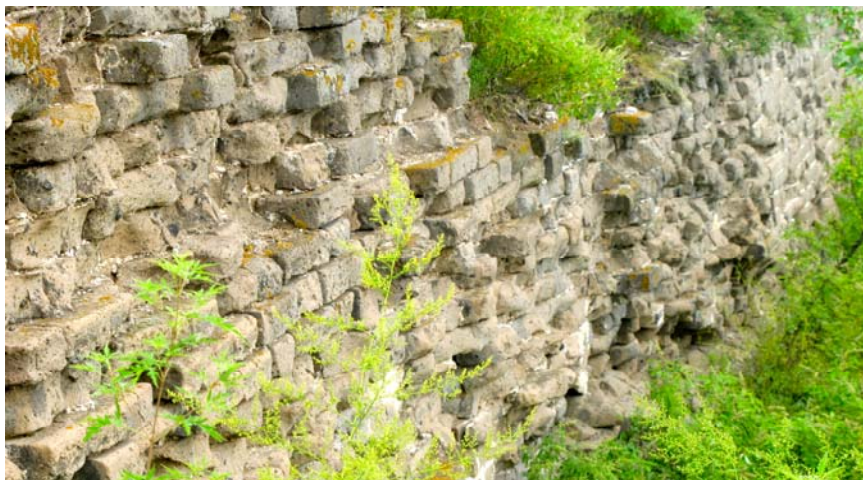
Sticky-Rice and Lime mortar & disintegrating bricks. #5

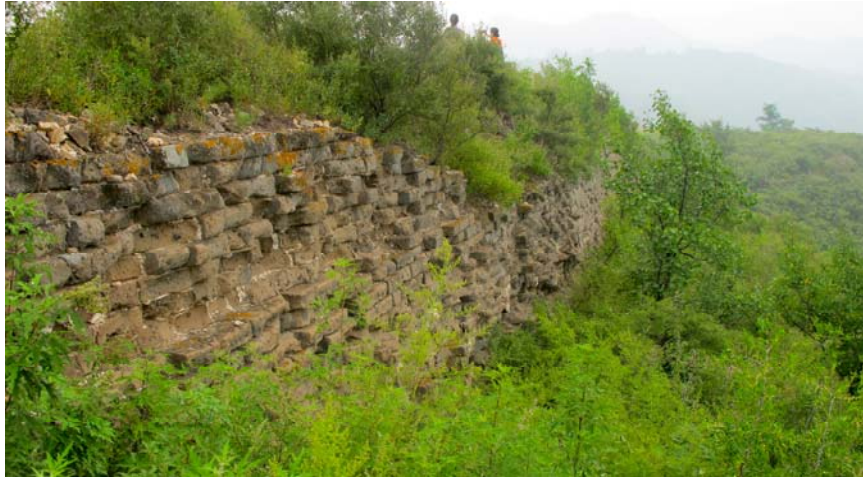
Sticky-Rice and Lime mortar &
disintegrating bricks. #5

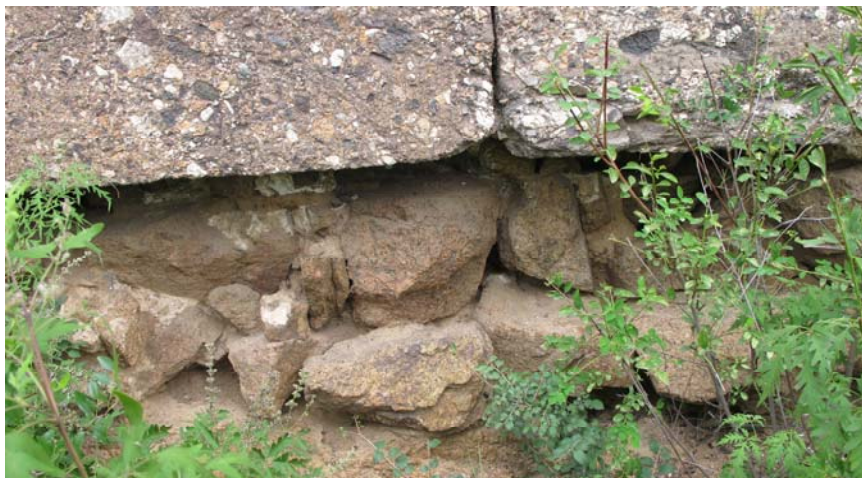
Figure 6. Rubble Foundation, erosion
on very steep incline. #5

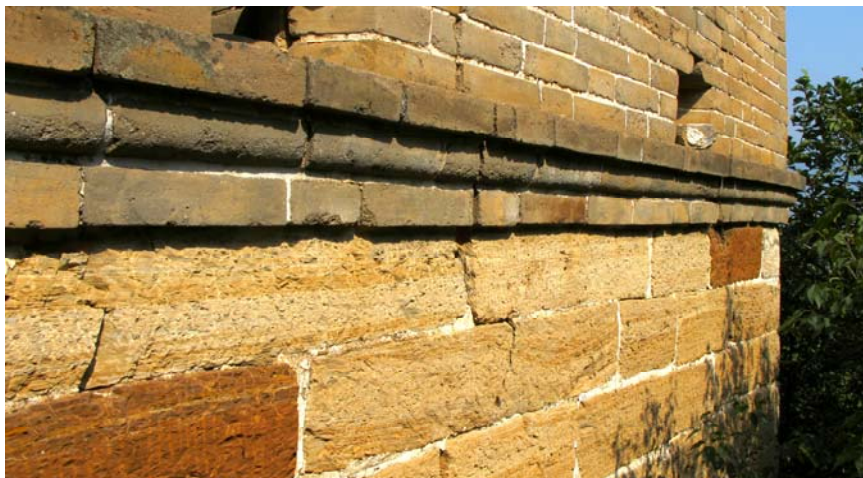
Quarried Stone on earth foundation.
Badly cracked walls. #8

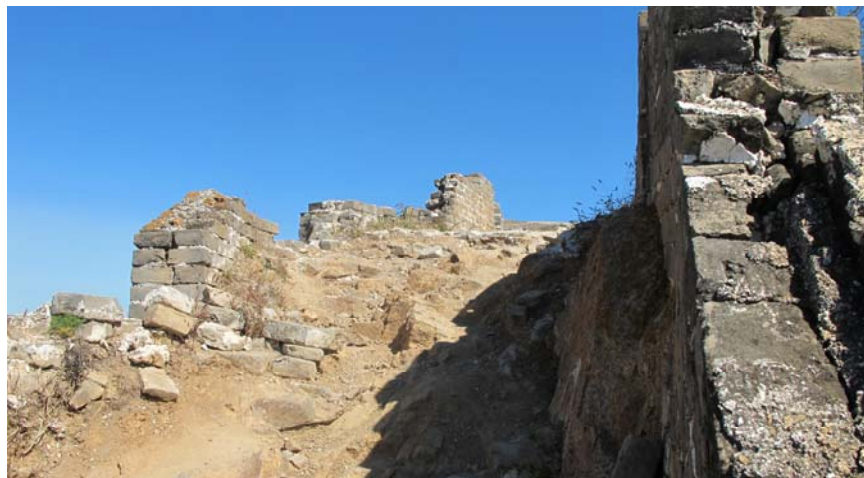
Figure 10. Foot traffic erosion. #4

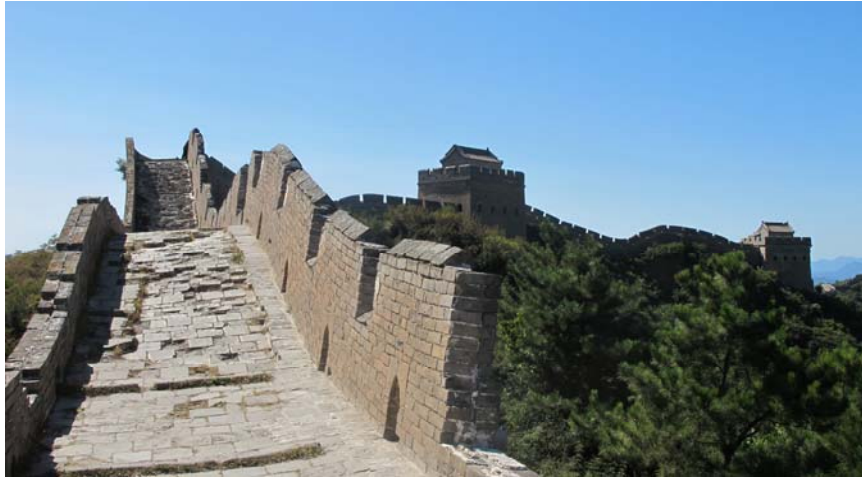
Figure 11. Outward lean. Parapet on right fallen away. #4

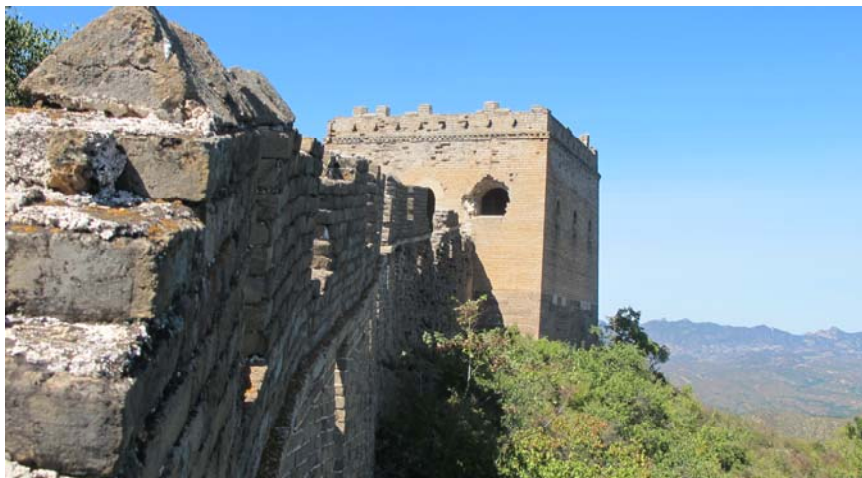
Outward lean & buckle. #4

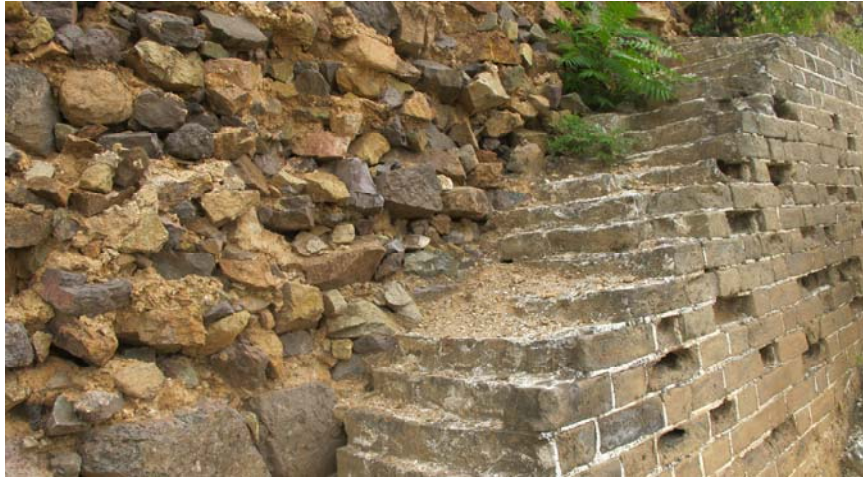
Figure 8. Rubble Core. Brick wall leaning in. #5

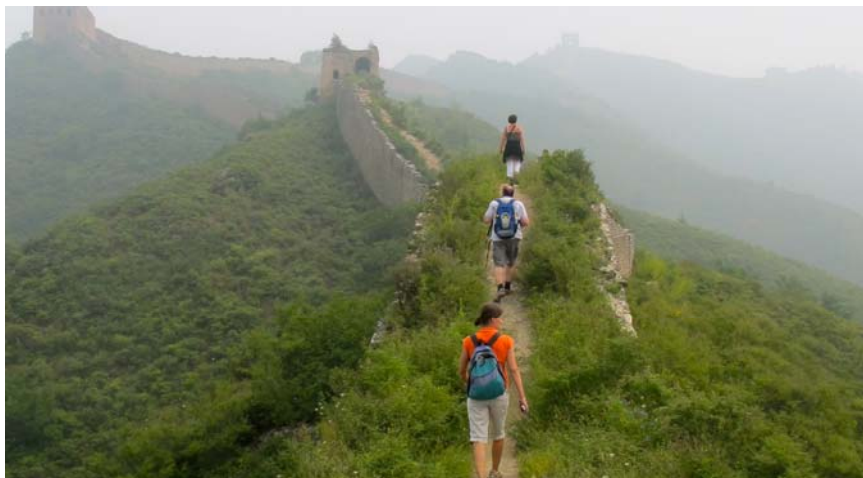
Wall intact but parapet missing. #5

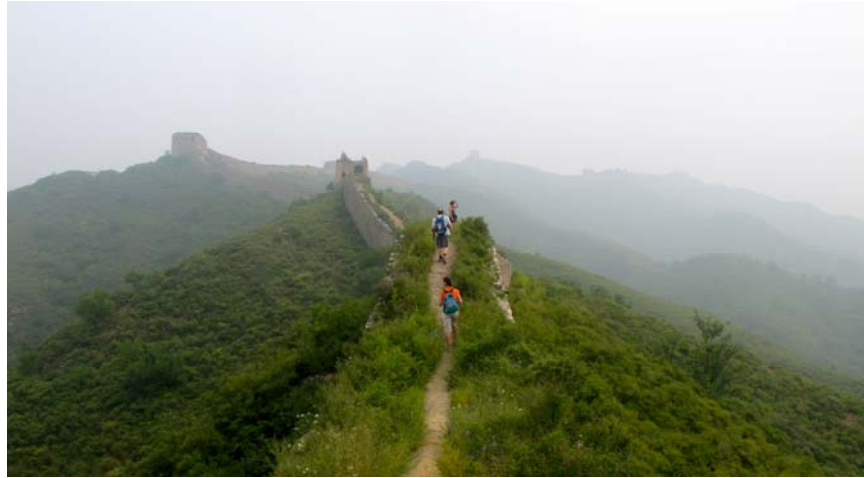
Figure 12. Outer walls brick walls slipped away. #5

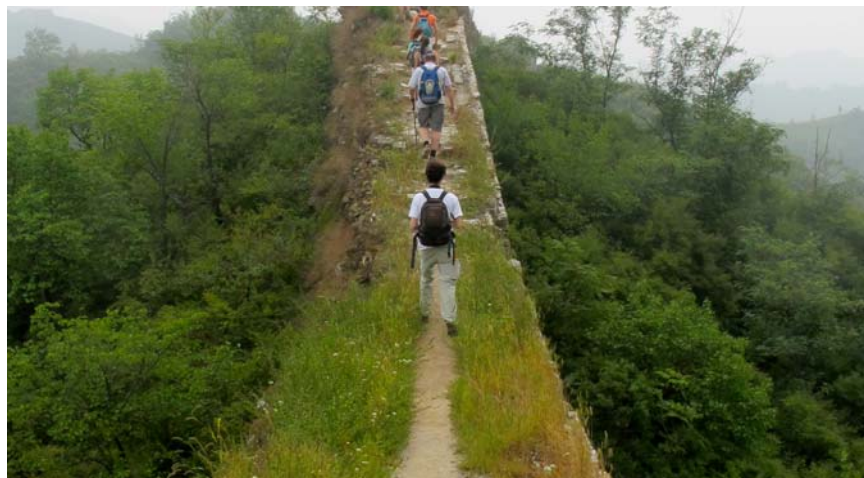
Slip section with Rammed Earth Core torn and exposed at an angle. #5

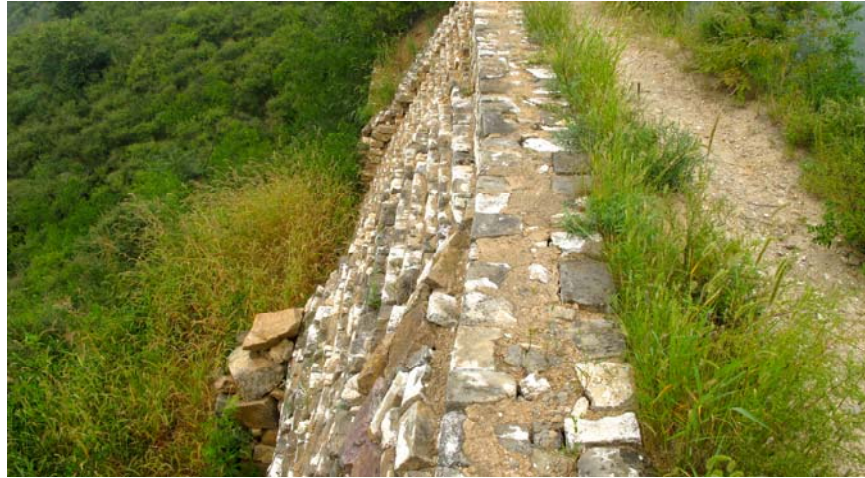
Repairs to a slipped section. #5

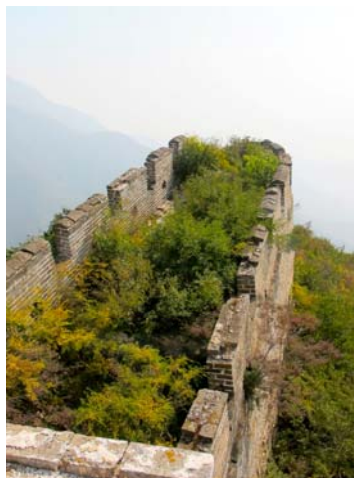
Vegetation in some areas is dense. #8

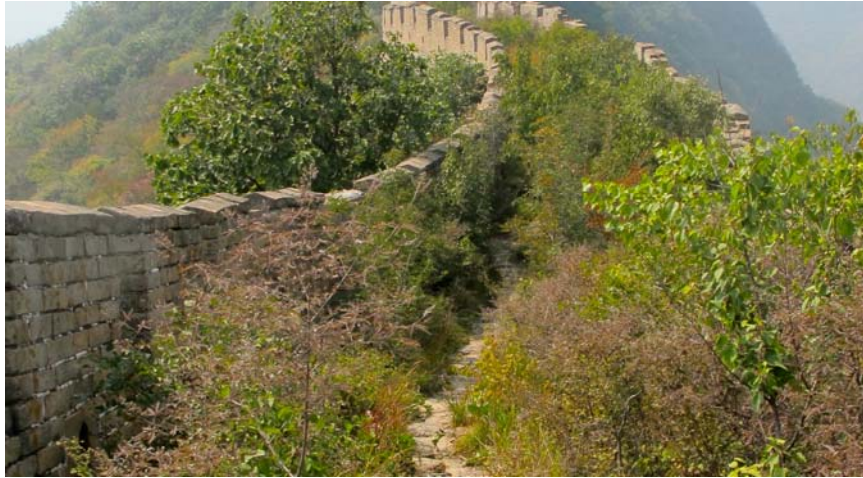
Vegetation in some areas is dense. #8

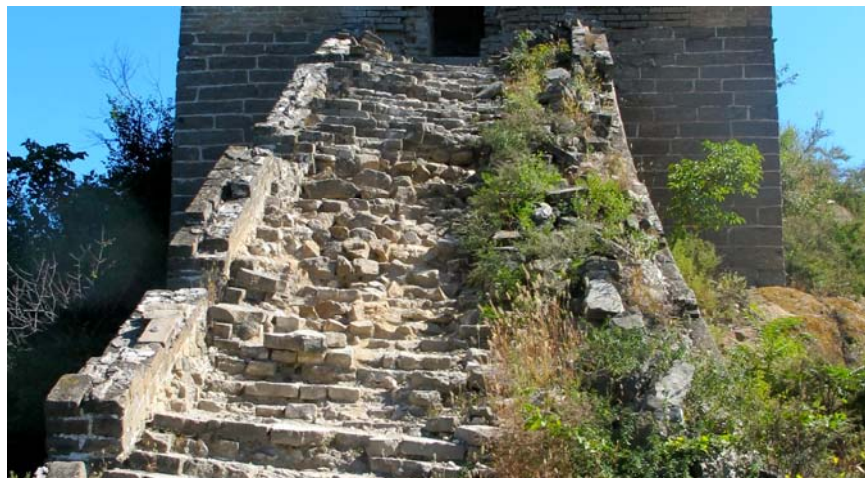
Rubble Core with some foot traffic erosion. #5

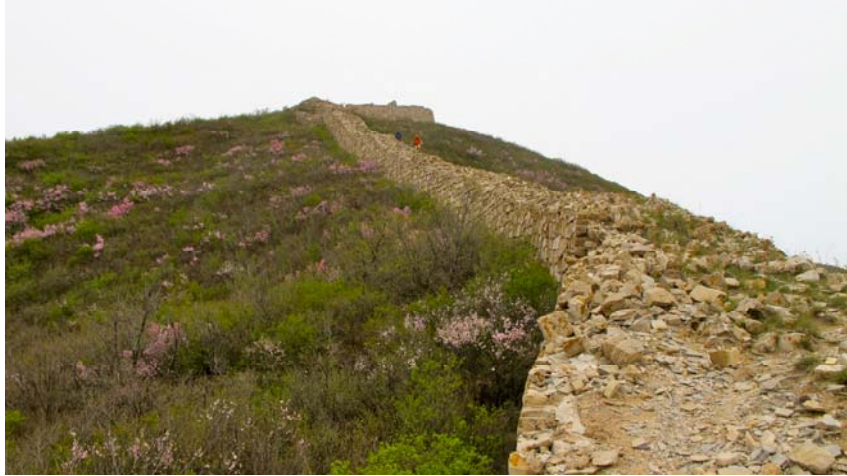
Stone parapets fall far sooner than brick on steep sections. West of #14

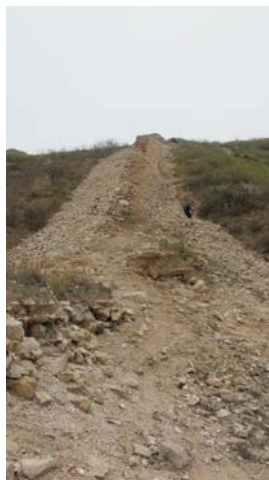
Steeper still the Wall readily falls to pieces. West of #14

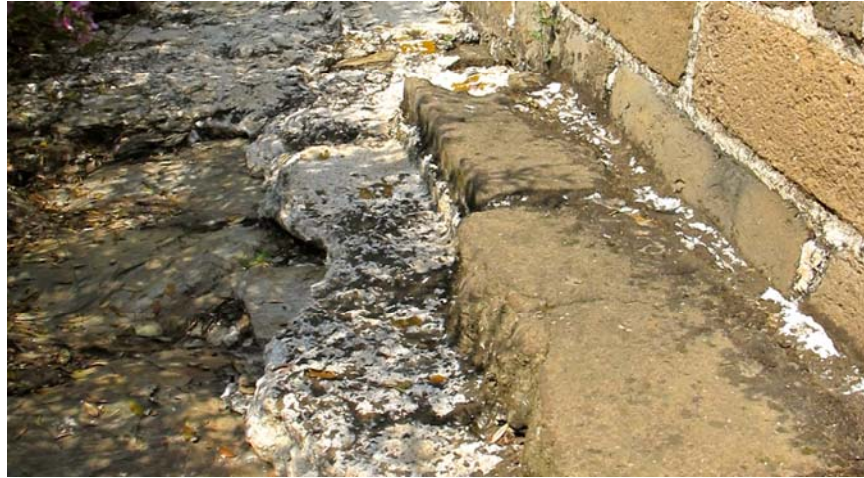
Only 1 course of (removed?) Pavers
over inferior Rubble Core. #8

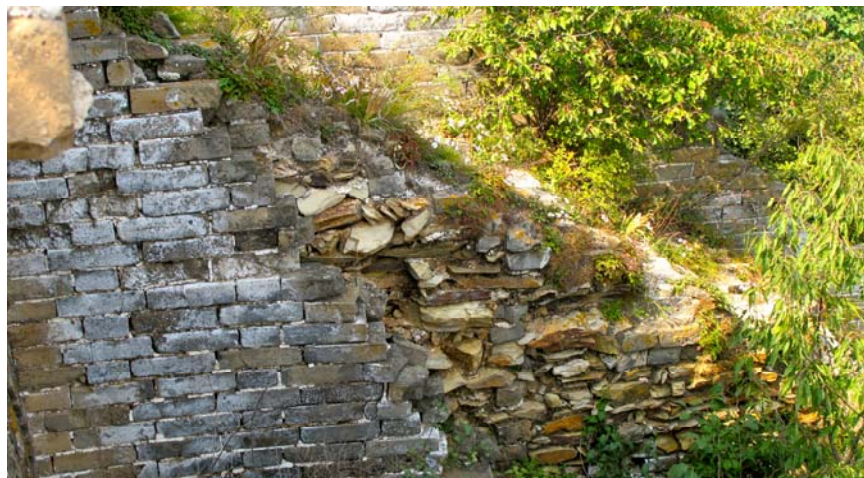
Inferior Rubble Core with little earth
between. #8

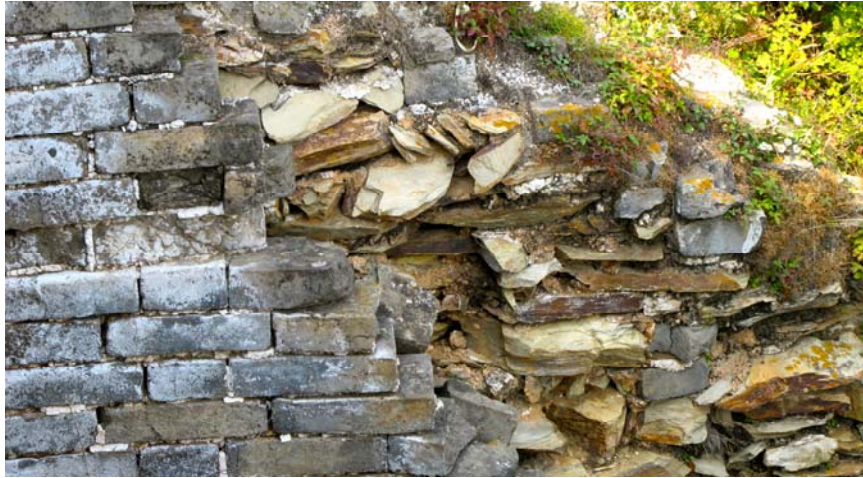
Inferior Rubble Core with little earth
between. #8

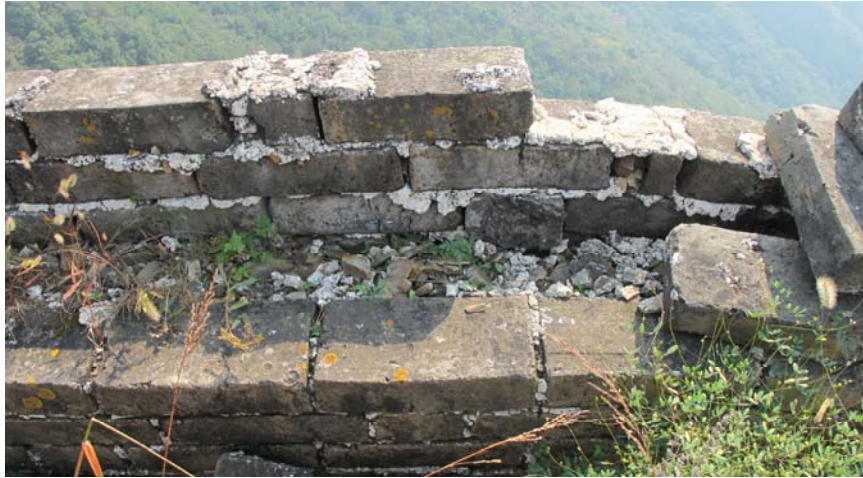
Poor design. #8

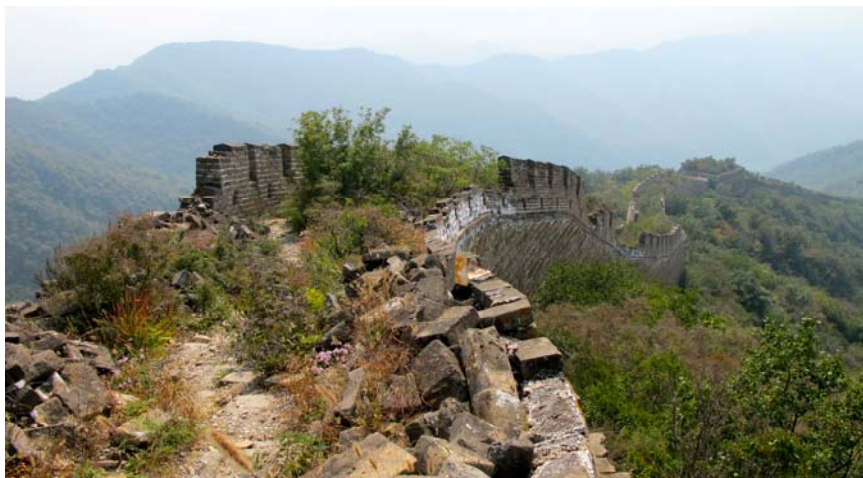
Poor design. #8

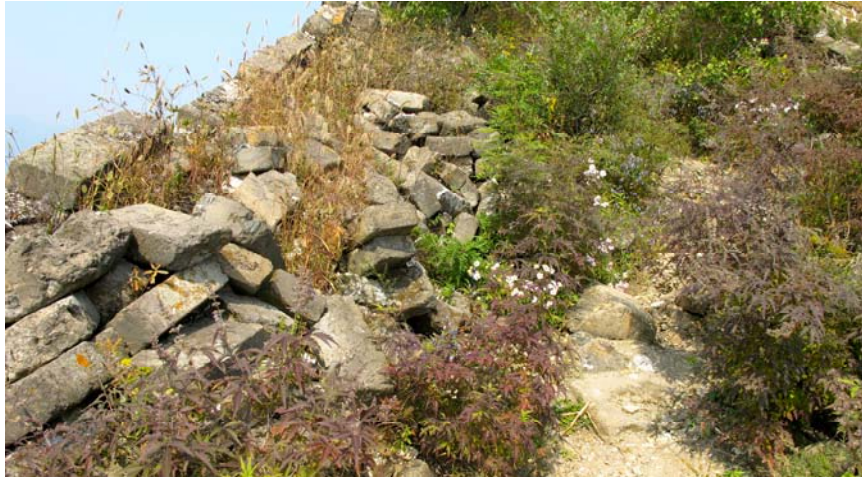
Parapet walls fallen in. Note extreme angle of wall. #8

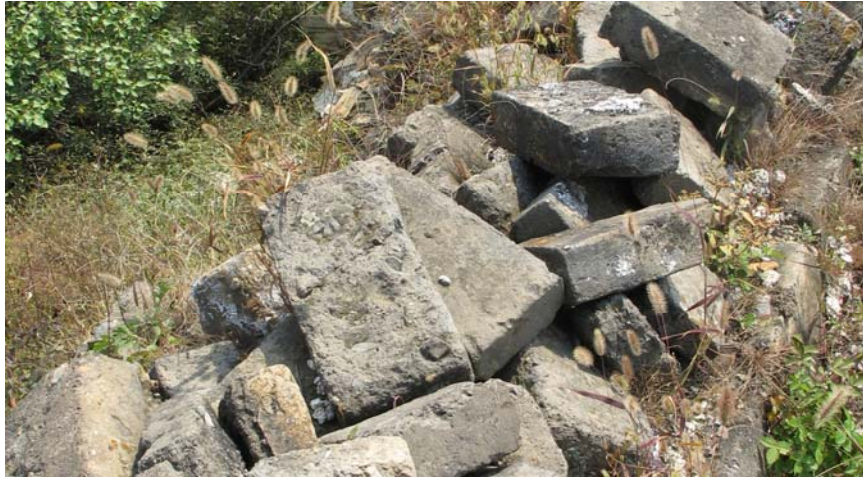
Parapet walls fallen in. Outer wall collapsed. #8
