Annual Report for Period:01/2010 - 12/2010

Award ID: 0908199

SGER: Material and Structural Response of Historic Hakka Rammed Earth Structures

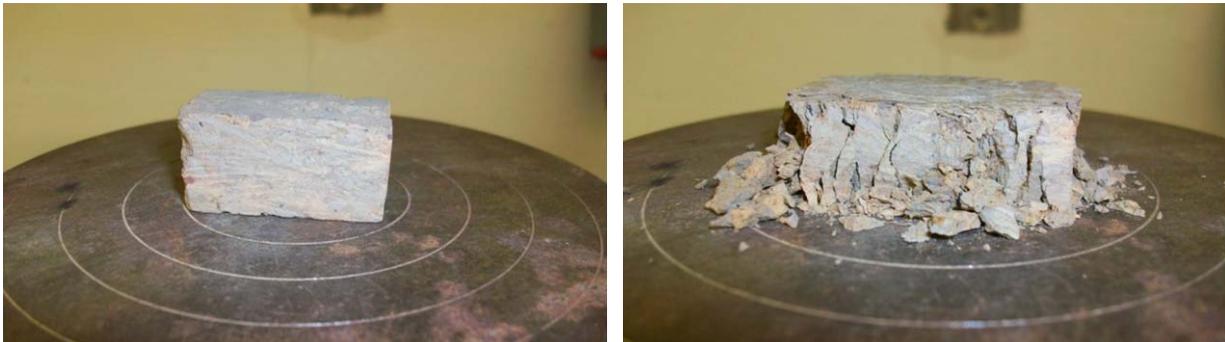
Figure 10: Chengqi Earth Sample before and after Testing at WVU

Rammed earth samples from the main wall structures of five Tulous were extracted and tested. Figure 10 shows representatively Chengqi Tulou earth sample before and after testing, while the resulting stress/strain curve is shown in Figure 11. Table 3 summarizes the results of the rammed earth compression tests performed by both WVU and Xiamen University. Note that testing of Huanji Tulou earth samples did not result in reliable property data.

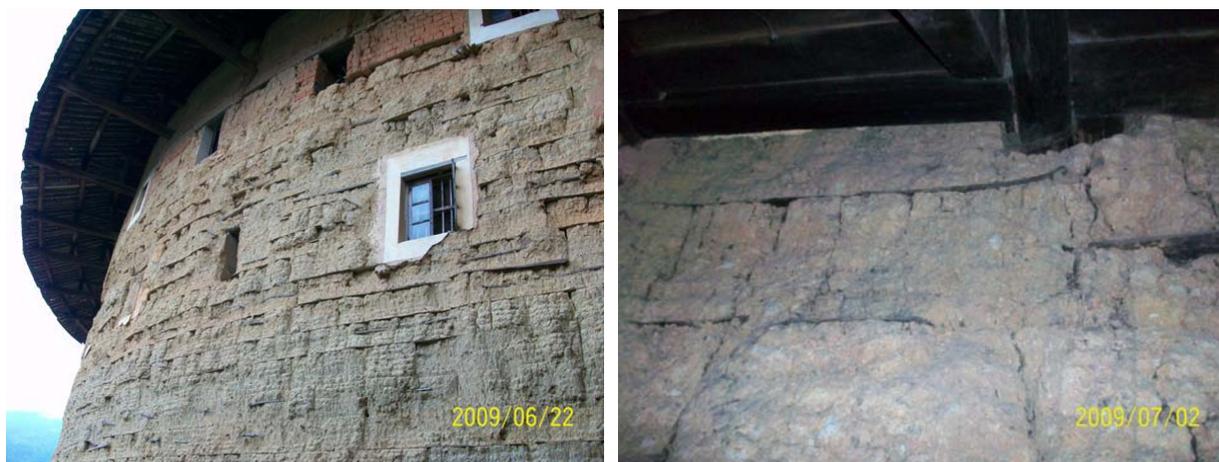
Figure 12: Rough Rammed Earth Walls of Chengqi Tulou Showing Layer Construction and Wall Ribs

properties (Figure 13) and typical stress/strain curves are shown in Figure 14. Table 4 shows the test results of wood and bamboo reinforcement strips as well as structural wood that were used in the inner structures of the Hakka Tulous.

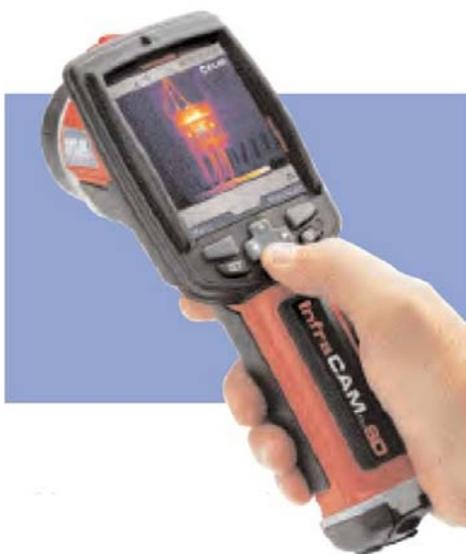
Figure 19: Portable Handheld IRT Camera Used

Infrared thermography (IRT) is a viable non-destructive evaluation method potentially capable of scanning a large area of testing structure and detecting subsurface delaminations and debonding between the surface layer and the substrate. This technique is based on the principle that subsurface defects and delaminations affect the overall thermal conductivity of the material, leading to different rates of heat transfer through sound and defective regions and thus, surface temperature differentials. For the present study, a brand new portable IRT camera model InfraCAM SD Camera was purchased (shown in Figure 20) and brought to China for field studies.

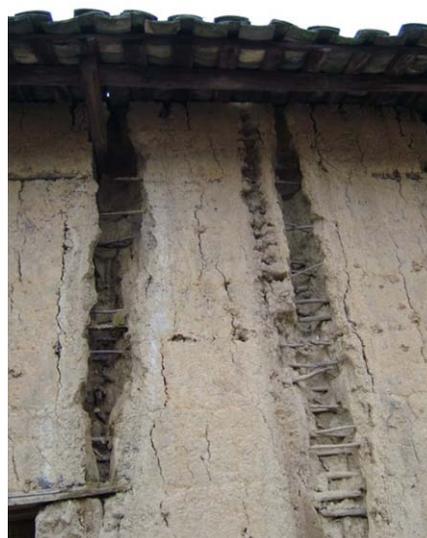
Figure 21: Eroded Rammed Earth Wall of a Tulou Exposing Wooden Chips Inside [19].

IRT camera was intended to perform a couple of functions upon verification of its usefulness during field study. One function would be explored if it could be used to identify the presence of a wall rib with reference to a wall without wall ribs. If successful, we would be able to quantify the spacing, pattern, size and total volume of wood or bamboo wall ribs used as reinforcement within the rammed earth walls. A clear view of wall ribs inside a wall is shown in Figure 21.

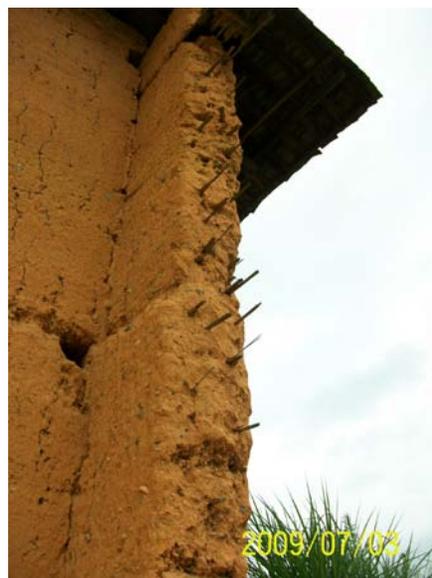
Figure 23: Bamboo Strips as Wall Ribs

To estimate the volume of reinforcement in a typical rammed wall, instead of using IRT scanning camera, a cross section of rammed earth wall was identified with pultruding bamboo wall ribs and shown in Figure 23. Dimensions of the exposed wall ribs, their spacing, and the wall thickness were field-measured and used to estimate the volume of reinforcement for this particular wall, also known as the fiber volume fraction that is needed in order to model the structural response of Tulous.

Bamboo samples were tested both in tension by the Xiamen University and in compression by West Virginia University. In tension, bamboo showed an average modulus of elasticity of 463178 psi and an ultimate strength of 4452 psi. In compression, bamboo showed an average modulus of elasticity of 300023 psi and an ultimate strength of 11039 psi. Even though this modulus is much higher than wood it is still much lower than that of the typical average modulus of elasticity of tension for bamboo which is about 2.76 msi [16]. Similar to the wood samples, the lower modulus of elasticity for the bamboo samples tested could be due to the age of the samples, representing degradation of the bamboo through aging since they were collected by cutting the pultruding section from the wall (Figure 23). The non-standard size of the samples tested may have also altered the results.

Based on the samples collected, the wooden rib samples were typically round and varying at around 1.5 inches in diameter, which results in a fiber cross section of 1.767 in² while bamboo rib samples were in rectangular strips with dimensions typically around .5 inch x 1 inch, which results in a fiber cross section area of .5 in². If one is to assume that the same spacing is used for both wood reinforcement and bamboo reinforcement as exhibited by the exposed wall ribs in Figure 23, then the volume fraction for wood reinforcement comes out to be 6.7% and the volume fraction for bamboo reinforcement to be 1.8%.

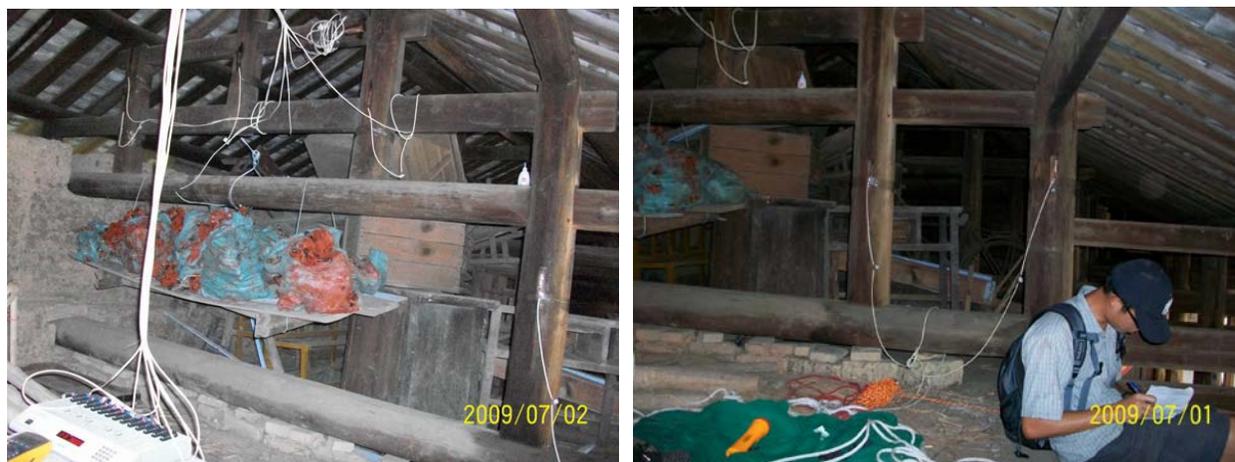
Figure 27: Load Testing of Roof Truss

The roof truss structure is much more complicated as compared to the floor system and is shown in Figure 27. The roof truss system consists of a group of horizontal members and vertical members, with each being connected to another through pinned connection. The roof truss load testing was also conducted at Chengqi Tulou by means of a two point loading of up to 550 lbs. The load was applied onto a horizontal beam with the largest span while several vertical members were attached to this beam, which support roof beams. Figure 27 shows the major sections of the roof truss structure being evaluated while the entire roof truss structure is schematically illustrated in Figure 28 where each member is assigned with a number (M1 to M14) and strain gage locations are indicated with reference to mounting member. More specifically, the load was loaded onto Beam M10 between Columns M3 and M4.

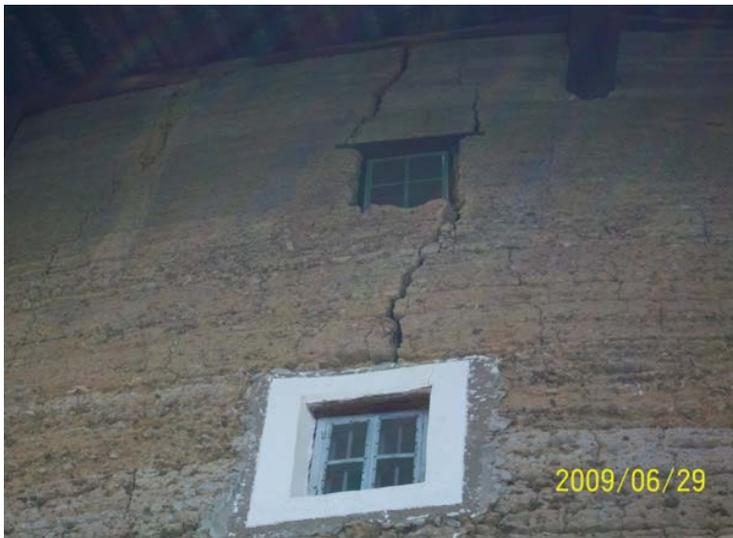
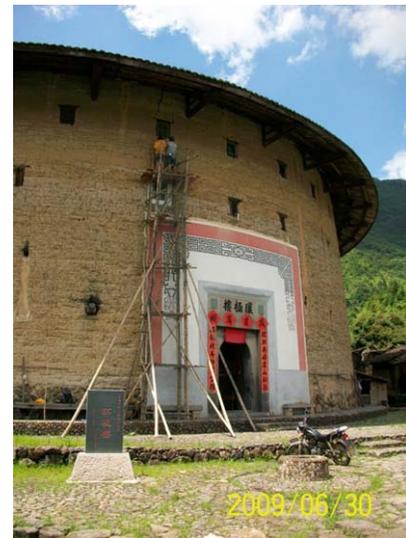
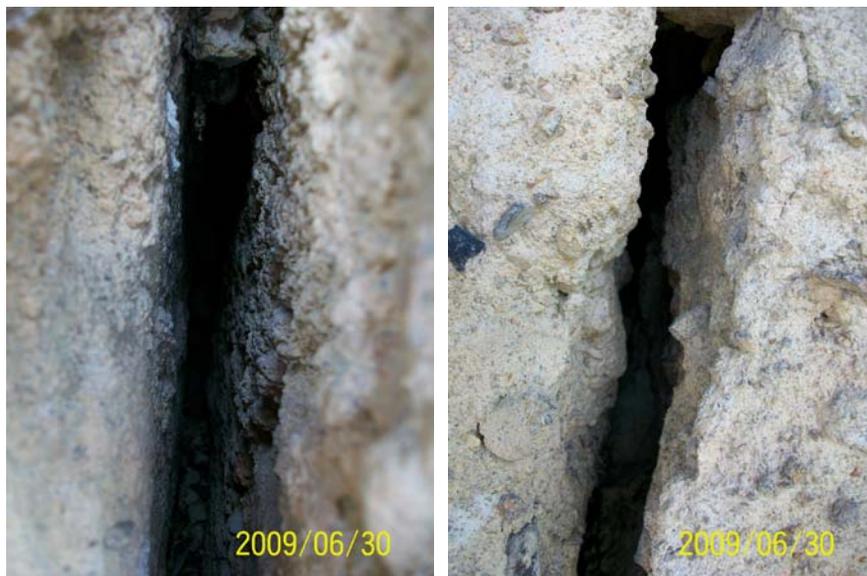
Huanjilou Tulou has an O/D 43.2m and 20m in height. The crack is about 10 meter above the ground. To access and examine the crack, a construction worker was hired to build an access platform using bamboo to that height during field study (Figure 31). After measuring the crack during the field study in the summer of 2009, including use of laser distance to measure its depth, it has been found that the crack is about 350 cm in height including the crack thru the 4th floor window, with the crack between 4th floor window and 3rd floor window being the worst. That section is 178 cm in height, 5 to 10 cm in width, and 93 cm in depth. As shown in Figure 32, this crack is across the entire wall thickness and there are no wall ribs in the wall.

Figure 30: Huanji Tulou Crack After Earthquake

Figure 31: The Location of Huanji Tulou Wall Crack and the Access Platform Used during Field Study

Figure 32: The Through-the-Wall Thickness Crack of Huanji Tulou

If in fact the crack was originally 20 cm in width as initially reported, there could be some kind of self healing process that can possibly be explained scientifically. In order to further analyze the structural behavior of the Hakka Tulou buildings, finite element modeling was used to duplicate the structural behavior experienced in real world conditions. Figure 33 shows the 3D model using the modulus of elasticity values reported in Table 4 as well as actual dimensions of the Huanji Tulou. The modulus of elasticity used was taken from Wuyun Tulou samples as this value is most conservative and no property data available for the earth samples from the Huanji Tulou. Also included in the model is the reported 20 cm wide crack that is 3 meters in length.

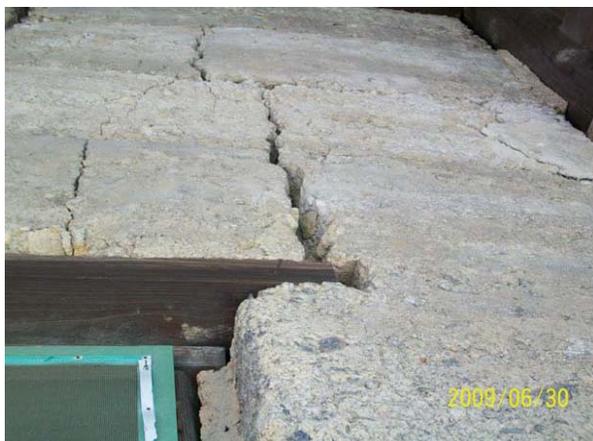
Figure 35: The Cracking and Cavity at Lintel End

Figure 36: Lintel Behavior

The crack at the Huanji Tulou reportedly occurred due to a strong earthquake that hit the region. The crack began at the end of a window lintel due to high stress concentrations occurring from bending of the upper portion of the lintel. Why and where exactly the crack formed (Figure 35) has been accurately modeled using FE analysis, based on Lintel behavior as shown in Figure 36 along with an earthquake load, using the material property data generated from this study. Figure 37 is a chart illustrating the stress in vertical direction upon application of a 220 kips horizontal load induced by an earthquake. Details can be found in [26]. Through the FE modeling one can see exactly how an earthquake load can cause increased loading in the Tulou and in return cause higher stresses leading to potential cracking. The FE modeling further demonstrated that if the rammed earth wall of Huanji Tulou were reinforced with wall ribs, such cracking could be totally avoided. Cracking could have also been avoided by using a stiffer lintel. This might explain why other Hakka Tulous in the area survived from the earthquake even without cracking.

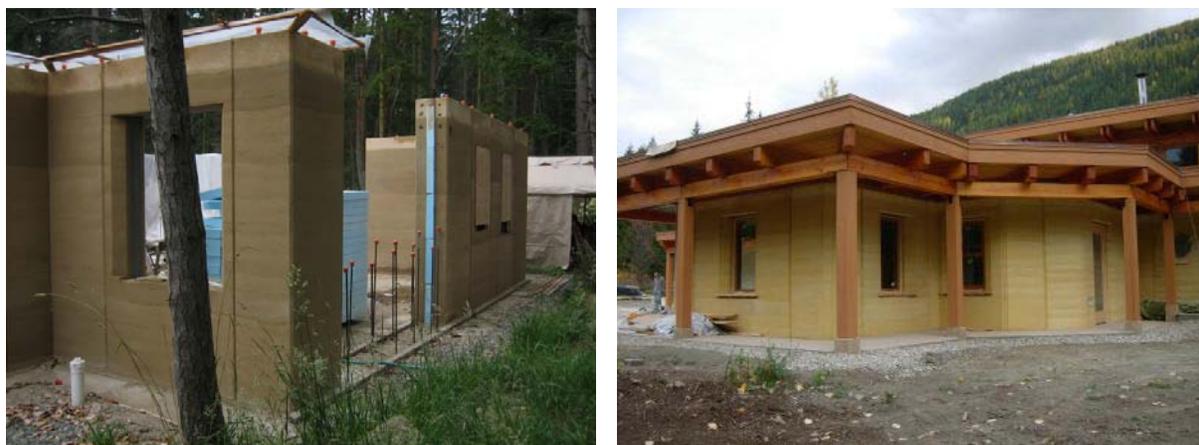
Figure 43: Modern Rammed Earth Construction [5]

Modern construction focuses much more on the use of concrete in structures as it too has a high thermal mass and even higher material strength than that of rammed earth. The benefit to using rammed earth lies in its numerous environmental benefits including zero CO₂ emissions when compared to concrete and steel. Rammed earth is a completely natural material that involves a timely production process involving compressing a natural mixture of earth, rock, and other materials. This process releases zero CO₂ during and after the fabrication process of rammed earth, while wood comes from trees that absorb CO₂ through photosynthesis process that converts carbon dioxide into organic compounds, using the energy from sunlight. Cement production on the other hand, a common ingredient in concrete, releases anywhere from 5-10% of the world's total CO₂ emissions into the earth's atmosphere [42]. As already known, CO₂ emissions have been an important topic of debate as CO₂ is listed as one of the more common greenhouse gases in existence. Other benefits from rammed earth construction include its recycleability, low operation cost, and cost savings in material, transportation, and energy. With the Hakka Tulous serving as a prime example of what rammed earth construction can offer, rammed earth could prove as a viable building material option over that of concrete. Modern rammed earth construction can take what the Hakka people created and make it even more energy-efficient. Examples of modern rammed earth constructions are shown in Figure 43.

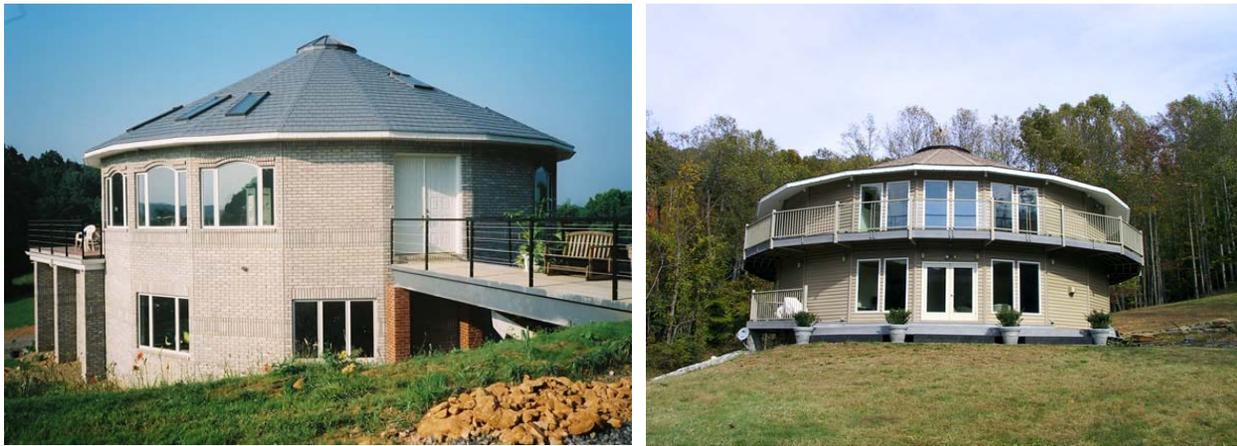
Figure 44: Round Houses Built by Deltec Homes [44]

Other than the materials, Hakka Tulous offer outstanding architectural designs that have existed for over one thousand years and survived from several major earthquakes and numerous hurricanes. Our FE modeling of this study has demonstrated those Hakka Tulou structures’ superior earthquake resistance, while a Japanese research team has simulated Hakka Tulou’s response under strong wind [43]. These observations and continuing effort may lead to potentially transformative research ideas for modern construction of more disaster resistant structures. For example, school building design and construction, in the paths of potential hurricanes, floods and tornadoes or in earthquake-prone regions, might adopt the style of Hakka Tulou structures. It was reported that the round single family houses built by Deltec Homes Inc as shown in Figure 44, were much more hurricane resistant and energy efficient than conventional houses [44]. When Hurricane Katrina struck the Gulf Coast in 2005, none of the Deltec homes in her path suffered any structural damage from Katrina’s category 5 hurricane force winds, because there is not enough surface area on any part of the round house for pressure to build up. In addition, their less exposed surface area than square house offer

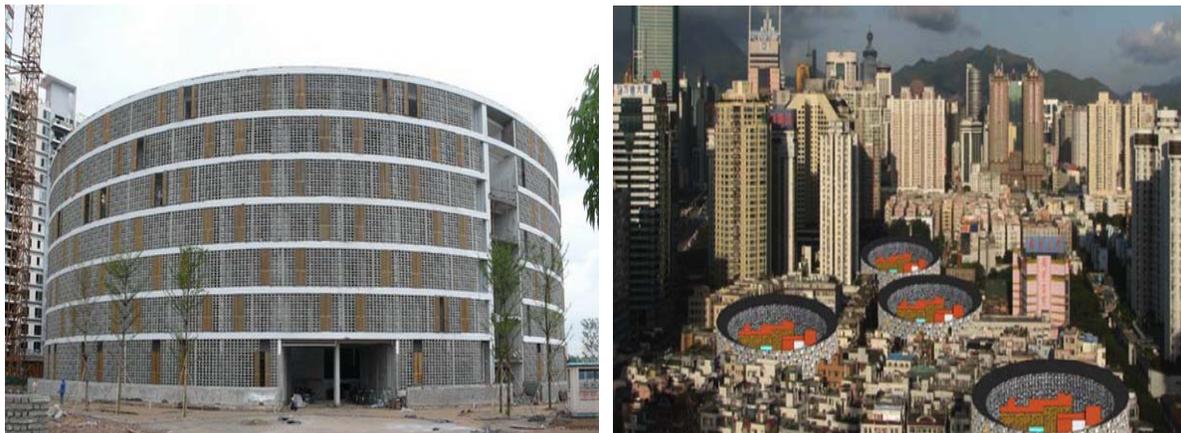
Figure 45: Modern “Tulou” under Construction in Guangzhou, China (Designed by Urbanus) [45]

superior energy efficiency and improved durability [44]. The style and design of Hakka Tulous might be also emulated for construction of multi-story, multi-family dwellings in city. A design group named Urbanus in Shenzhen, China is currently experimenting Hakka Tulou concept in Guangzhou, China as a solution to provided affordable housing for people and the experimental project, a round apartment as shown in Figure 45, incorporates 278 apartment units, a dormitory, a small hotel, shops, a gymnasium, a library, and various public spaces [45].
