Structural Responses and Finite Element Modeling of Hakka Tulou Rammed Earth Structures

Thesis submitted to the
College of Engineering and Mineral Resources at
West Virginia University in
partial fulfillment of the requirements
for the degree of

**Master of Science
in
Civil Engineering**

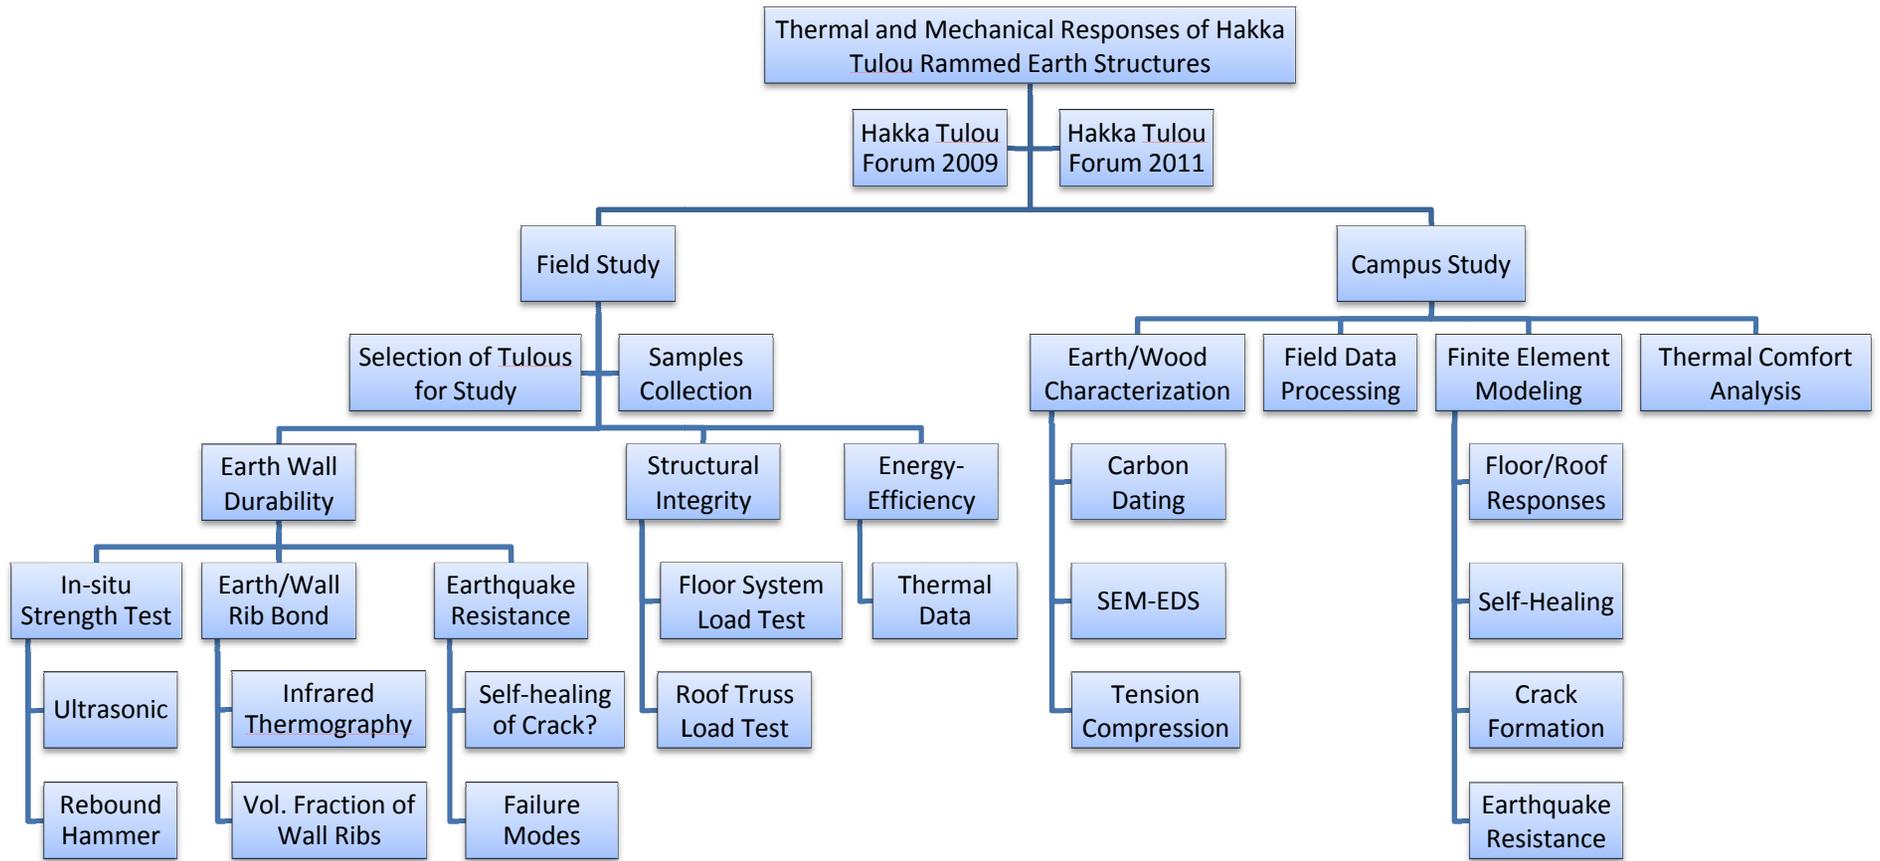
Figure 1-Scope of Work

All field studies were conducted in a nondestructive manner using techniques and equipment such as Infrared Thermography (IRT) Scanning Camera, Rebound Hammer, Ultrasonic Testing Device, strain data acquisition for load tests on the wooden roof truss and floor components, and thermal data acquisition including humidity data from thermocouples. The data collected from the field study was then further processed at West Virginia University for their implications and material samples that were collected were further tested at laboratories for their mechanical properties. Computer modeling on the structural responses of Hakka Tulous was conducted using the material properties generated from the lab testing. The overall scope of work of the project is illustrated in Figure 1.

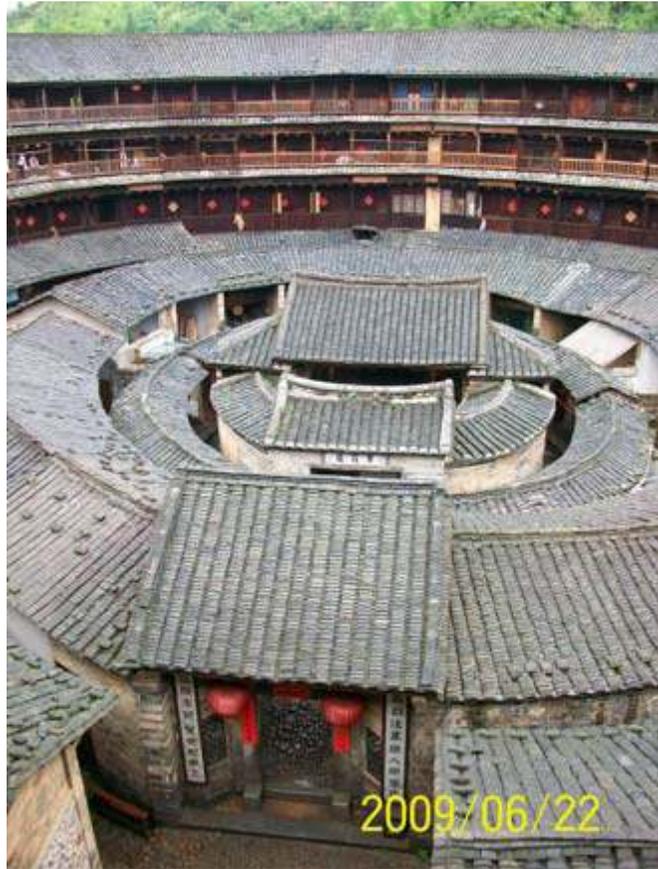
Figure 3-Interior of Chengqi Tulou

(Wang 2008). The Tulous can house anywhere from 5 to 600 people, with the largest Tulou having over 250 residential rooms. The construction of the Hakka Tulous is very unique as can be seen by the interior picture of a circular Tulou in Figure 3.

Every Tulou is built around an ancestral shrine that is home to Chinese superstitions. This ancestral shrine, which can be seen in the center of the courtyard in Figure 3, is of great importance to the local culture and tradition of the Hakka people. Each Tulou has one main entrance into the structure which leads directly into the courtyard of the building. From this courtyard, one is better able to see the wooden interior structure of the Tulou. Aaberg-Jorgenson (2003) has also created a cross section of a typical circular Tulou that can be seen in Figure 4.

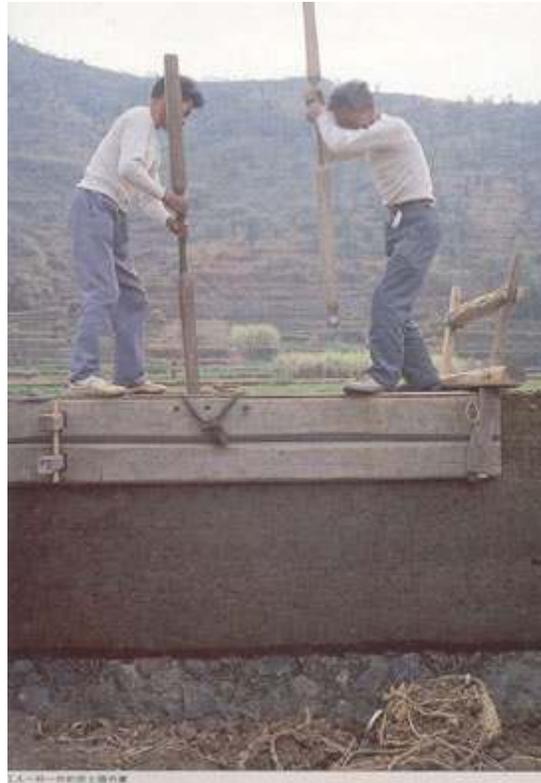
Figure 5-Rammed Earth Process (Aaberg-Jorgensen 2003)

comfort to the inhabitants of the Tulou. The construction of the rammed earth walls is a laborious process that requires a mould in which the sanhetu will be placed. Bamboo and/or wooden sticks/chips are also added to the mix to act as reinforcement. From this step, the mixture is rammed together using either stones or other tools, as can be seen in Figure 5.

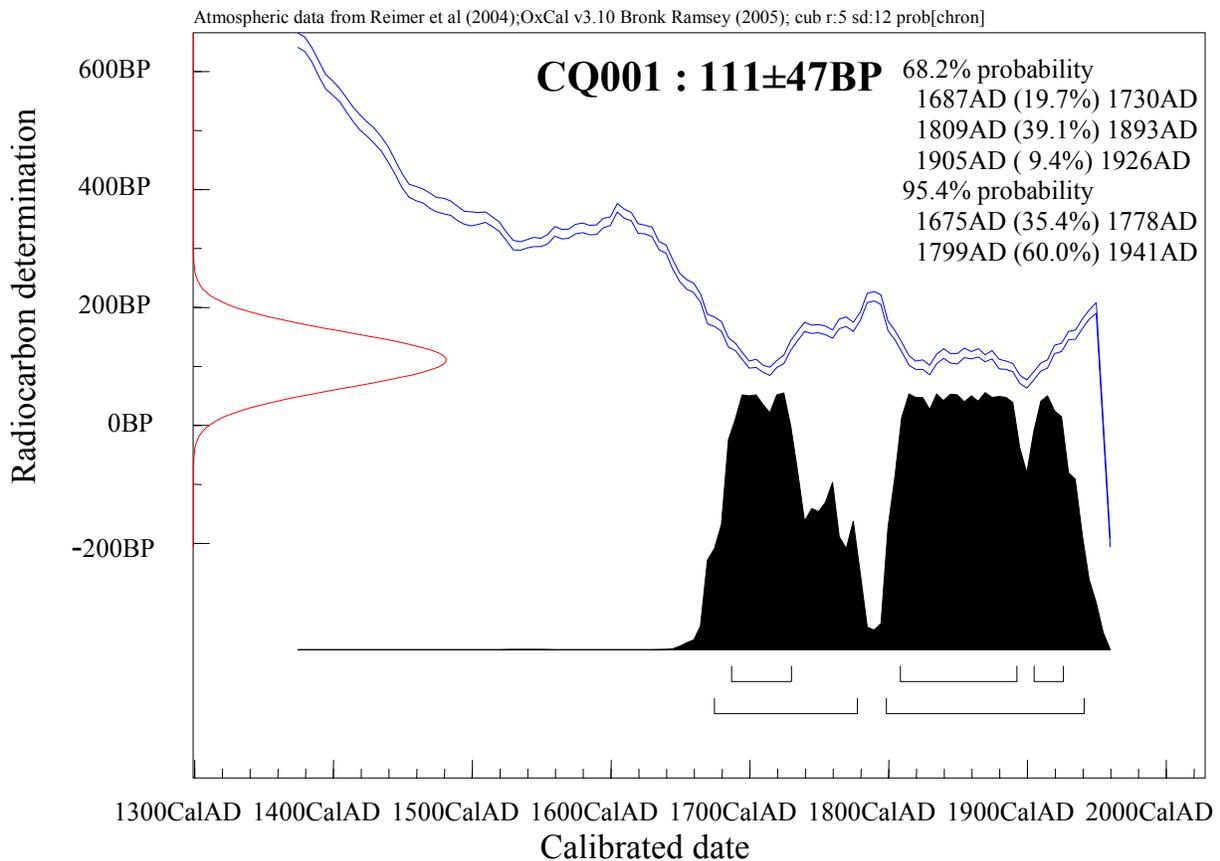
Figure 6-Carbon Dating Results of Chengqi Tulou

To validate the ages of the Tulou buildings and material samples, initially provided to us by local records and locals of the respective Tulou regions, a material sample was sent for carbon dating. A wooden sample from a roof truss beam in the Chengqi Tulou, estimated by records to be built from 1662-1709, was sent to the NSF Arizona AMS Facility at the University of Arizona for carbon dating. The results of the carbon dating test can be seen below in Figure 6.

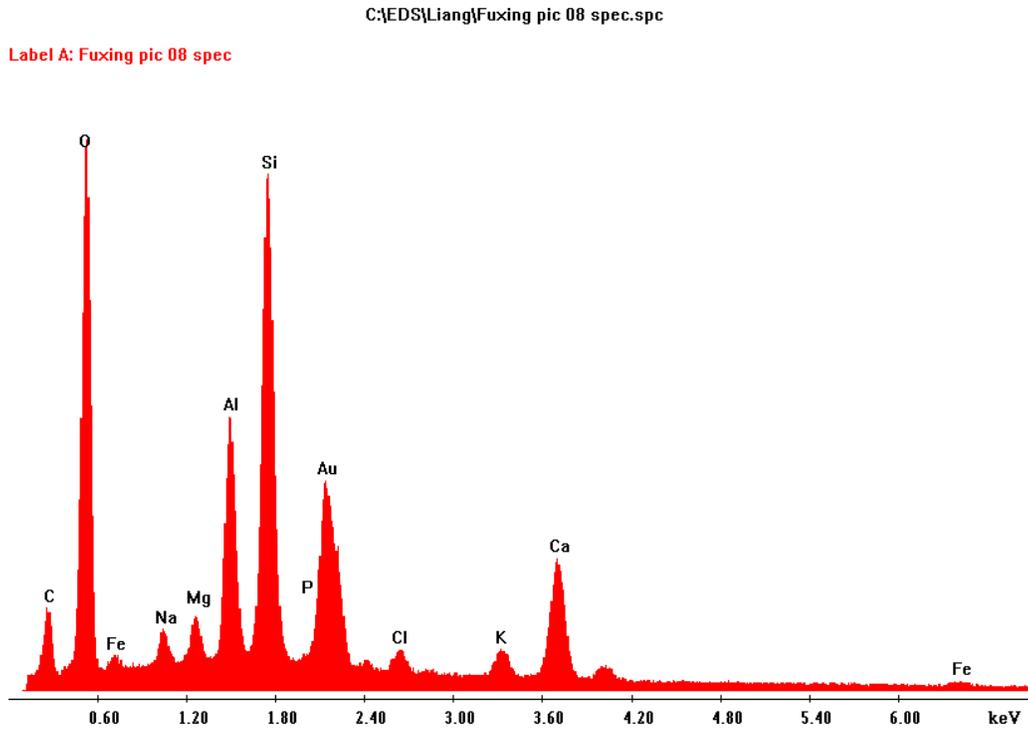
Figure 12-Fuxing EDS Results

existing elements relatively to each other. Figures 12-16 below show the chemical composition from samples of five Tulous organized from the oldest to youngest Tulou.

From the EDS data one can see that all of the samples from the five different Tulous show an abundance in oxygen, silicon, and aluminum as well as gold. It was noted by the test administrator that gold should be neglected from the results as it is from the sample preparation coating, not from earth samples themselves. Three of the five Tulous, Zhencheng, Chengqi, and Wuyun, show an abundance in titanium and the Chengqi and Wuyun Tulous also show significant amounts of carbon, due to the presence of wood peices. As can be seen from the varying results above, the composition of these samples is unique to what is locally available on site for each of the respective Tulou. For the autogenous healing process discussed later in section 4.3.2, the key ingredient that one is to look for is calcium. Calcium is the key element in lime which is what causes self healing as explained later. The initial theory was that lime must be existent in the rammed earth of the Huanji Tulou in order for the crack of 20 cm to self heal. Based on the EDS data, no calcium was found in the sample of the Huanji Tulou and so this theory is thrown into question. One variable that could explain the lack of calcium is simply that the sample tested was a small sample with respect to the rest of the structure. There is a possibility that other areas of the rammed earth wall do contain calcium and simply the sample tested did not. Overall, out of the samples tested, only the oldest Tulou, the Fuxing Tulou, displays an abundant amount of calcium. This large amount of calcium in the Fuxing Tulou has

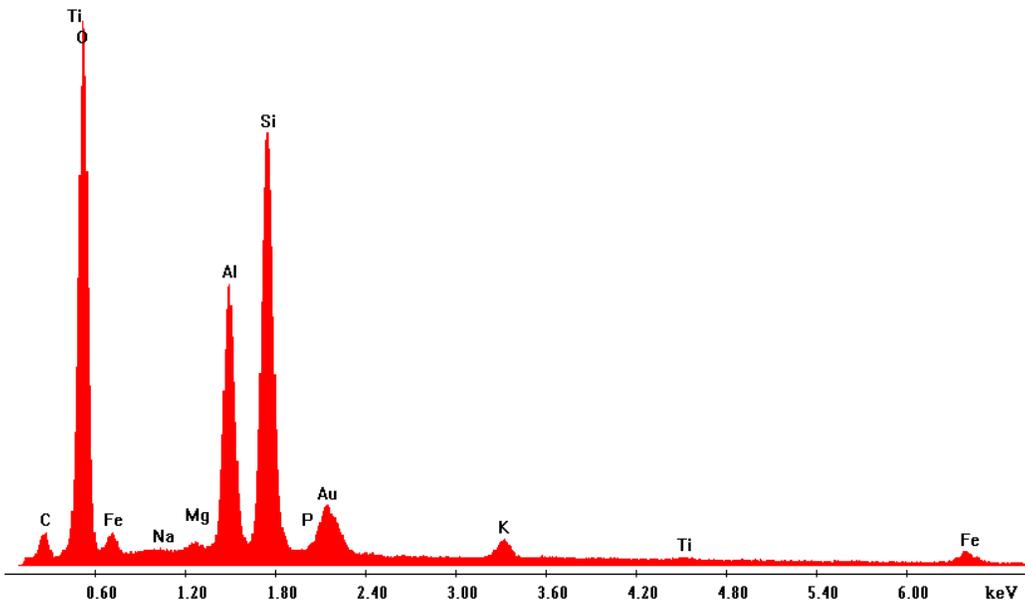
Figure 16-Zhencheng EDS Results

Label A: Zhen Cheng pic 05 spec

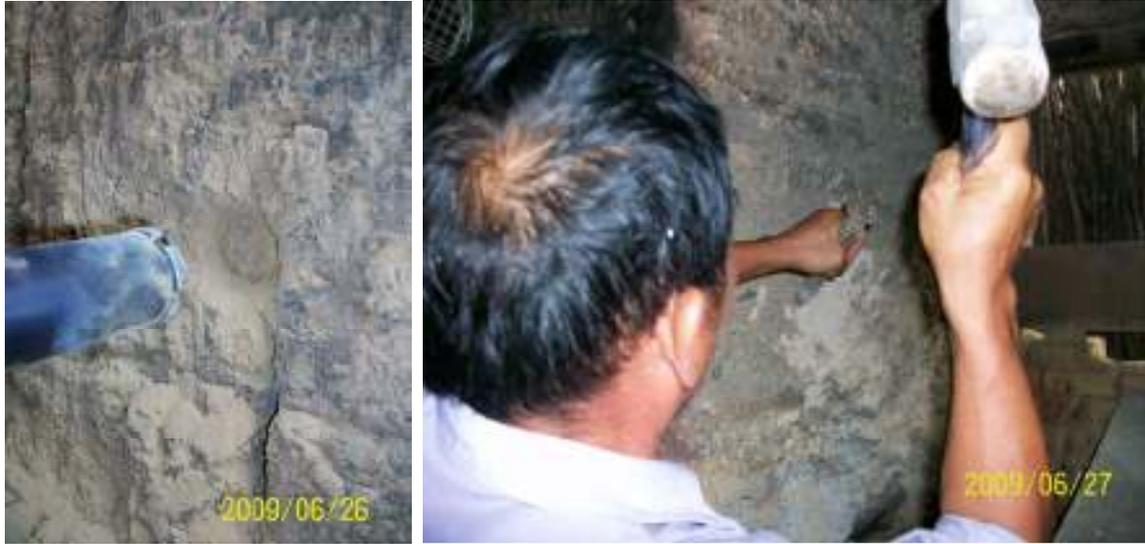
Figure 17-Failure of Core Extraction and Collection of Wall Samples

In order to analyze and accurately model the Hakka Tulous, an understanding of the strength of materials must be acquired. Samples of materials, such as rammed earth and wooden and bamboo reinforcement that were used in some Tulous rammed earth walls for increased strength, were taken from several of the Tulous that were visited during June 15-July 15, 2009. Samples of the materials are not of ASTM standards in size due to the destructive nature of collecting the samples from the existing historic structures. ASTM suggests that for wood compression tests parallel to the grain samples be 2x2x8in in size and that rammed earth tests follow standard construction material tests (ASTM 2010). Cores of the rammed earth walls from the Tulous were not able to be successfully extracted due to the rammed earth becoming brittle under the vibrations caused by the extracting equipment. Instead samples had to be chiseled out of the wall as can be seen in Figure 17 below.

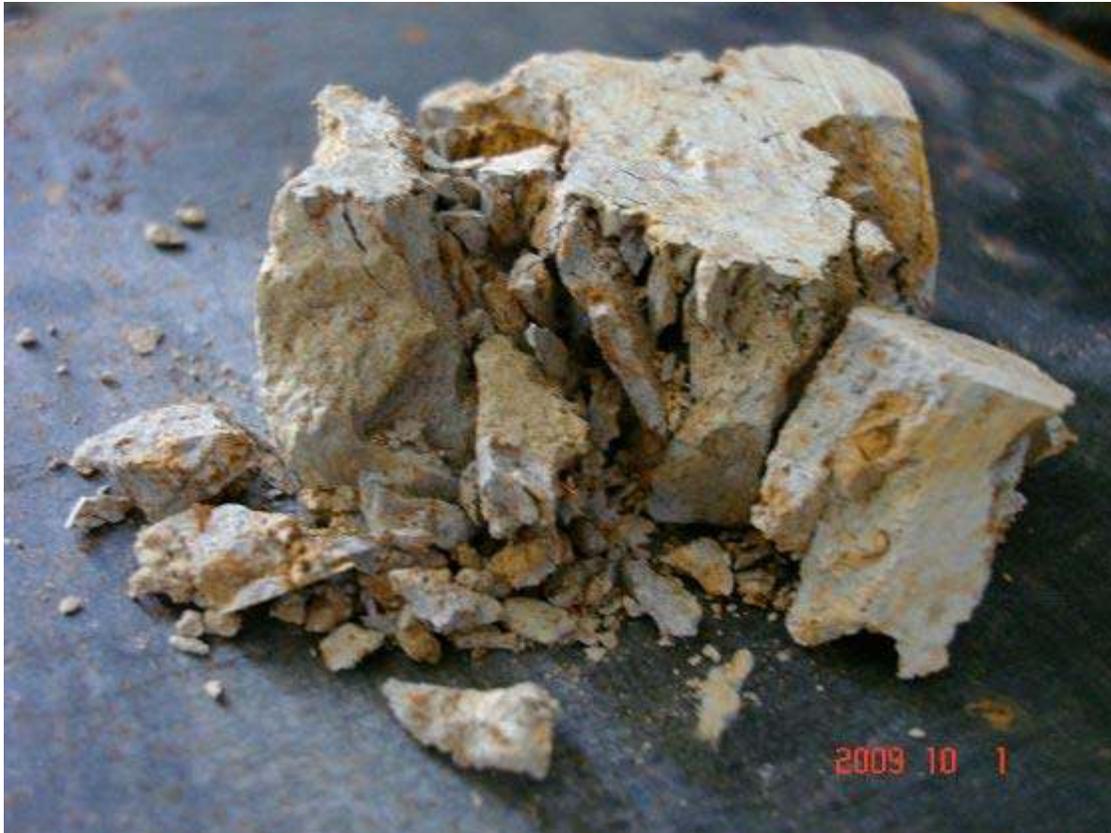
Figure 18-Failed Earth Samples

Rammed earth samples that came from the main wall structure of the Tulous were extracted and tested from three locations, Fuxing Tulou, Wuyun Tulou, and Zhencheng Tulou. The Fuxing Tulou is the oldest of the Tulous that were visited at an approximate age of 1,240 years. The structure is rectangular in shape which is typical of the older Tulous in the region. The Wuyun Tulou is also a square Tulou with an approximate age of 500 years and the Zhencheng Tulou is circular in shape and the youngest of the all the Tulous visited at 100 years old. A failed earth sample from a compression test can be seen in Figure 18 below.

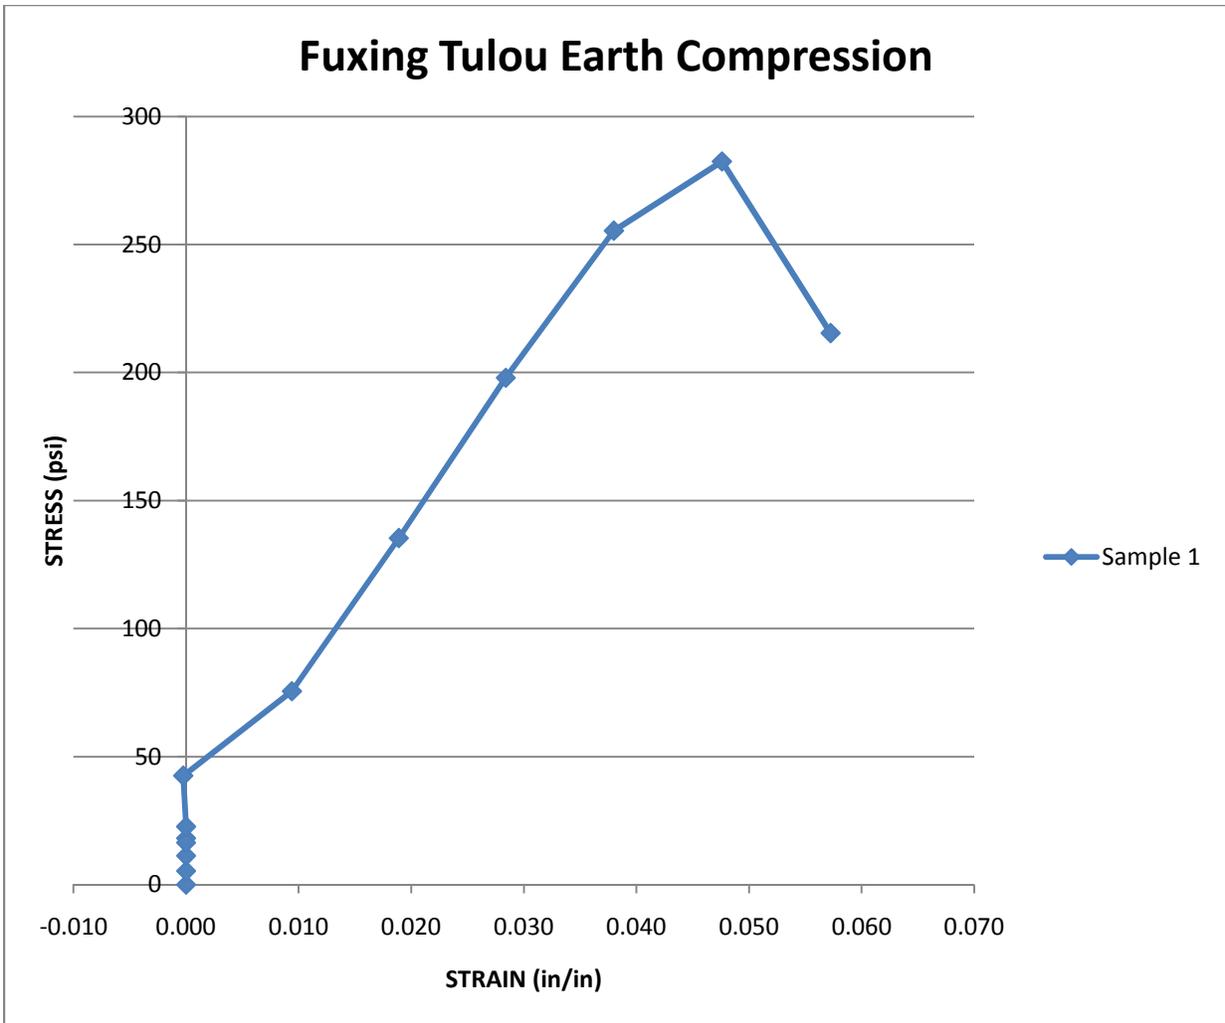
Figure 19-Fuxing Tulou Earth Stress/Strain Curve, XMU

As seen in Figure 19 below, only one sample yielded good results from testing which means that a modulus of elasticity value could only be extrapolated from this single data set. From Figure 19, the modulus of elasticity for this rammed earth sample is calculated as being 6,318 psi and the ultimate strength for this sample is found to be 282 psi.

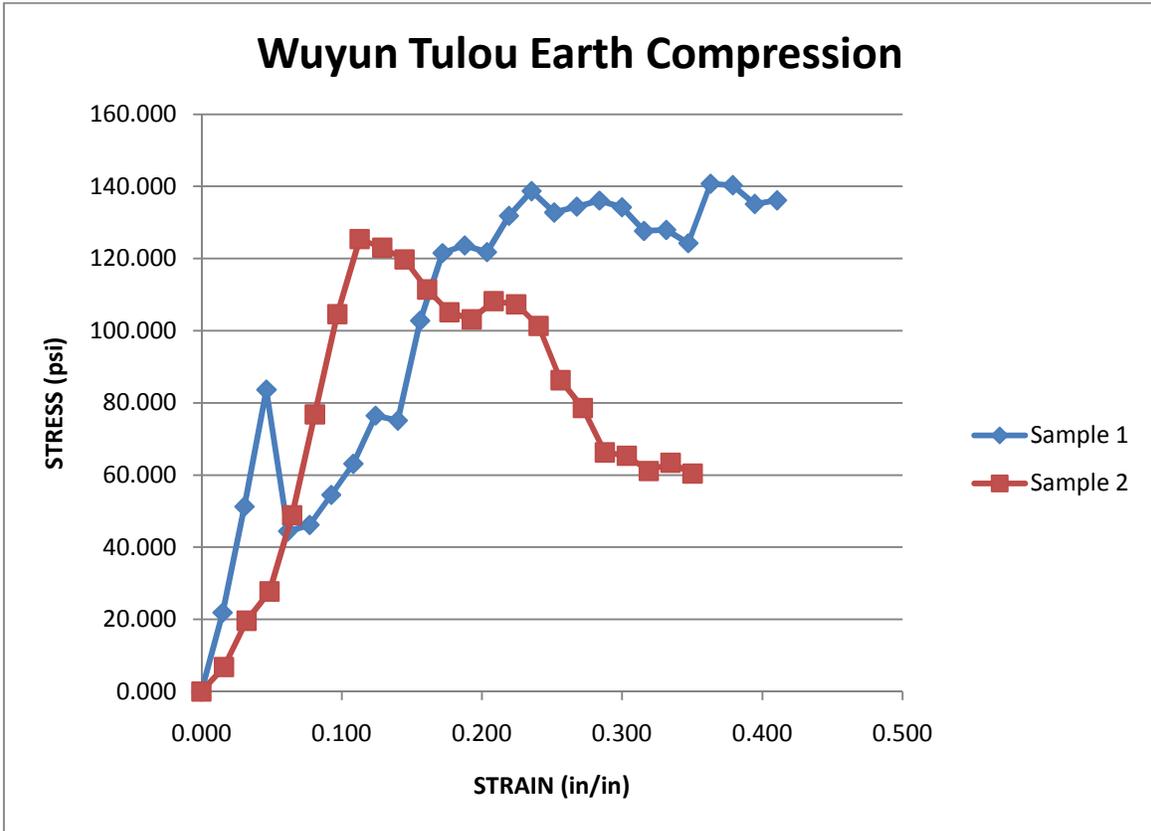
Figure 20-Wuyun Tulou Earth Stress/Strain Curve, XMU

As seen in Figure 20 below, two test samples gave valid results which means that a modulus of elasticity value was averaged from two data sets. From Figure 20, the average modulus of elasticity, for the rammed earth samples, is calculated as being 1,706 psi and the average ultimate strength is found to be 133 psi. The modulus of elasticity for each sample was calculated from the initial point of loading to the first perceived failure, for example, in sample one only the first four points were considered for the modulus of elasticity.

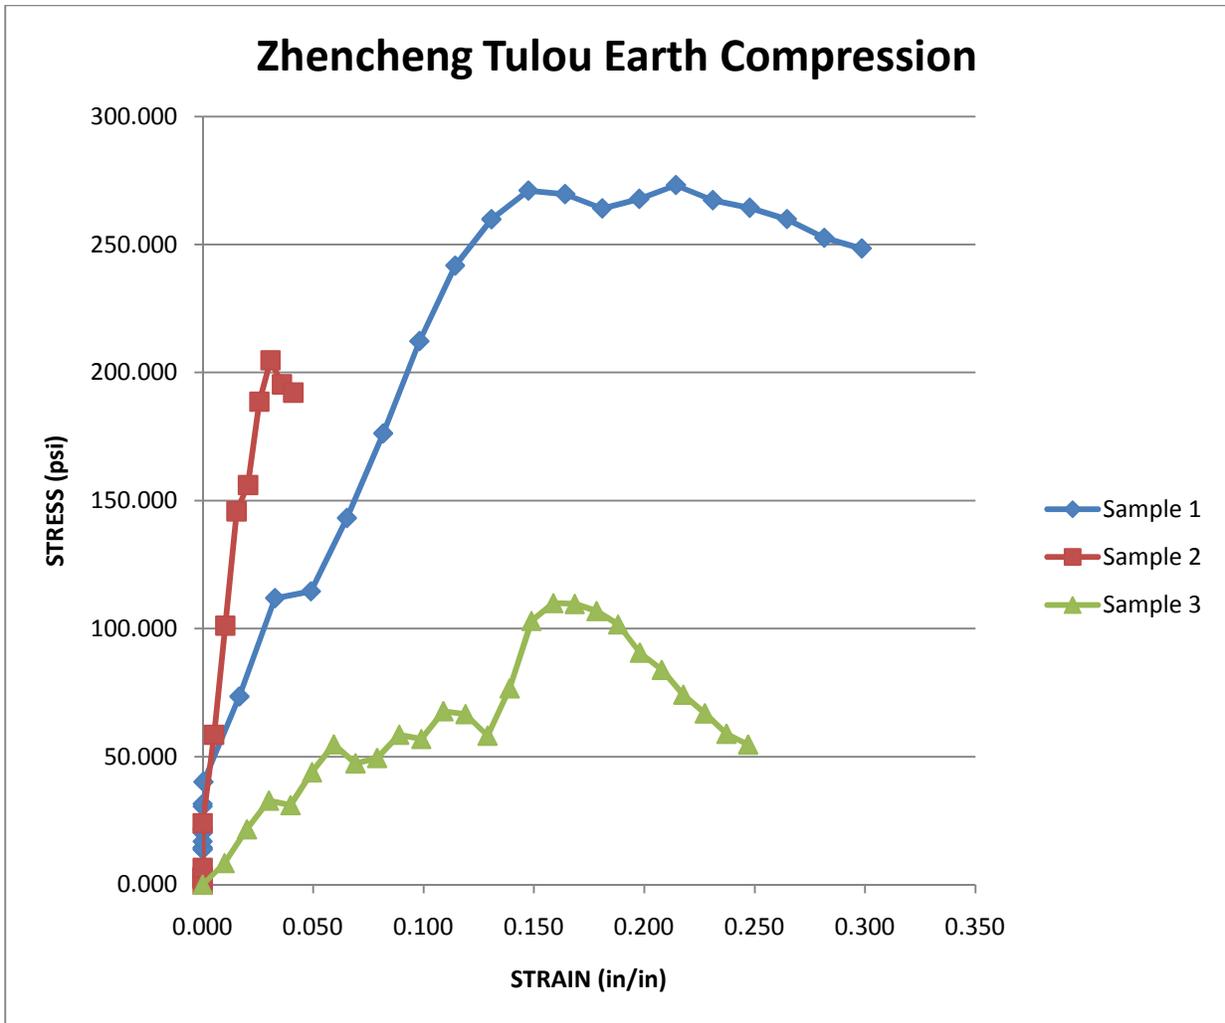
Figure 21-Zhencheng Tulou Earth Stress/Strain Curve, XMU

As seen in Figure 21 below, three samples gave valid results. The average modulus of elasticity for this rammed earth is calculated as being 3,598 psi and the average ultimate strength is found to be 196 psi.

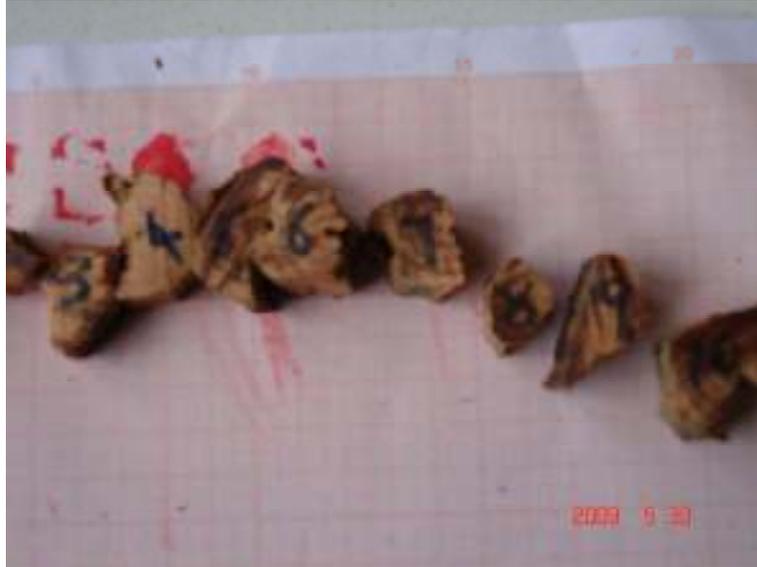
Figure 22-Wood Rib Samples

Wood samples that can be seen in Figure 22 below, were acquired from protruding ‘ribs’ as seen in Figure 23, and were tested under compression. The wooden wall ribs tested by the Xiamen University came from the Chengqi Tulou. The wooden ribs act as reinforcement for the rammed earth walls and increase strength of the structure in order to better withstand loads from high winds and earthquakes.

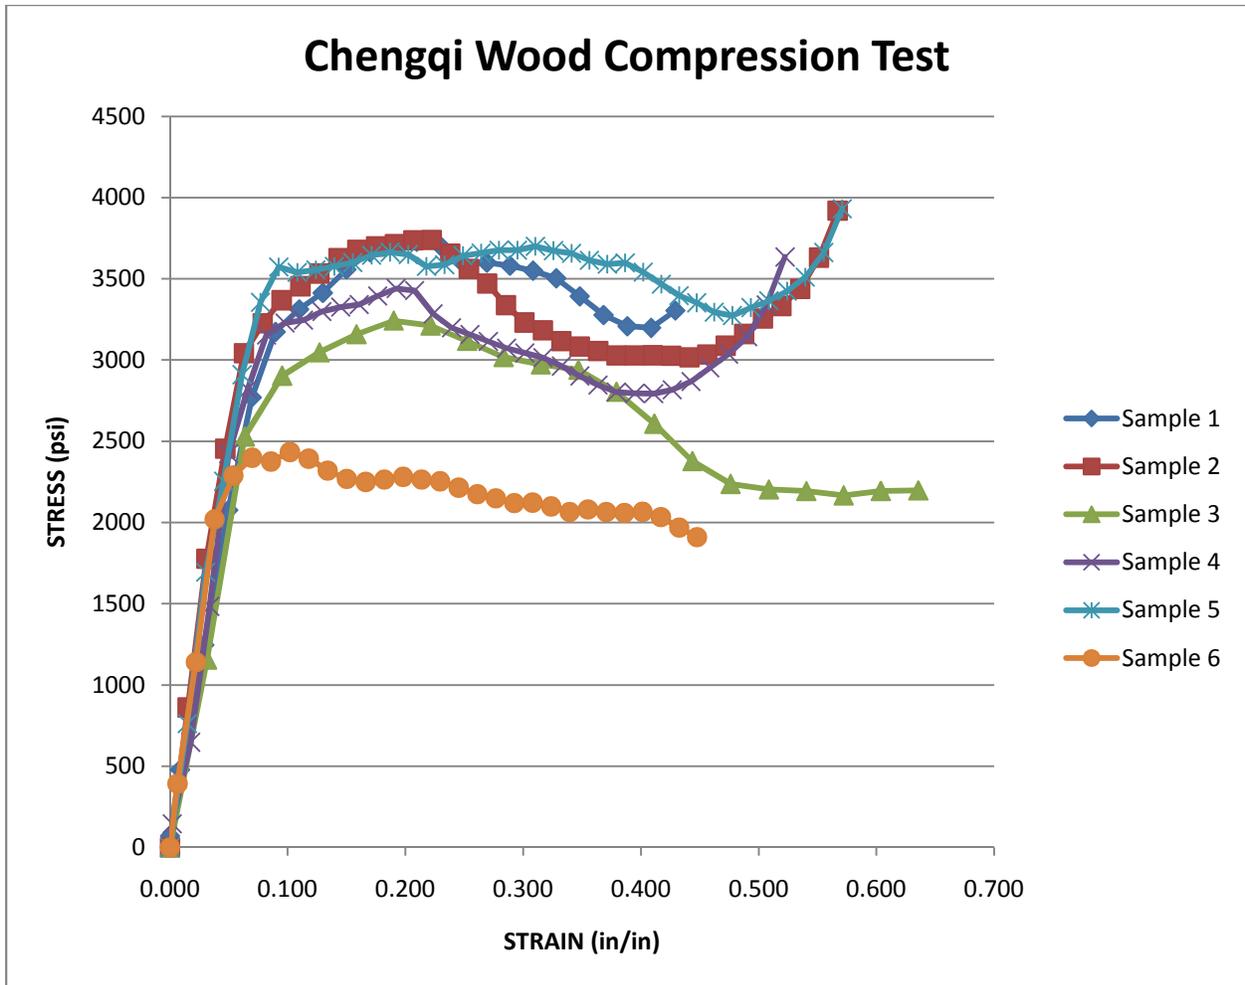
Figure 24-Wood in Compression Stress/Strain Curve

As seen in Figure 24 below, six samples displayed good results from testing which means that a modulus of elasticity value was extrapolated from six data sets. From Figure 24, the average modulus of elasticity for this piece of wood rib sample in compression is calculated to be 46,799 psi and the average ultimate strength is found to be 3,382 psi.

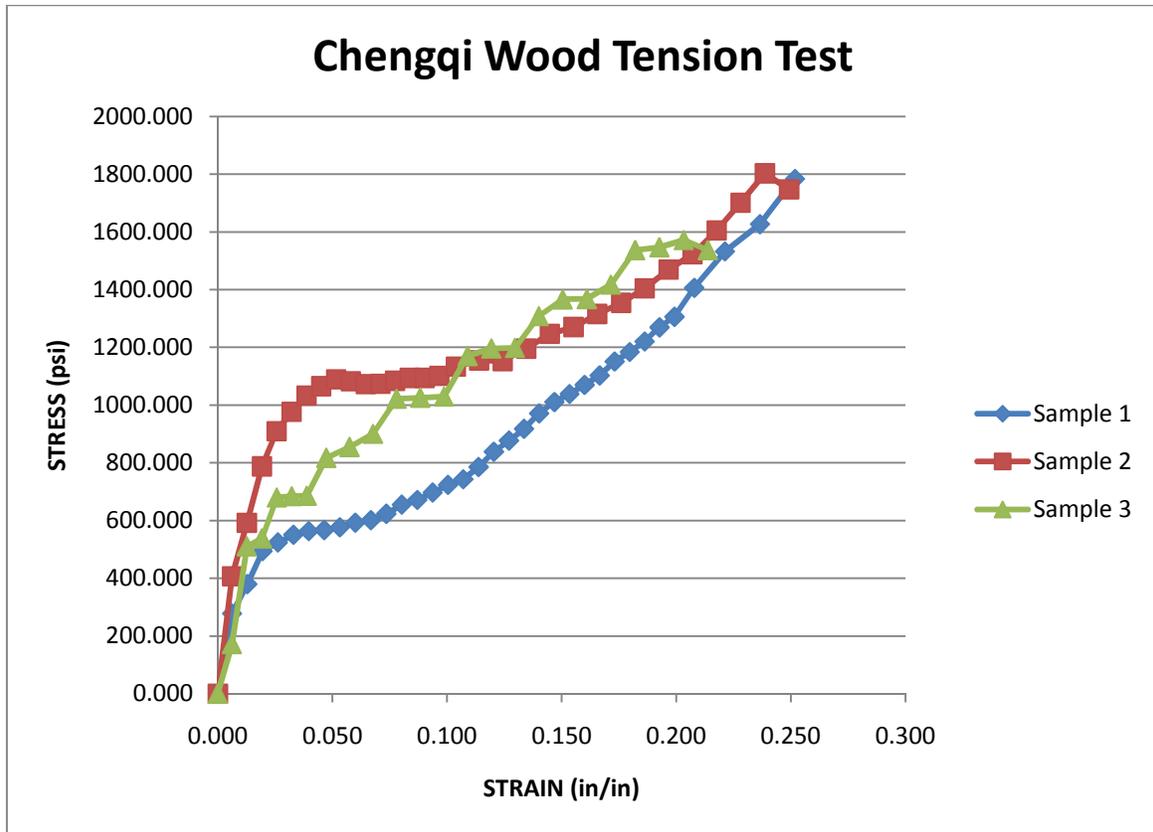
Figure 25-Wood in Tension Stress/Strain Curve, XMU

gave valid results. The average modulus of elasticity for the wood rib sample under tension is calculated to be 34,737 psi and the average ultimate strength is found to be 1,707 psi.

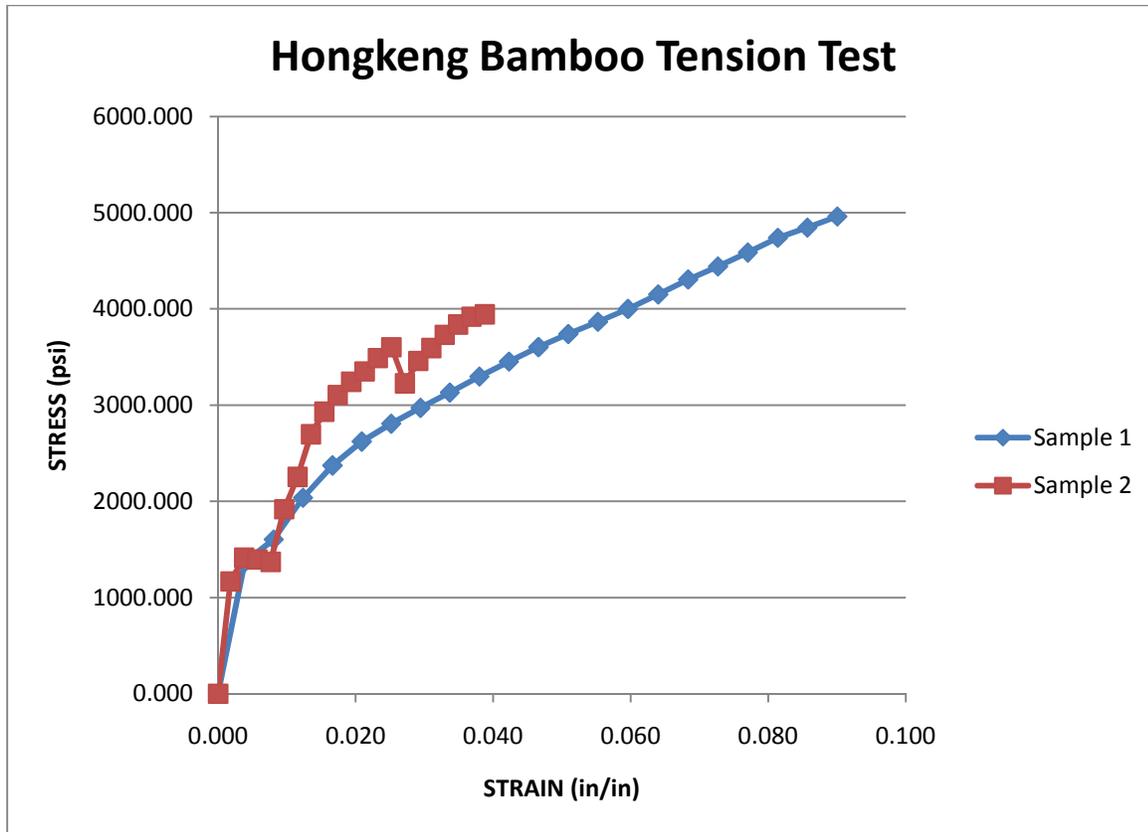
Figure 26-HongKeng Bamboo under Tension Stress/Strain Curve, XMU

One of the Tulous, located in the HongKeng village, was found to have bamboo reinforcing its rammed earth walls. The bamboo samples were acquired from protruding ribs and were tested in a tension strength test just like their wooden counterparts. As seen in Figure 26 below, two samples displayed good results from testing. The average modulus of elasticity for the bamboo rib samples under tension is calculated to be 463,178 psi and the average ultimate strength is found to be 4,452 psi.

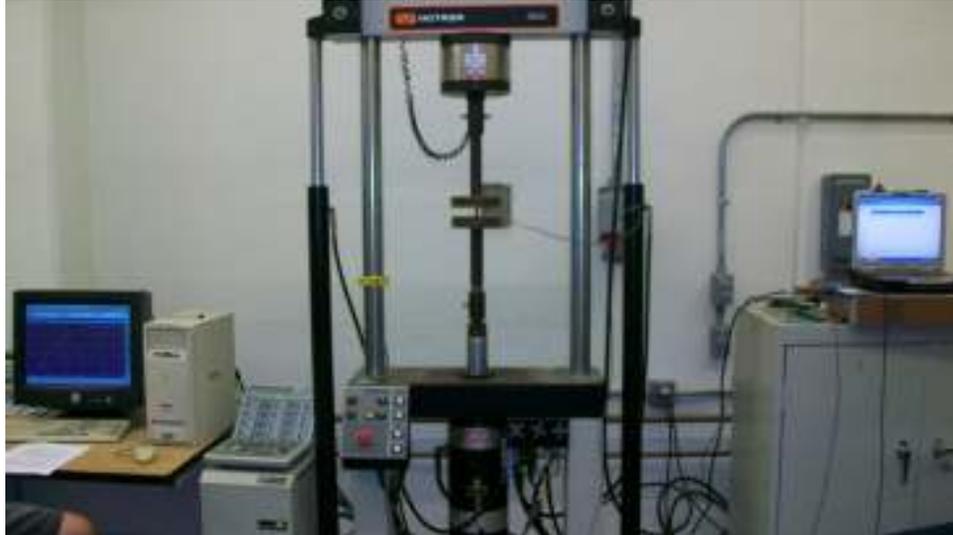
Figure 28-Compression Test Setup

It is important to note that there was difficulty in extracting rammed earth samples from the walls as discussed earlier, thus this has limited the amount of samples available to be tested. The samples that were successfully extracted were cut to represent a rectangular shape however this was not always possible, consequently the sample sizes are not to ASTM standard. Compression tests were performed on an Instron testing instrument at a loading rate of 120 lbs/min in order to stay within ASTM loading rates of 10-30 psi/s. A compression fixture was not used during testing which led to local crushing of at least the Chengqi wood and bark ribs, resulting in smaller than expected values. Figure 28 below shows the testing setup that was used for all samples.

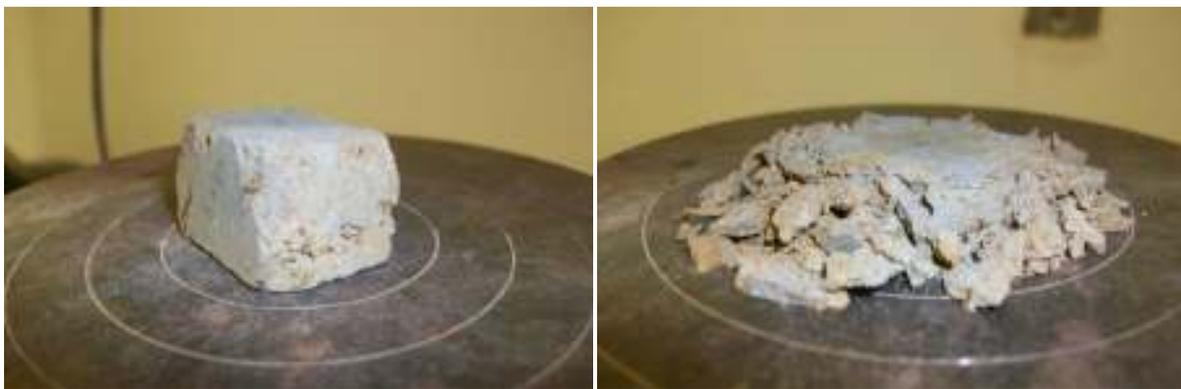
Figure 29-Wuyun Earth Sample Before and After Testing

In Figure 29, one can see the rammed earth sample from the Wuyun Tulou before and after compression testing. Only one sample was made available from the rammed earth wall of the Wuyun Tulou. From Figure 30, the modulus of elasticity for this rammed earth sample is calculated to be 2129 psi and the ultimate strength for this sample is found to be 279 psi.

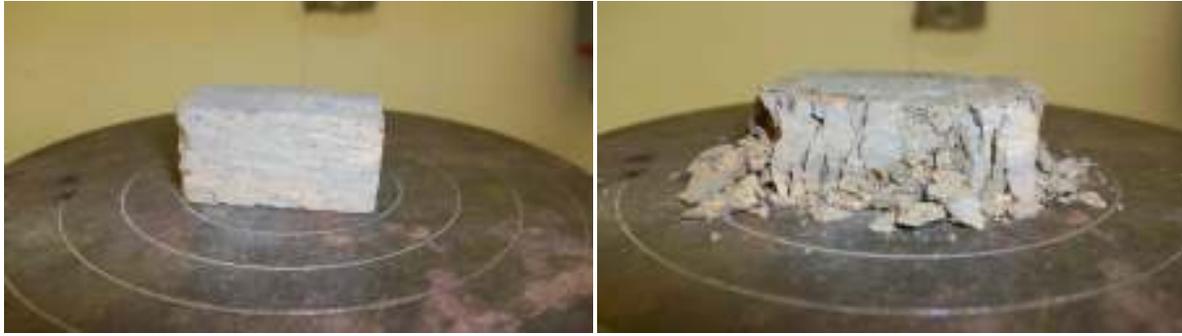
Figure 31-Chengqi Earth Sample Before and After Testing

In Figure 31, one can see the rammed earth sample from the Chengqi Tulou before and after compression testing. From Figure 32, the modulus of elasticity for this rammed earth sample is calculated to be 8,147 psi and the ultimate strength for this sample is found to be 411 psi.

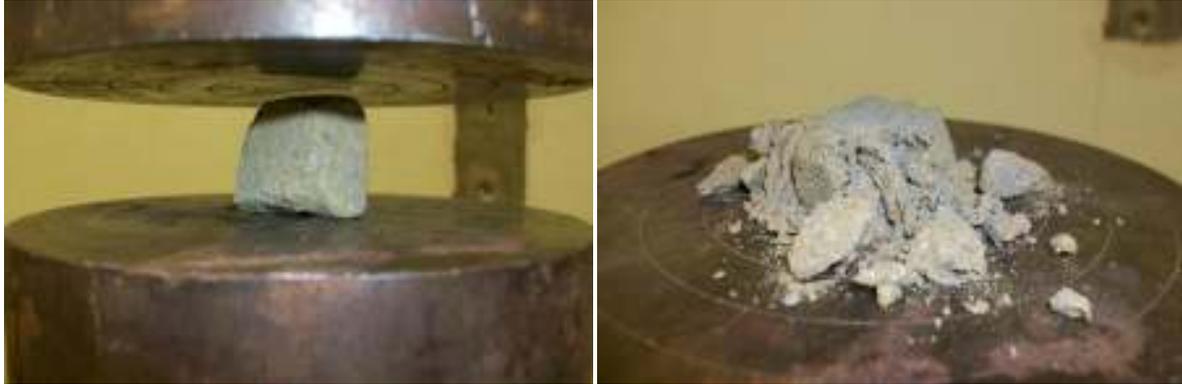
Figure 33-Zhencheng Earth Sample Before and After Testing

In Figure 33, one can see the rammed earth sample from the Zhencheng Tulou before and after compression testing. From Figure 34, the modulus of elasticity for this rammed earth sample is calculated to be 4,291 psi and the ultimate strength for this sample is found to be 126 psi.

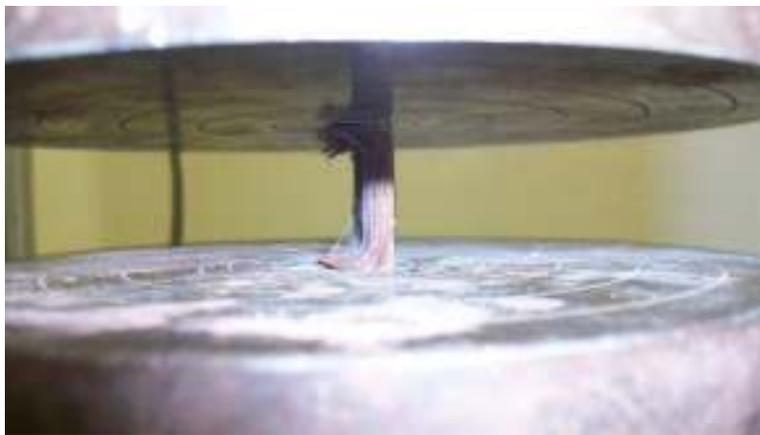
Figure 35-Delamination of Chengqi Bark Sample

Bark samples were acquired from protruding ‘ribs’ at the Chengqi Tulou. The bark ribs act as reinforcement for the rammed earth walls and increase strength of the structure in order to better withstand loads from high winds and earthquakes. Figure 35 below shows a bark sample delaminating before failure; this was the primary mode of failure for both samples tested. Such failure is known as local crushing and is a direct result of not using compression fixtures during testing, thus lowering strength values.

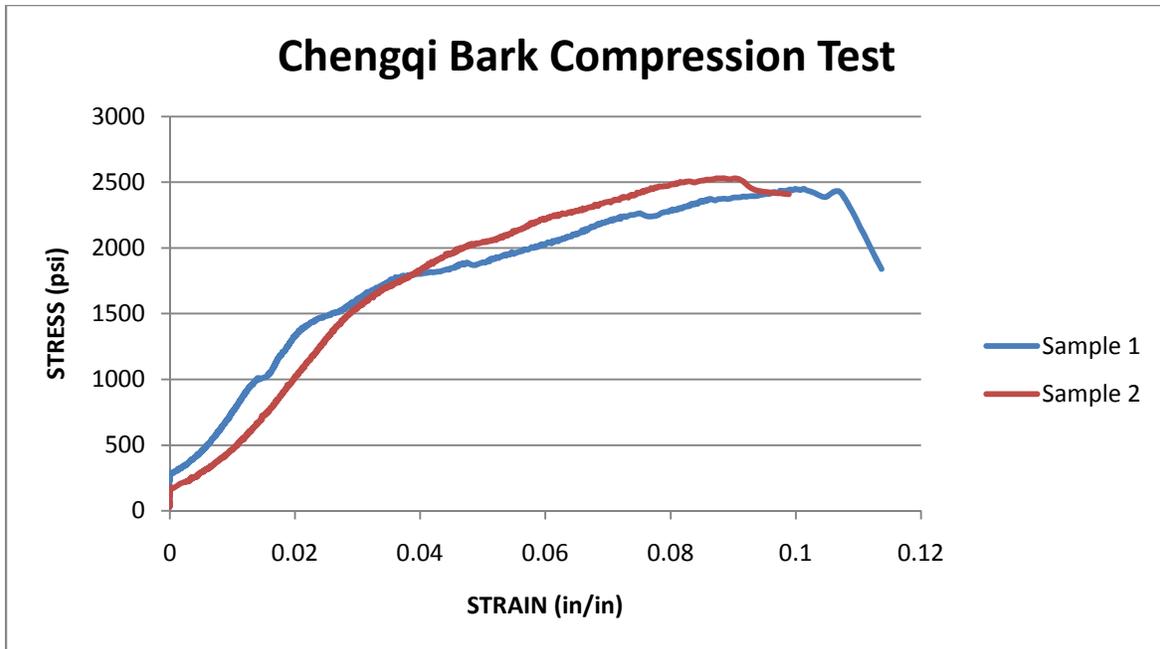
Figure 36-Chengqi Bark Stress/Strain Curve, WVU

From Figure 36, the average modulus of elasticity for the bark wall rib samples in compression is calculated to be 52,583 psi and the average ultimate strength is found to be 2,484 psi.

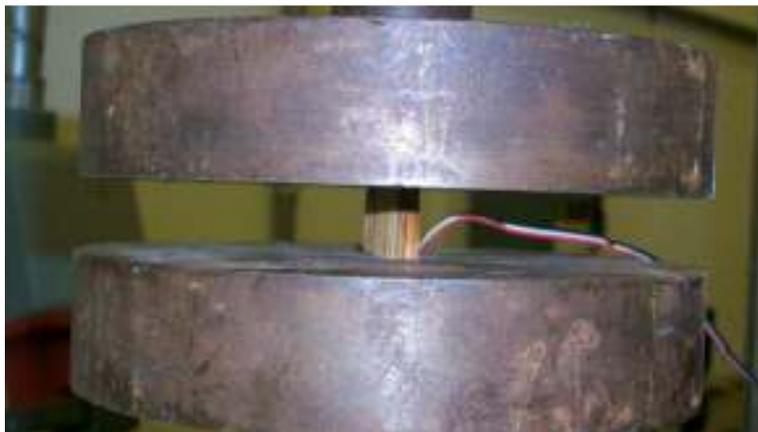
Figure 37-Chengqi Roof Beam Wood Ready for Testing

Wooden wall rib samples were acquired from protruding ‘ribs’ at the Chengqi Tulou. The wood ribs act as reinforcement for the rammed earth walls similarly as does the bark reinforcement. Figure 37 shows one of the wooden wall rib samples seated in the Instron machine readied for compression testing.

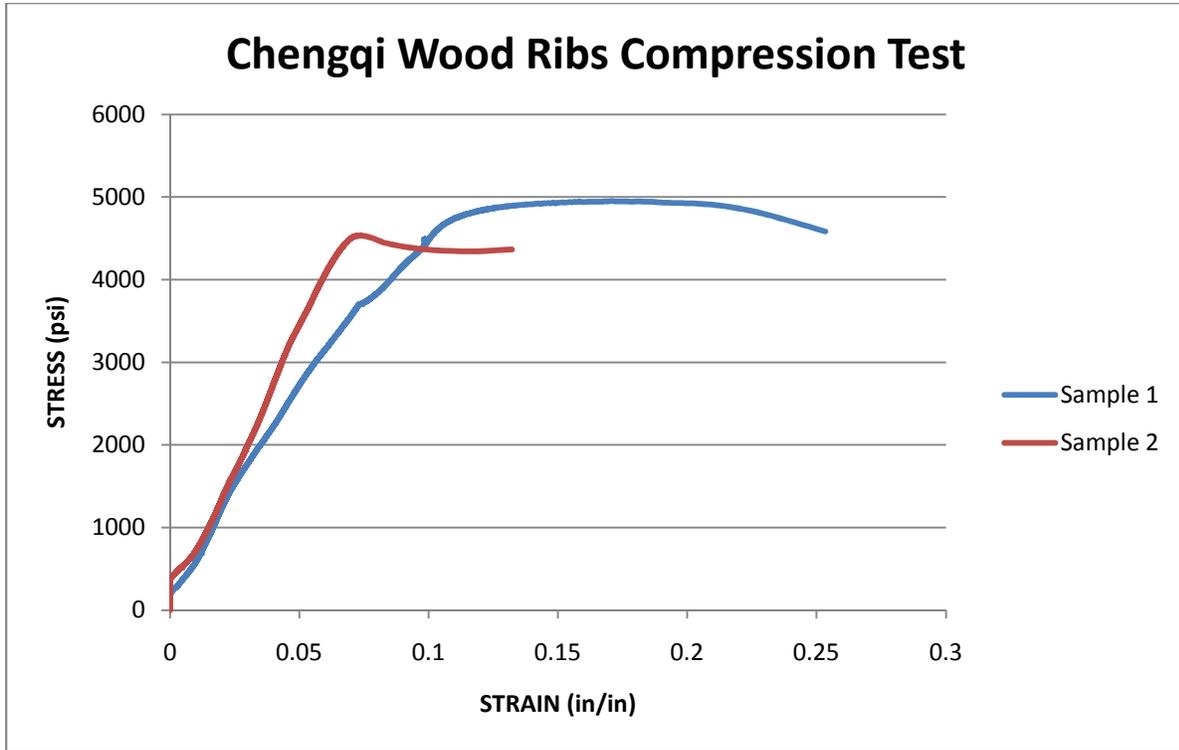
Figure 38-Chengqi Wood Ribs Stress/Strain Curve, WVU

From Figure 38, the average modulus of elasticity for the wood samples is calculated to be 57,308 psi and the average ultimate strength for these samples is found to be 4,717 psi

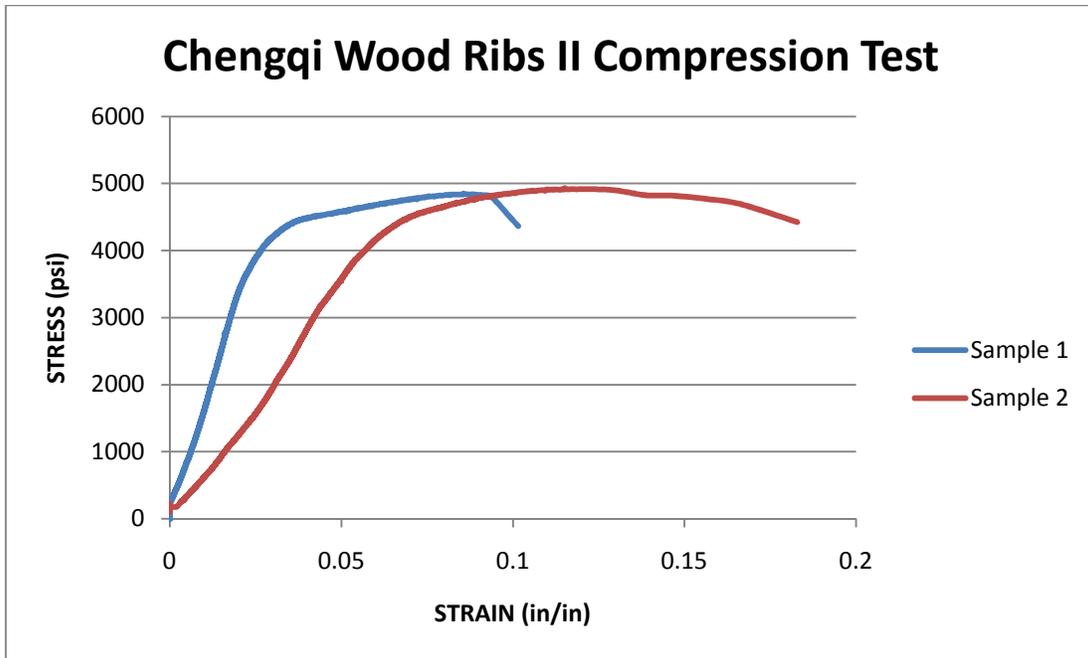
Figure 39-Chengqi Wood Ribs II Stress/Strain Curve, WVU

Two more samples of wall ribs were taken from a different location from the Chengqi Tulou. From Figure 39, the average modulus of elasticity for the wooden wall rib samples in compression is calculated to be 303,364 psi and the average ultimate strength is found to be 4,870 psi.
