Structural Responses and Finite Element Modeling of Hakka Tulou Rammed Earth Structures

Thesis submitted to the
College of Engineering and Mineral Resources at
West Virginia University in
partial fulfillment of the requirements
for the degree of

**Master of Science
in
Civil Engineering**

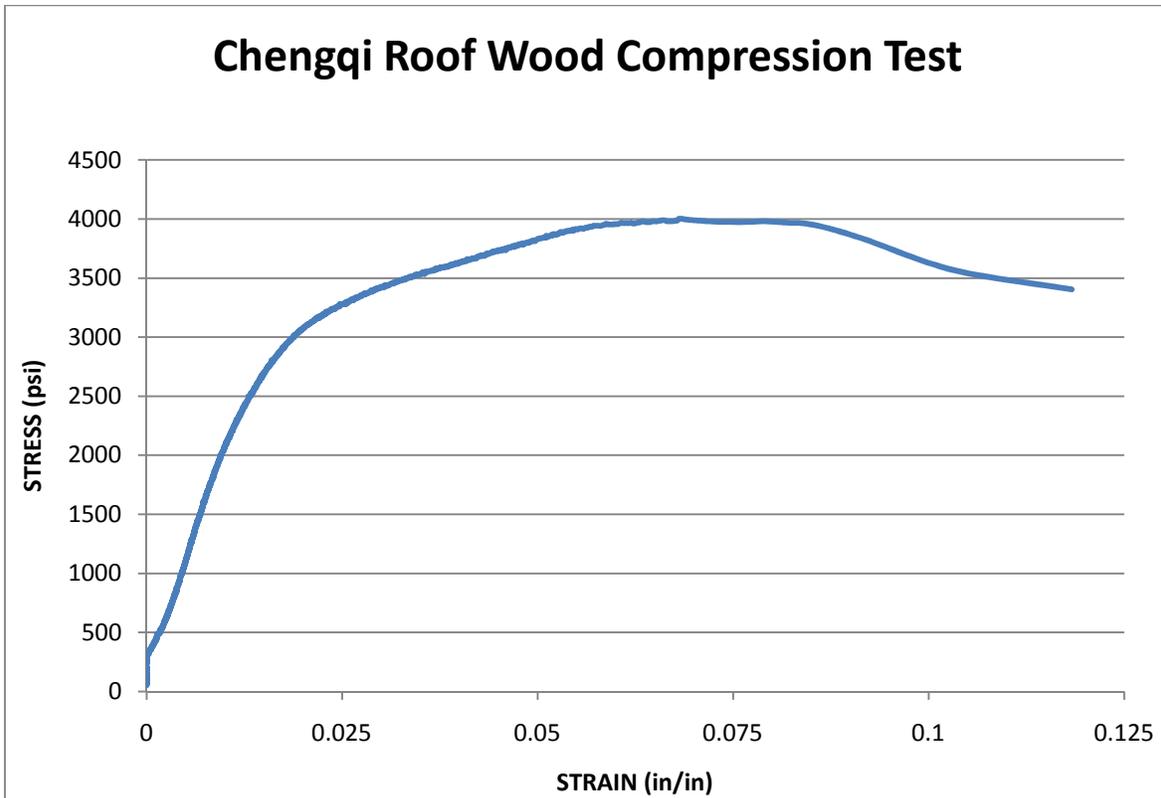
Figure 40-Chengqi Roof Wood Stress/Strain Curve, WVU

A sample of wood was acquired from the wooden roof truss of the Chengqi Tulou. The wood plays a key role in the structural integrity of the roof truss as it directly supports roof loads. From Figure 40, the modulus of elasticity for this wood sample is calculated to be 175,461 psi and the ultimate strength for this sample is found to be 3,990 psi

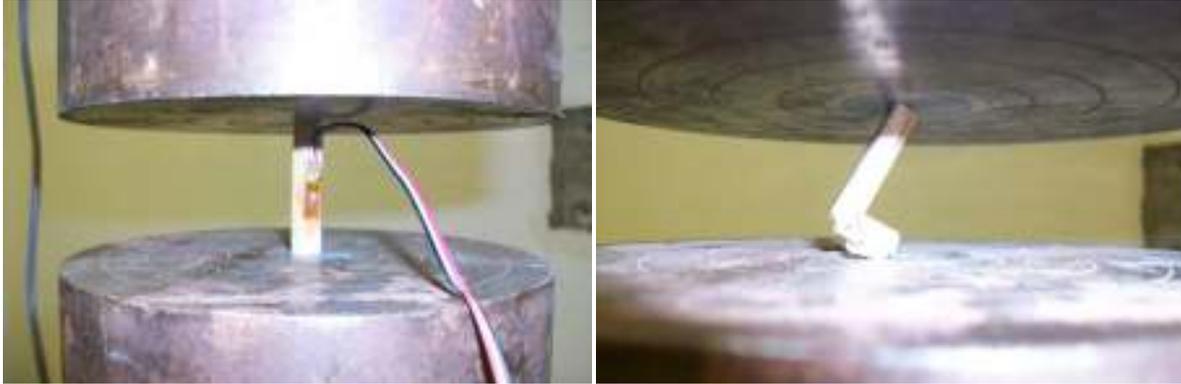
Figure 41-Fuxing Wood Sample Before and After Testing

A larger amount of wooden wall ribs were successfully extracted from the Fuxing Tulou. The wooden ribs perform as reinforcement for the rammed earth walls just as they do at the Chengqi Tulou. Figure 41 below shows a Fuxing wood sample before and after compression testing, it is interesting to note that all 8 samples failed in a similar buckling manner.

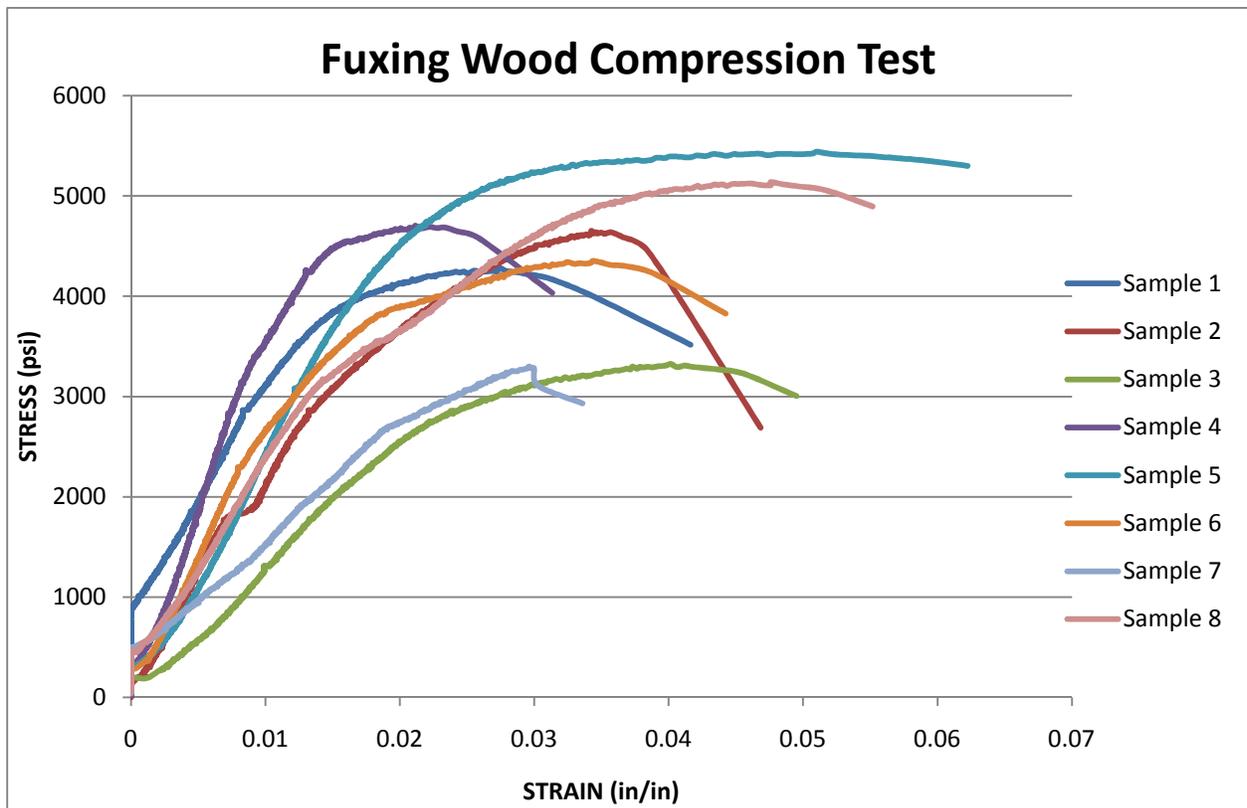
Figure 42-Fuxing Wood Stress/Strain Curve, WVU

From Figure 42, the average modulus of elasticity for the wooden wall rib samples in compression is calculated to be 227,944 psi and the average ultimate strength is found to be 4,376 psi.

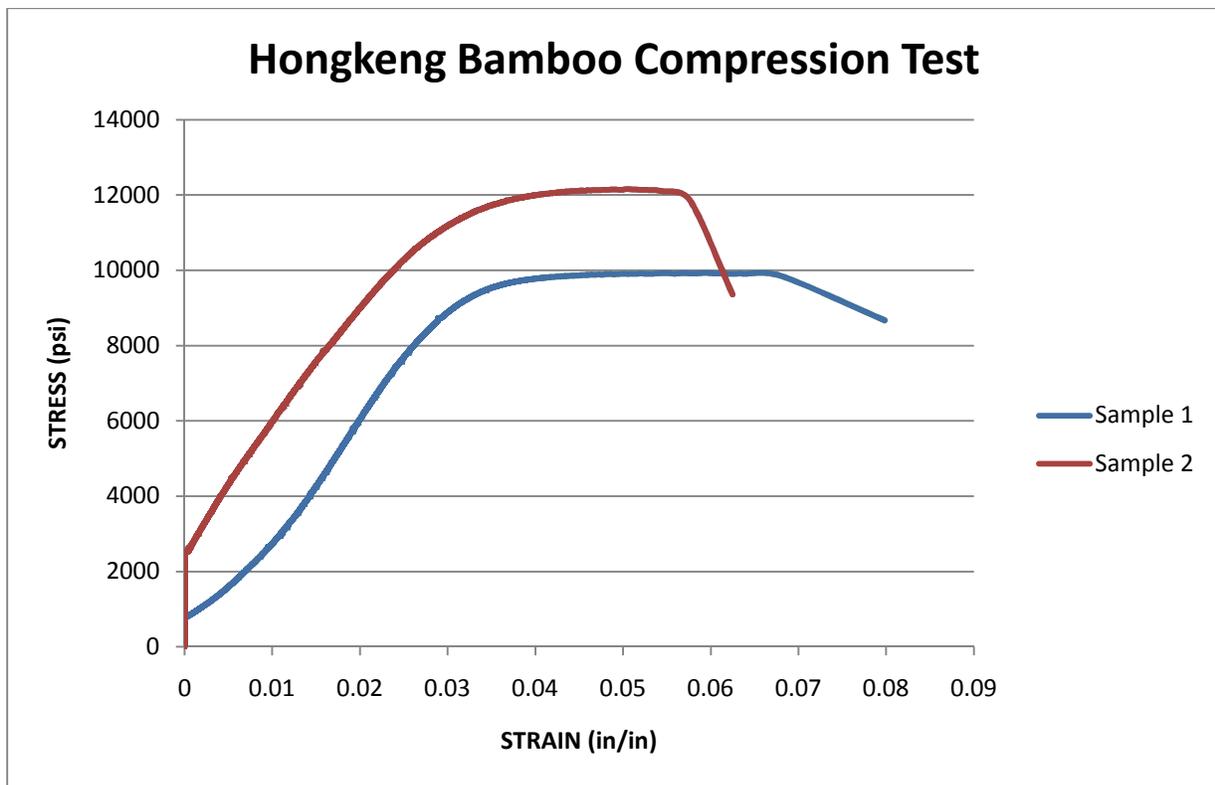
Figure 43-HongKeng Bamboo in Compression Stress/Strain Curve, WVU

Bamboo samples acquired from a Tulou in the Hongkeng village were also tested in a compression strength test just like their wooden counterparts. As seen in Figure 43 below, two samples gave valid results. The average modulus of elasticity for the bamboo rib samples in compression is calculated to be 300,023 psi and the average ultimate strength is found to be 11,039 psi.

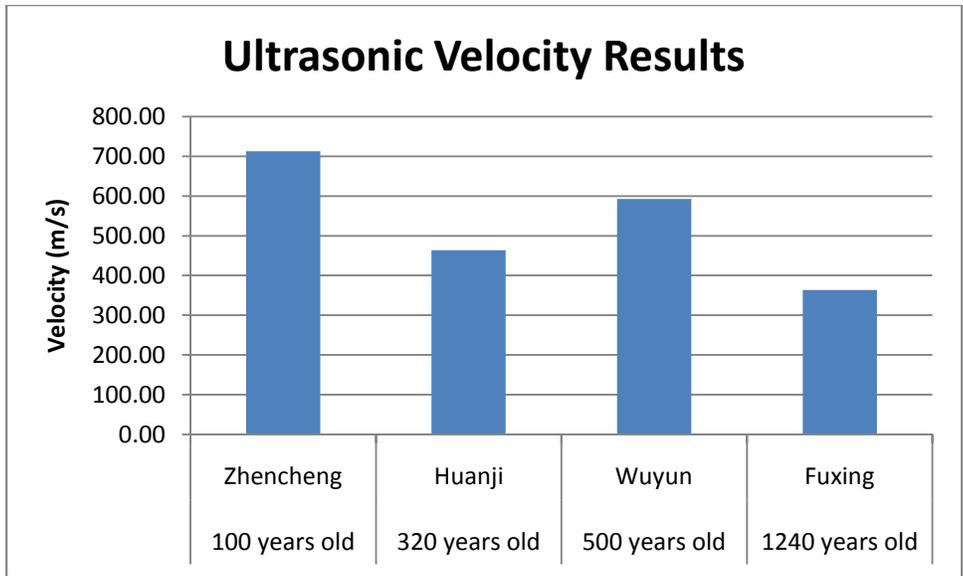
Figure 44-Ultrasonic Velocity Results

One would expect the most recently built Tulou to have the highest strength due to deterioration effects that occur over the years. The velocity of the wave created by an ultrasonic transducer is directly proportional to that of the modulus of elasticity of the material meaning the higher the modulus of elasticity, the higher the expected velocity. In Figure 44 seen below, the average values of multiple velocity readings are shown for the Tulous tested. As can be seen in this figure there is somewhat of a correlation between the age of a Tulou and the velocity of the ultrasonic wave, meaning that there is possibly a correlation between the strength of the rammed earth walls and the age of the structure.

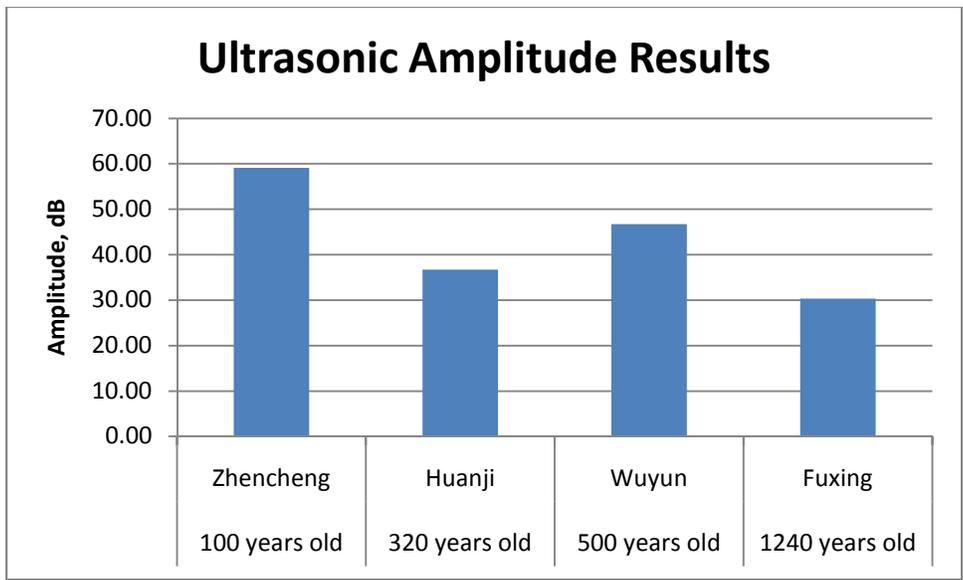
Figure 45-Ultrasonic Amplitude Results

The amplitude of the wave sent through a material is also expected to be higher through a more “sound” material or a material that shows fewer defects. As can be seen in Figure 45, the average amplitude reading is highest for the youngest Tulou and lowest for the oldest Tulou. This data shows that there also is somewhat of a correlation between age of the Tulou and the average amplitude reading of the wave.

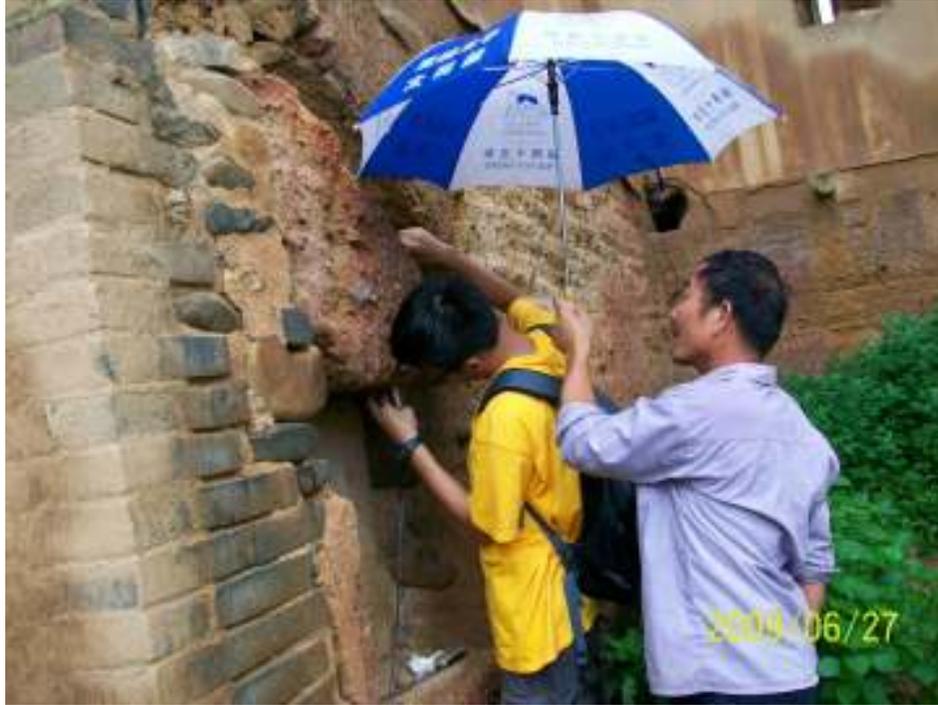
Figure 46-Rain During Fuxing Testing

Combining the data from both the velocity and amplitude results, yields data that is consistent with each other. This most likely means that no large defect exists in the areas of the material that were tested and that reduction in the readings can be correlated to both the deterioration of the rammed earth through increased age and/or the composition of the rammed earth. Theoretically, the velocity values should also match up with the modulus of elasticity values of the rammed earth that was analyzed in section 3.4.1.1. The velocity data unfortunately does not match up proportionally to the modulus of elasticity values of the Tulous, as the highest modulus of elasticity was found to be in the Fuxing Tulou which also happens to have the lowest wave velocity and wave amplitude. Such discrepancies could have occurred due to the non uniform sample sizes being tested in the earth compression test as well as differences in the composition of the rammed earth samples. It is also important to note that during testing of the Fuxing Tulou it was raining as seen in Figure 46 and as a result the rammed earth walls were wet which could have affected the results.

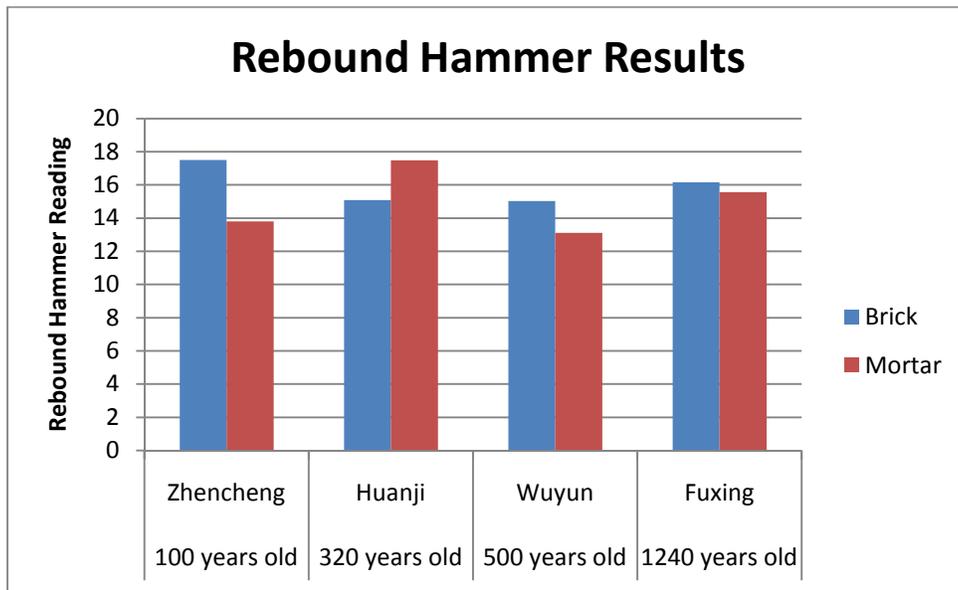
Figure 47-Rebound Hammer Results

The rebound hammer test consisted of using two different rebound hammers, one specifically for brick and another specifically for mortar. As shown in Figure 47, the average rebound hammer readings do not show as good of a correlation between age of the Tulou and hardness of the sample as did the ultrasonic data. If anything can be extrapolated from this set of data it could be that the mortar rebound hammer represents the conditions of the rammed earth wall more accurately than the brick rebound hammer by showing results that are more consistent to that of material testing. If this proves to be true, then according to the mortar rebound hammer results, strength of the rammed earth walls does not correlate to the age of the structure, rather to

the composition of the rammed earth. To further explain, from the material testing the Fuxing Tulou had the strongest modulus of the elasticity, the Wuyun Tulou had the weakest, and the Zhencheng was in between the two, this is consistent with what the mortar rebound hammer shows as the Fuxing Tulou had the hardest material, Wuyun the weakest, and the Zhencheng in between the two. Such correlations show that the oldest Tulou is the strongest and the youngest Tulou is in the middle of the two in terms of strength. Since this set of data match material testing results where age is not correlated to strength, it is believed that the rebound hammer results are more accurate than the ultrasonic results.

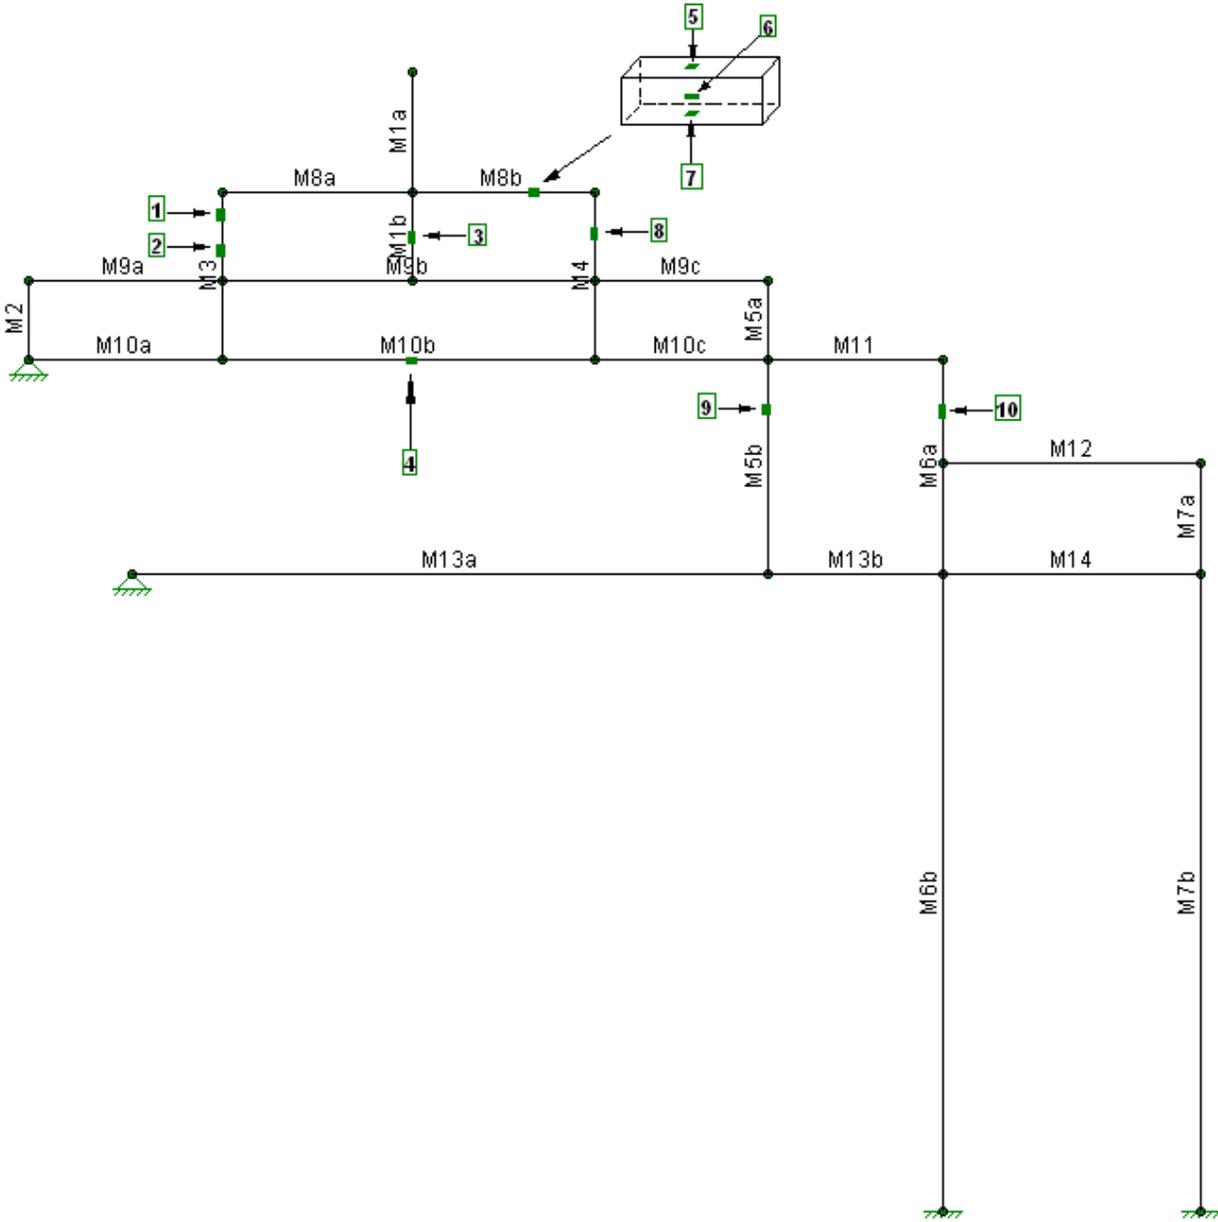
Figure 49-Tulou Roof Truss Model

In Figure 49, one can see that at the location where the roof truss ties into the rammed earth wall the support condition is assumed as pinned. This assumption was made because although the beam is not connected directly to the wall, rather it is laying in a groove made in the

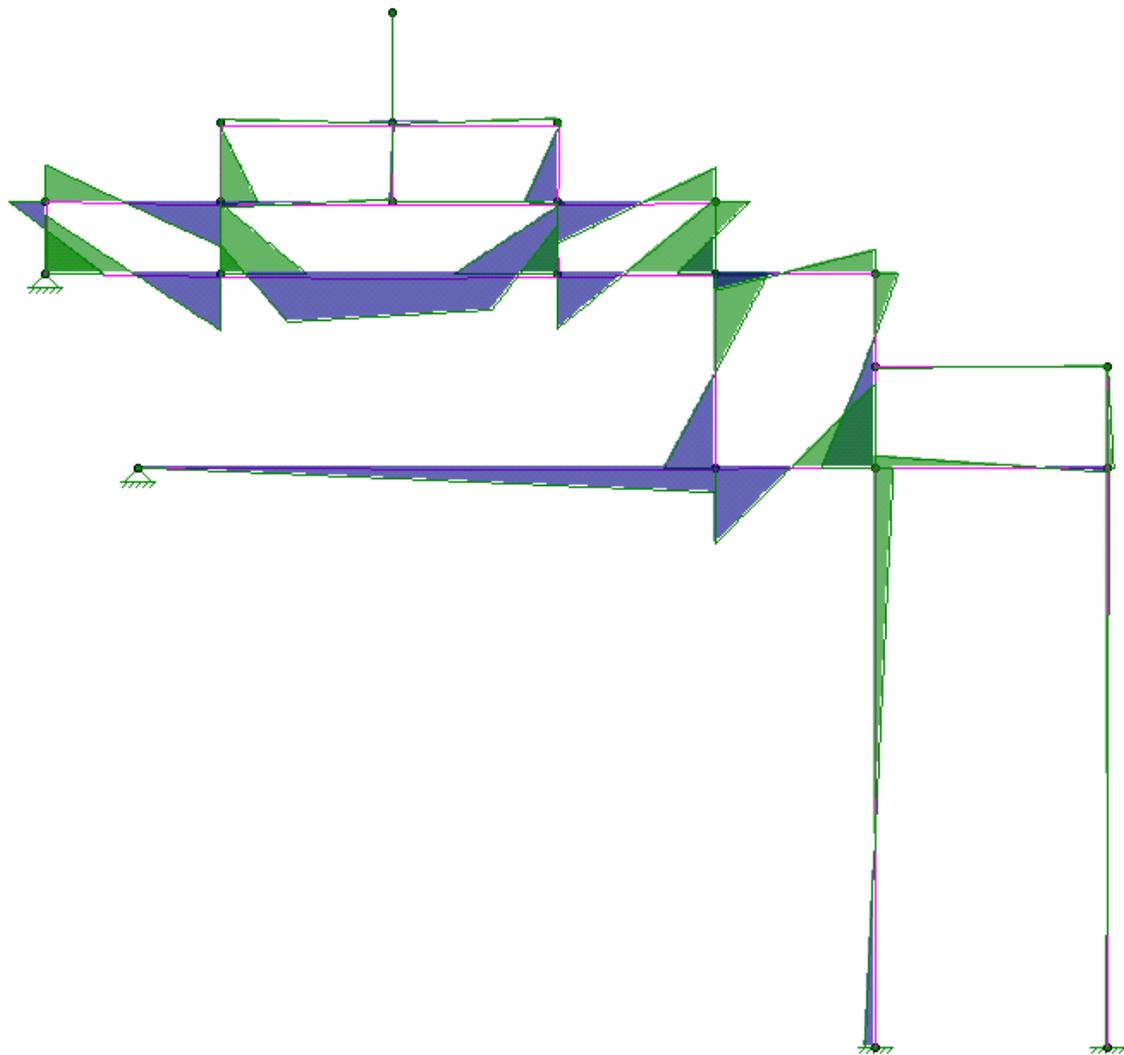
Figure 50-Tulou Roof Truss Moment Distribution

Before comparing strain results of specific members from the model to that of field tests, an interesting observation can be made from Figure 50.

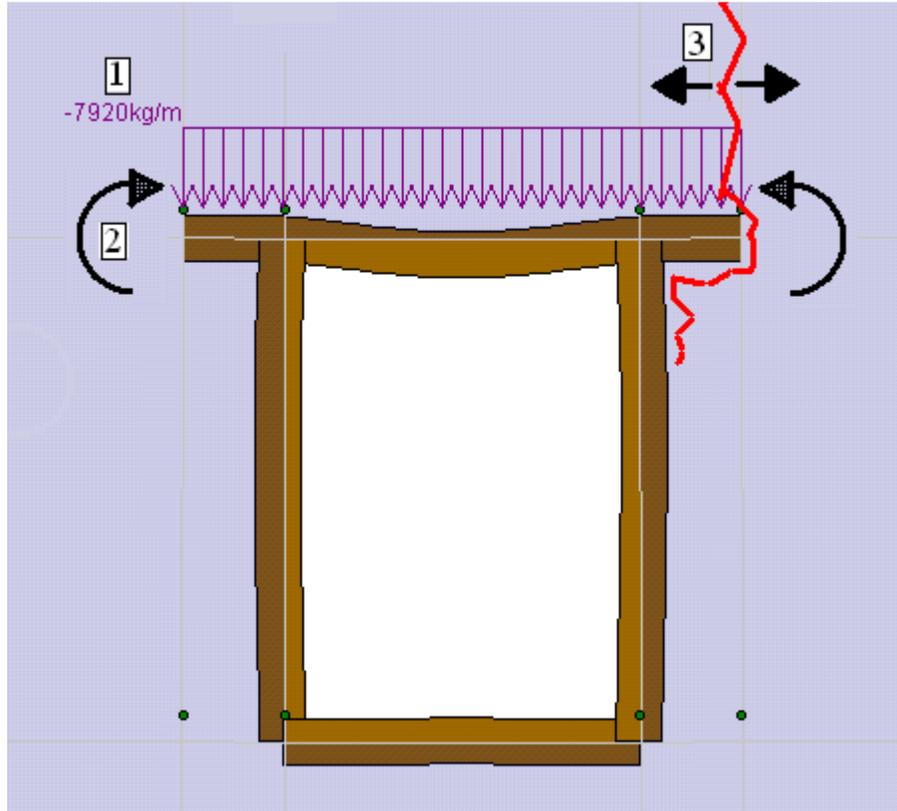
Figure 57-Lintel Behavior

dead load force can be seen below in Figure 57.

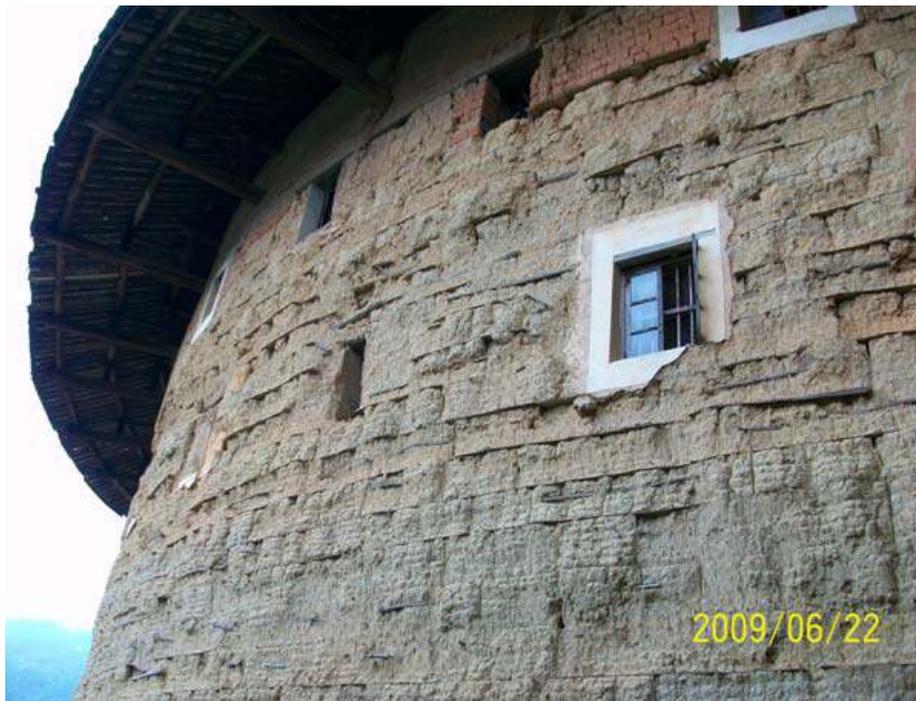
Figure 80-Rough Rammed Earth Walls of Chengqi Tulou

The outside walls are also very rough as can be seen in Figure 80, absorbing rather than reflective sunlight that plays a very vital role during the winter season.

The roof structure that can also be seen in the figure above, extends nearly 10 feet out, not only protected the rammed earth walls from weathering effects which include monsoons and storms experienced in the region, but also shading the rammed earth walls during the summer (UNESCO 2008). As previously mentioned, during the summer the angle of incidence from the sun is much higher and thus a large extended roof such as this one prevents the rammed earth walls from constant contact with the sun, preventing the rammed earth walls from becoming over saturated in heat and thus ineffective in maintaining a stable interior temperature. The round structure of the Tulou as well as the openness of the structure also allows winds to go around and through the structure cooling the rammed earth walls initiating the heat release cycle that is experienced during the cooler nights of the summer.
