## **NONDESTRUCTIVE EVALUATION OF HISTORIC HAKKA RAMMED EARTH STRUCTURES**

**Abstract:** The in-service Hakka rammed earth buildings, in the Fujian Province of China, are unique in design and performance. The UNESCO's inscription as World Heritage recognizes their artistic, cultural and historic significance. Sponsored by National Science Foundation of the United States, the authors have investigated the engineering values of those buildings in terms of low energy consumption but still comfortable living, sustainability, and durability. The objective of this study was to better understand the thermo-mechanical and aging responses of Hakka earth buildings under thermal and earthquake loads through nondestructive field evaluation including full-scale roof truss and floor testing, laboratory testing of field samples and finite element modeling. The scope of work included: 1) identification of constituent materials in rammed earth and investigation of durability of the constituents; 2) investigation of structural integrity of Hakka buildings for structural efficiency under extreme loads, including potential modes of failure and verification (if any) of the reported self-healing of cra

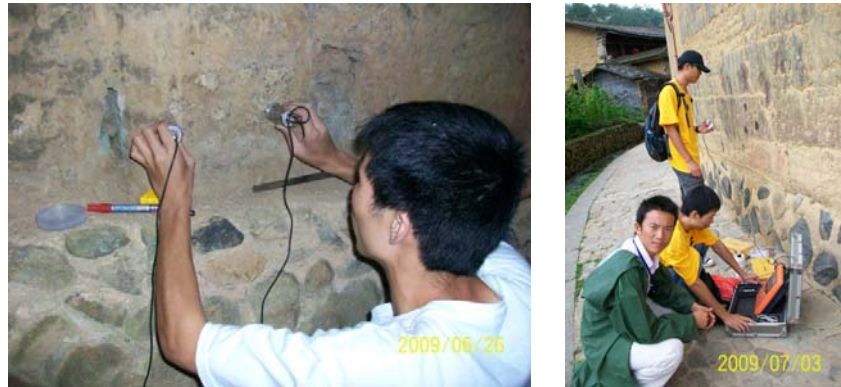
Fig 1: Ultrasonic testing heads and device

Ultrasonic testing is a NDE test which can tell us the strength of the material as well as if defects are present in the material. A wave, in this case produced by an ultrasonic transducer, will travel through a material such as the rammed earth wall and be detected by a receiver (as shown in Figure 1). The way how the wave propagates can give valuable information with respect to the structural integrity of the structure being tested. More specifically, the velocity of the wave is a function of the material's properties such as stiffness, density, and Poisson's ratio as well as the presence of defects. Similarly, the amplitude of the wave sent through a material is expected to be higher through a more "sound" material or a material that shows fewer defects. A combination of velocity and amplitude measurements provides more useful information by increasing the sensitivity of the ultrasonic technique to defects. In most cases a decrease in wave amplitude represents a possible defect. One can compare the velocity of a wave to the amplitude to see if there are inconsistencies. If inconsistencies exist then there is a possibility that a defect may be present (Halabe et al, 1995).

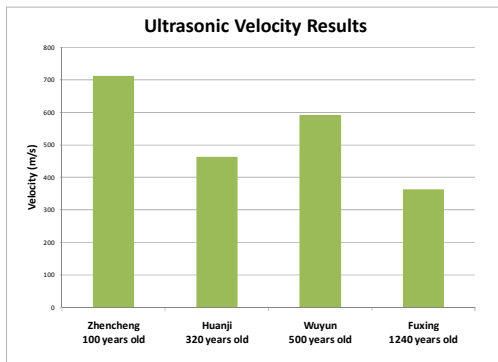
Fig 2: Ultrasonic velocity results\*

Figures 2 and 3 show the ultrasonic velocity and amplitude results for the buildings tested. Both charts are consistent and show the same trend. This most likely means that no large defect exists in the areas of the material that were tested and that the readings may reflect the strength of the materials. Note that each data point represents an average of 25 to 30 measurements. As can be seen in Figs 2 and 3, apparently, there is no direct correlation between the age of the Tulou structures and the velocity/amplitude (the strength of the rammed earth walls) of the ultrasonic wave. Other than the age, there are many more parameters in the wall

A useful discussion on these NDE data can be made with reference to the mechanical properties and other testing results of the rammed earth wall samples that were generated in the laboratory (Liang et al, 2011). Ultrasonic data indicate Zhencheng earth wall has the highest strength. This observation is generally supported by the SEM and static test results. Wuyun has higher velocity than Fuxing and Huanji. Huanji Tulou earth sample is brittle and the researchers were not able to prepare any specimens of a regular shape. Thus, Huanji Tulou earth sample would have the lowest strength among the buildings studied. Contradictorily, Fuxing Tulou earth sample has been proven strong and hard. Its lowest ultrasonic velocity should be attributed to the fact that all the measurements from Fuxing were conducted on wet walls because of raining weather during field study and the earth wall might have become soft. Having the above points in mind, the Ultrasonic testing result does agree with the mechanical properties of the earth wall samples

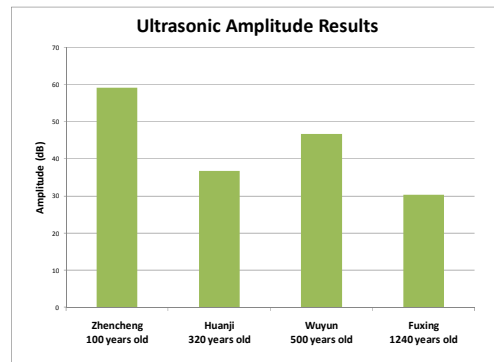
Fig 3: Ultrasonic amplitude results\*

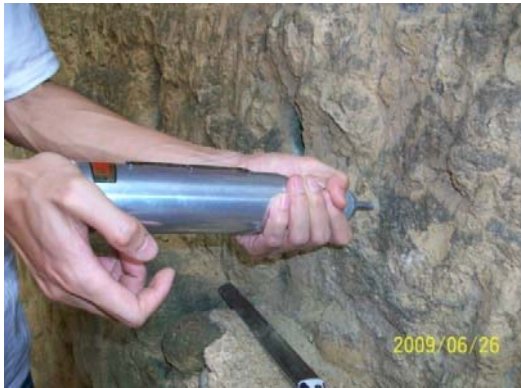
Fig 4: Rebound Hammer

As per ASTM C805, a rebound hammer works as follows: A steel hammer impacts, with a predetermined amount of energy, a steel plunger in contact with a surface of concrete, and the distance that the hammer rebounds is measured. This is shown in Figure 4. During the field study, two types of rebound hammers were used, one specifically for brick and another specifically for mortar. Figure 5 shows the results of the rebound hammer test. Note that Rebound Hammer is not designed for rammed earth wall but offers a method to quantitatively evaluate the strength of Tulou earth walls. Each data point represents an average of 32 to 64 readings in case of rebound hammer measurement. Also, all the measurements from Fuxing were conducted on wet walls because of raining weather during field study and its value was likely underestimated. In a similar

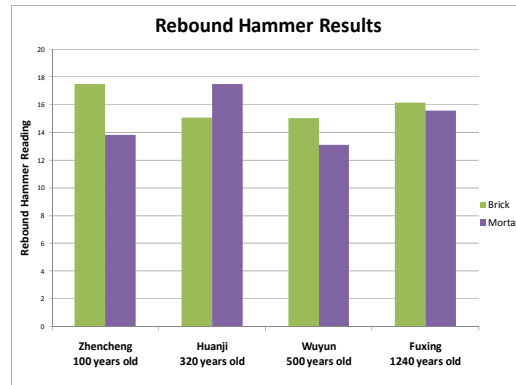
Fig 5: Rebound Hammer results

As shown in Figure 5, the average rebound hammer readings do not show any correlation between age of the Tulou and hardness of the material tested. Apparently, the brick rebound hammer represents the conditions of the rammed earth wall more accurately than the mortar rebound hammer with reference to the experimental modulus data of the rammed earth walls. According to the brick rebound hammer values, the Zhencheng would have the highest modulus of the elasticity, followed by Fuxing, and the Wuyun and Huanji would have similar low modulus values. Except for Huanji where the mortar rebound hammer average reading was much higher than the brick rebound hammer, for other Tulou, the brick rebound hammer always gave higher average reading than the mortar rebound hammer. Note that each value is a statistical average over a number of measurements.

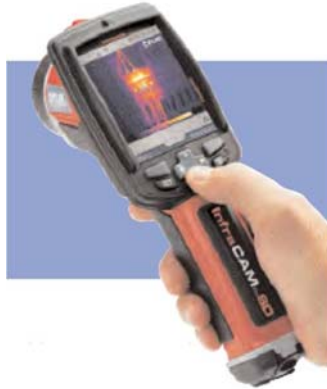
Fig 6: Portable IRT camera used

Infrared thermography (IRT) is a viable NDE method potentially capable of scanning a large area of testing structure and detecting subsurface delaminations and debonding between the surface layer and the substrate. This technique is based on the principle that subsurface defects and delaminations affect the overall thermal conductivity of the material, leading to different rates of heat transfer through sound and defective regions and thus, surface temperature differentials. For the present study, a brand new portable IRT camera model InfraCAM SD Camera was purchased (shown in Figure 6) and brought to China for field studies.

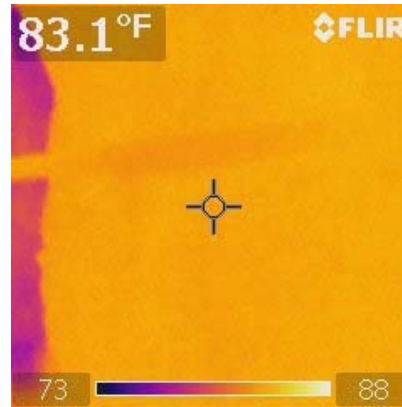
Fig 7: IRT detecting shallow wall rib

IRT camera was intended to perform a couple of functions upon verification of its usefulness during field study. One function would be to identify the presence of a wall rib with reference to a wall without wall ribs. If successful, we would be able to quantify the spacing, pattern, size and total volume of wood or bamboo wall ribs used as reinforcement within the rammed earth walls. Unfortunately, it was found that the IRT was not sensitive enough to detect the difference in the heat transfer rate between the walls with or without wall ribs. This is because the constituent materials to build a rammed wall, including earth, wood, bamboo, stone and others are all natural materials. Under a normal condition, they are all thermally in equilibrium. The surface temperature difference between the walls with or without wall ribs is almost zero, especially when the wall ribs are embedded in depth away from the wall surface and the wall has a thickness of 1.5 to 2 meter. Note that IRT is only able to identify defects under subsurface (at a limited depth). For example, the IRT is indeed able to detect the wall rib as shown in Figure 7 where a slightly dark shadow represents the wall rib, when the wall is around 12" in thickness with a crack in the vicinity. Due to crack, wind effects and shallow embedment of the rib in the wall, the temperature difference between the wall rib embedding area and its surrounding just meet the camera's sensitivity (~0.5C).

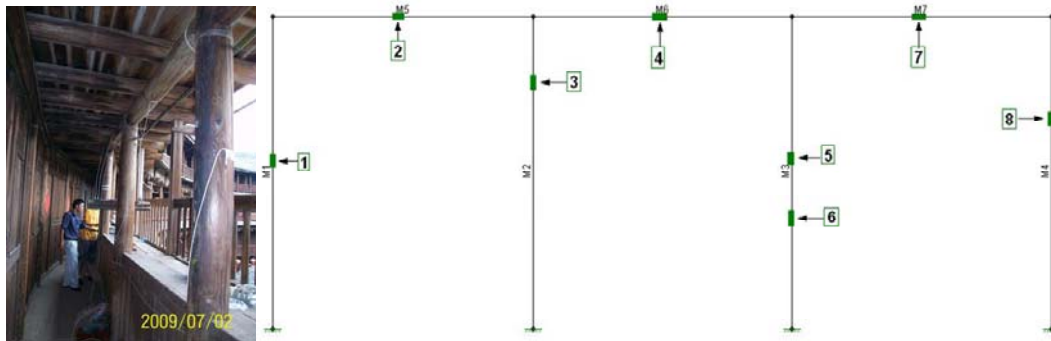
Fig 8: Load testing of floor system, member definition and strain gage locations

The floor system of a Tulou building consists of a number of columns, beams and floor panels (Figure 8). Each load carrying member is jointed to each other through pinned connection. All horizontal beams are connected around the inner yard to make a circle. The focus of this set of load testing is to better understand how the floor member responds to an external load and how the load is distributed among the neighboring members.

The floor system of Chengqi Tulou was tested by means of a two point load of up to 550 lbs. The test section of the floor is shown in Figures 8 along with a schematic illustration where each member is assigned with a number (M1 to M7) and strain gage locations are indicated. The load was applied onto Beam M6 between Column M2 and Column M3 as two equal concentrated loads symmetrically placed.

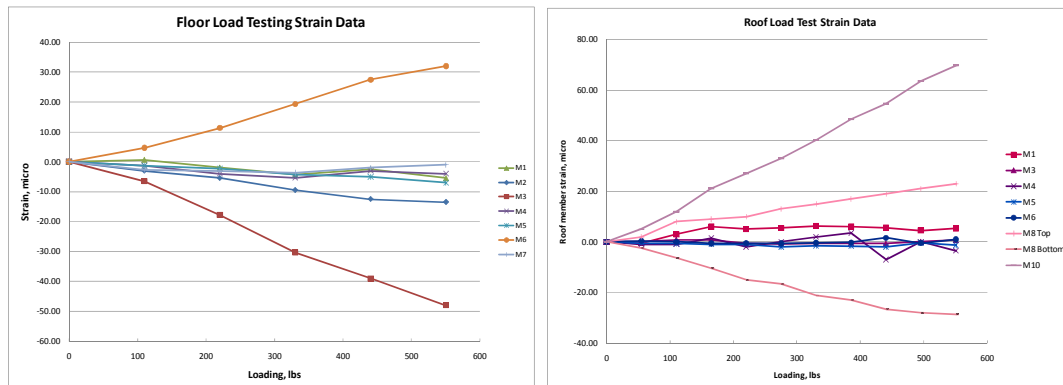
Fig 9: Strain data from load testing, a) floor system member strain data and b) roof truss member strain data

The strain data generated from the floor testing are graphically shown in Figure 9a, in terms of the strain gage locations and corresponding structural members as defined in Figure 8. The strain was recorded as a function of loadings for each member. Each strain value at a given loading was an average of three measurements from three separate runs. The load applying member M6 (gage #4) behaved as expected and gave a strain of 32 microstrain under maximal loading of 550 lbs. All other members had small strain values except the vertical member M3 (gage #5) that had unusual much higher values and gave a strain of 48 microstrain under 550 lbs.

The strain data generated from the roof truss structure testing are graphically shown in Figure 9b, as per the strain gage locations and corresponding structural members as defined in Figure 10. Similarly, the strain value was recorded as a function of loadings for each member mounted with strain gage. Each strain value at a given loading was an average of three measurements from three separate runs except that Member M4 (gage #8) had only two sets of data to average while the third set of data were mostly positive, resulting in uncertain trend for Member M4. It is not sure if this unclear trend was attributed to disturbance during testing or structural sensitivity. Note that the strain gages used were all 5 cm long gages to maximize the ability of detecting any small strains. All other members except M4 behaved as expected. The load applying member M10 (gage #4) gave a strain of 70 microstrain under maximal loading of 550 lbs. For M8, the bottom side was subjected to compression (negative strain) and the strain values were closely matching those of the top tension side.
