## **STRUCTURAL RESPONSES OF HAKKA RAMMED EARTH BUILDINGS UNDER EARTHQUAKE LOADS**

**Abstract:** Hakka Tulou are rammed earth structures that have survived the material aging, natural weathering and strong earthquakes for hundreds of years. To understand the structural response of a Hakka earth building under earthquake-induced load, finite element (FE) analyses were conducted. First, the constituent materials of rammed earth wall construction, including rammed earth, and wooden and bamboo reinforcement strips that were used in the Tulou walls for increased strength, were collected during field study and tested under tension and/or compression in the laboratory for their strength and modulus of elasticity properties. Secondly, the volume fraction of reinforcement in a typical rammed wall was determined. From these material property data, the modulus of elasticity of the reinforced rammed earth wall was estimated using the Rule of Mixture. Thirdly, the structural responses of the entire rammed earth wall structure of Huanji Tulou under an earthquake loading were evaluated through FE modeling as per the simplified lateral force analysis procedure provided by ASCE-7, under three vari

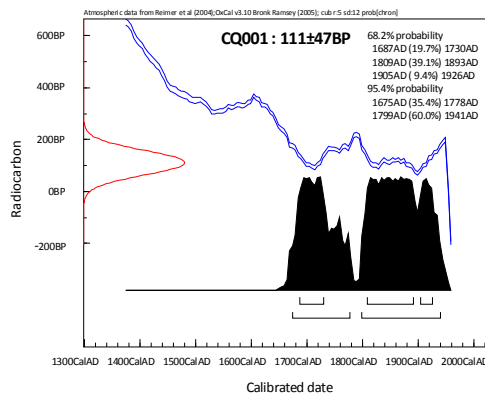
Figure 1: Carbon dating age of Chengqi Tulou

To validate the ages of the Tulou buildings and material samples that were reported among local official records, as a case study, a wooden sample from Chengqi Tulou was tested for its radiocarbon dating age. This wooden sample was cut from a roof truss beam in the Chengqi Tulou, reportedly built from 1662-1709, and was sent to the NSF- University of Arizona Accelerator Mass Spectrometry (AMS) Facility at the Department of Physics, University of Arizona, Tucson, AZ. The carbon dating measurement shows the sample at radiocarbon years 111 +/- 47 BP. Radiocarbon dates require calibration in order to transform them into calendar age ranges. The calibration plot for the sample tested is provided by NSF-Arizona AMS team and shown in Figure 1. The result indicates that there is a 95.4% probability that the sample is aged between the two calendar age ranges 1675AD -1778AD and 1799AD - 1941AD. This observation is consistent with the completion date of 1709 of Chengqi Tulou. Only the age of the wooden sample from Chengqi Tulou has been tested and verified while the ages of all other Tulou buildings reported herein are collected from local Government Records.

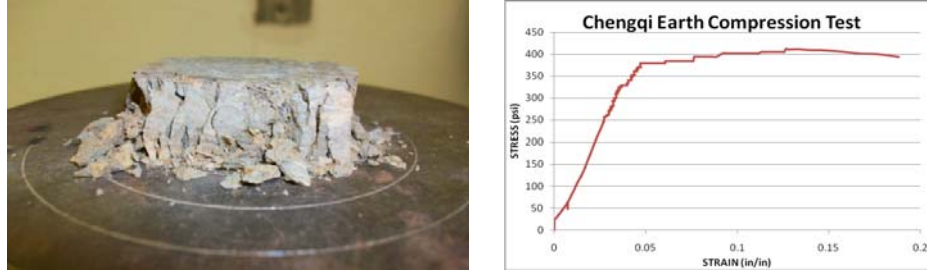
Figure 5: Chengqi earth sample after compression testing and resulting stress/strain curve

Rammed earth samples from the main wall structures of five Tulou were extracted and tested. Figure 5 shows representatively Chengqi Tulou earth sample after testing and resulting stress/strain curve. Table 1 summarizes the results of the rammed earth compression tests performed by both WVU and XMU. Note that testing of

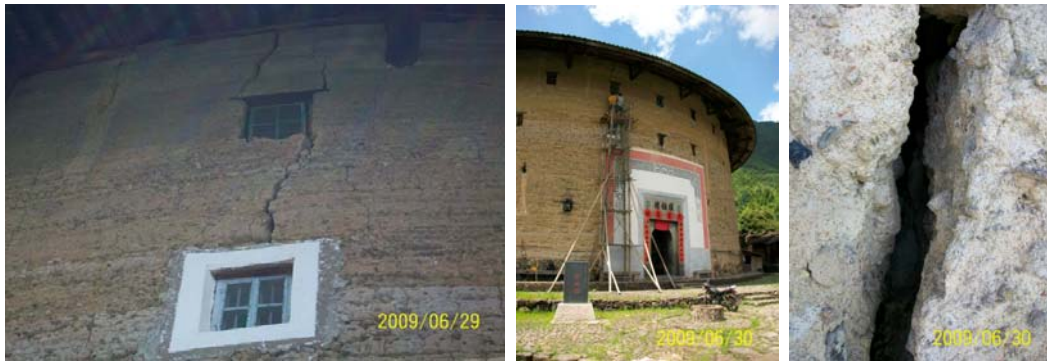
Figure 7: Huanji Tulou wall crack after earthquake, a) a global view of the crack, b) the crack location with reference to the ground and the access platform used during field study, c) close view of the crack

Huanji Tulou has an O/D 43.2m and 20m in height. It was reported that there was a 3m long crack of 20 cm in width due to a strong earthquake in 1918 that was self-healed after quake. As a matter of fact, the large crack is still on the wall. The reported earthquake-induced crack is about 10 meter above the ground. A global view of this crack is shown in Figure 7a. The crack begins from the 3<sup>rd</sup> floor window, across the 4<sup>th</sup> floor window and thru the top edge of rammed earth. To access and examine the crack, a construction worker was hired to build an access platform using bamboo during the field study in the summer of 2009, as shown in Figure 7b. After measuring the crack, including use of a laser distancer to measure its depth, the researchers found that the crack was about 350 cm in height including the crack thru the 4<sup>th</sup> floor window, with the crack between 4<sup>th</sup> floor window and 3<sup>rd</sup> floor window being the worst. That section was 178 cm in height, 5 to 10 cm in width, and 93 cm in depth. As shown in Figure 7c, this crack was actually across the entire wall thickness and most surprisingly, there were no wall ribs at all inside the rammed earth wall.

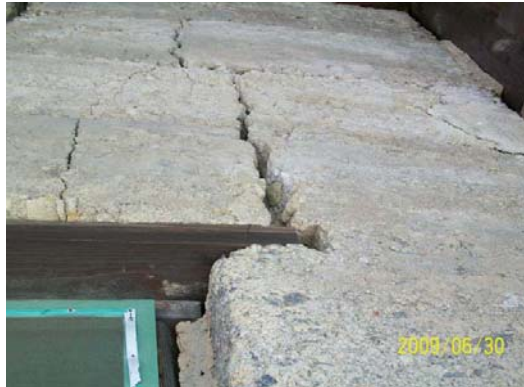
Figure 8: The crack and cavity at lintel end

Considering the scale of this crack, we would like to doubt if there was such story-telling self-healing. One observation from our close-examination of the crack can be drawn from Figure 8. It was noticed that there is a 5 cm cavity at lintel end. If the wall would have self-healed 5 cm, that cavity and most of the crack would disappear. Hence, we would like to interpret the fame of Huanji Tulou as the strongest Tulou as follows: Even though Huanji Tulou had such a large cross-thickness crack, it is still structurally sound. Why the crack occurred with Huanji Tulou is most likely because it does not have reinforcing wall ribs in its rammed earth wall.

The crack at the Huanji Tulou reportedly occurred due to a strong earthquake that hit the region. The crack began at the end of a window lintel due to high stress concentrations occurring from bending of the upper portion of the lintel. Why and where exactly the crack formed (Figure 8) has been accurately modeled using FE analysis, based on Lintel behavior as shown in Figure 9 along with an earthquake load, using the material property data generated from this study (Table 1). Figure 10 is a chart illustrating the stress in vertical direction upon application of a 220 kips horizontal load induced by an earthquake. Details can be found in (Stanislowski, 2011). Through the FE modeling one can see exactly how an earthquake load can cause increased loading in the Tulou and in return cause higher stresses leading to potential cracking. The FE modeling further demonstrated that if the rammed earth wall of Huanji Tulou were reinforced with wall ribs, such cracking could be totally avoided. Cracking could have also been avoided by using a stiffer lintel. This might explain why other Hakka Tulous in the area survived from the earthquake even without cracking.
