PERFORMANCE OBSERVATIONS OF THE BEIJING AREA'S UNRESTORED GREAT WALL: 'RAMMED EARTH AND RUBBLE CORE'

Abstract: This paper presents the author's observations of selected sections of the Great Wall around Beijing, specifically the condition of the rammed earth core and the factors which have and are affecting its present condition-longevity.

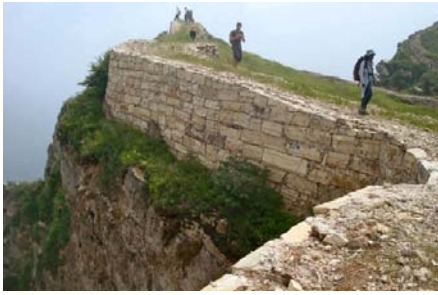
Figure 1

entirely of stone with a Rubble Core. (Figures 1 and 2) However a unifying factor between these sections, aside from a Rammed Earth or Rubble Core, which is the use of Sticky-Rice Lime mortar. (Figures 1, 3, 4)

Quarried stone blocks serve as the foundation for the entire Wall studied. Often many courses are used; perhaps where it is plentiful, where not, as few as one course is set in place, upon which the bricks are laid. The foundation stones vary in size shape and type considerably. (Figures 1, 3) The foundations themselves are undoubtedly well constructed which is clearly visible in many places where they are built straight onto bedrock. Due to the longevity of the Wall, the foundations placed on soil are undoubtedly well constructed also. Apart from a few locations where the soil has subsided but the Wall remained intact, they are not visible, and therefore not observed in this study.

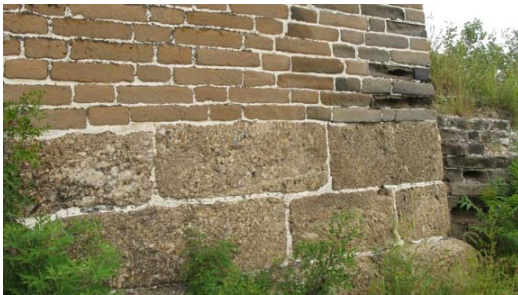
Figure 3

Fired bricks of approximately 285x145x90mm form the exterior of "most" of the studied sections and most of the great wall in the ranges North of Beijing. (Figures 3 and 4) A small portion of the studied Wall is built

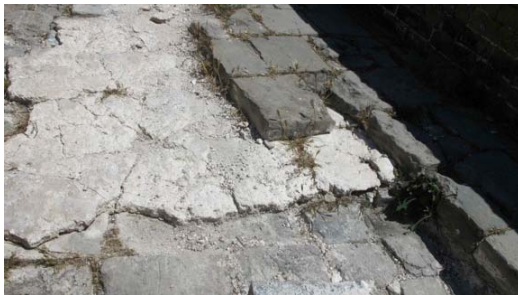
Figure 5

Depicts the liberal use of the mortar between courses of paving which form the Walls walkway. (Figure 5) There are three and sometimes four courses of paving laid over the Walls Core, forming the walkway. Under this is normally a rubble base, often itself laid in the mortar. Deeper still the Core proper consisting of more Rubble, sometimes of a different stone type and/or Rammed Earth.

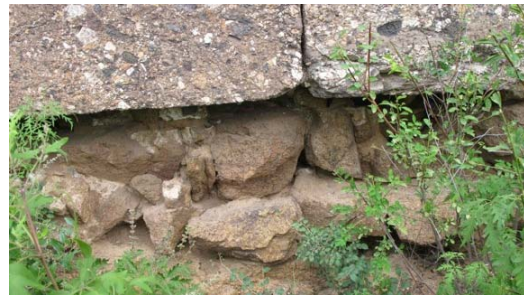
Figure 6

The Sticky-Rice and Lime Mortar has incredible properties, not least among them it ability to repel water. Without the superior nature of this mortar, it is doubtful that much of the wall would remain today. This mortar is used throughout the entire wall from the rubble and stone foundation, (Figure 6), to the brickwork and paving.

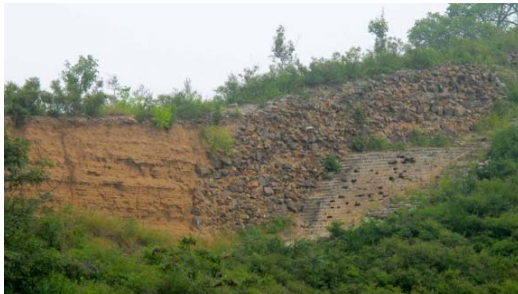
Figure 7

Where the Rubble is a robust and angular rock, it appears to have also been encased in the same soil as used in the Rammed section, and likewise rammed into place. (Figure 8) No visible difference in strength between these Rubble or Rammed sections is evident. However, some difference in weathering and erosion is evident with the Rubble sections performing better. (Figures 7, 8)

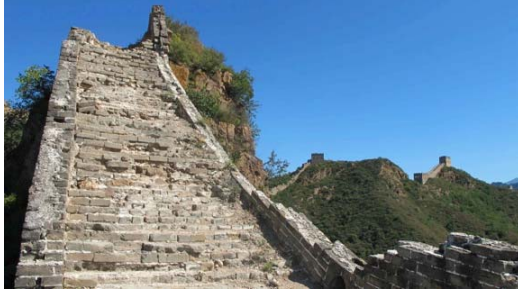
Figure 9

Where the Wall is built directly onto bedrock, and particularly where the Wall is very low, far less care with the Core's construction has been taken. (Figures 9,10) (Figure 10 is the upper extremity of Figure 9) The Wall at this point is at the top of a cliff and therefore does not necessitate a large Wall for defence, and is a few feet high. Less effort was taken with the Cores construction. In (Figure 10) you can see the erosion caused by the foot traffic of tourists. Little further damage can be done as the bedrock has been reached and is exposed already. This is the only location any such erosion was observed. This is in contract to locations such as (Figure 12) where foot traffic on the properly constructed Core, at present levels, seems to have no effect.
