*International Workshop on Rammed Earth Materials and Sustainable Structures & Hakka Tulou Forum 2011: Structures of Sustainability*

# Nondestructive Evaluation of Historic Hakka Rammed Earth Structures

**Ruifeng Liang**  
**rliang@mail.wvu.edu**

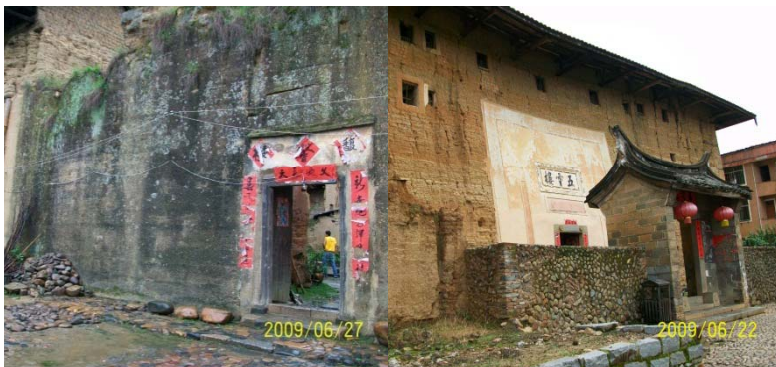
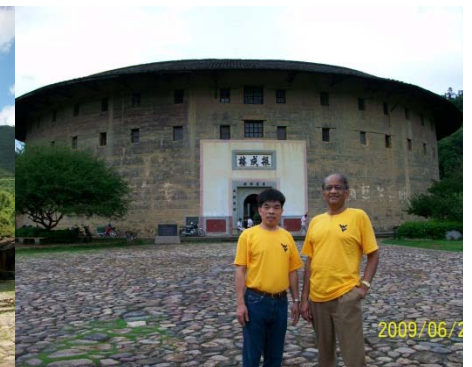
Title of Tulou	Shape	No. Storey	Age	Status
Fuxing Tulou	Square	2 storey	over 1200 years	partially in service
Wuyun Tulou	Square	4 storey	over 500 years	partially in service
Chengqi Tulou	Round	4 storey	over 300 years	in service
Huanji Tulou	Round	4 storey	over 300 years	in service
Zhencheng Tulou	Round	4 storey	about 100 years	in service

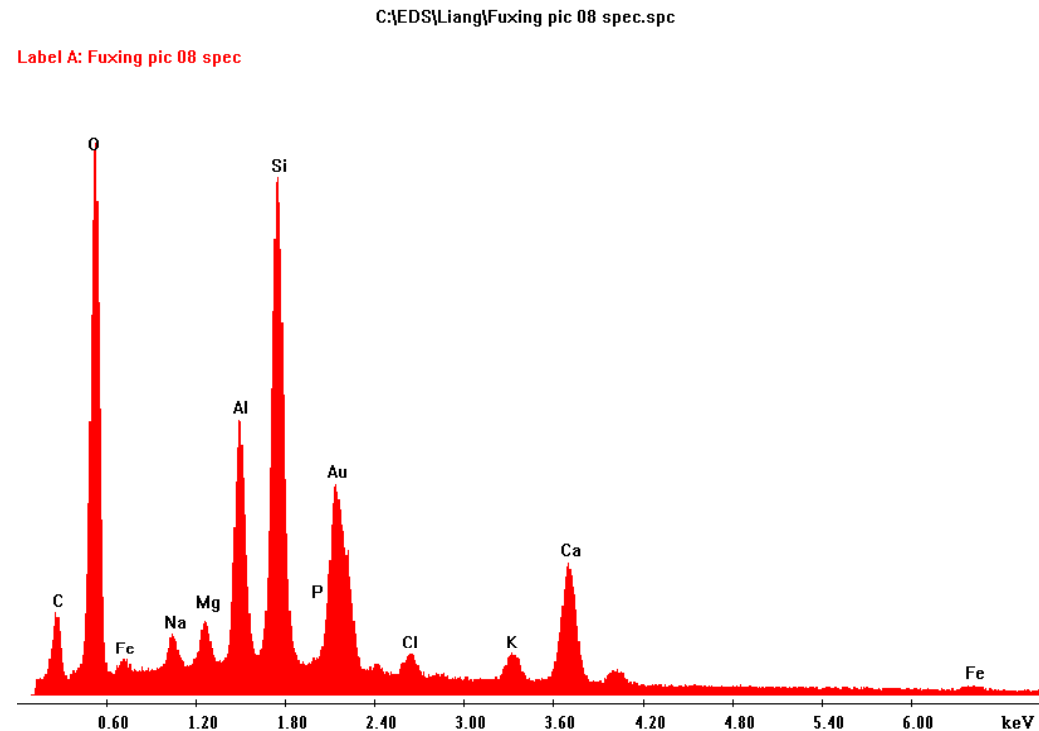
Fuxing RE sample EDS chart showing rich calcium content

- EDS-Energy-Dispersive X-ray Spectroscopy
  - To determine the chemical composition of a sample by showing the amount of existing elements relatively to each other.
- Allows one to compare composition of rammed earth samples from different locations

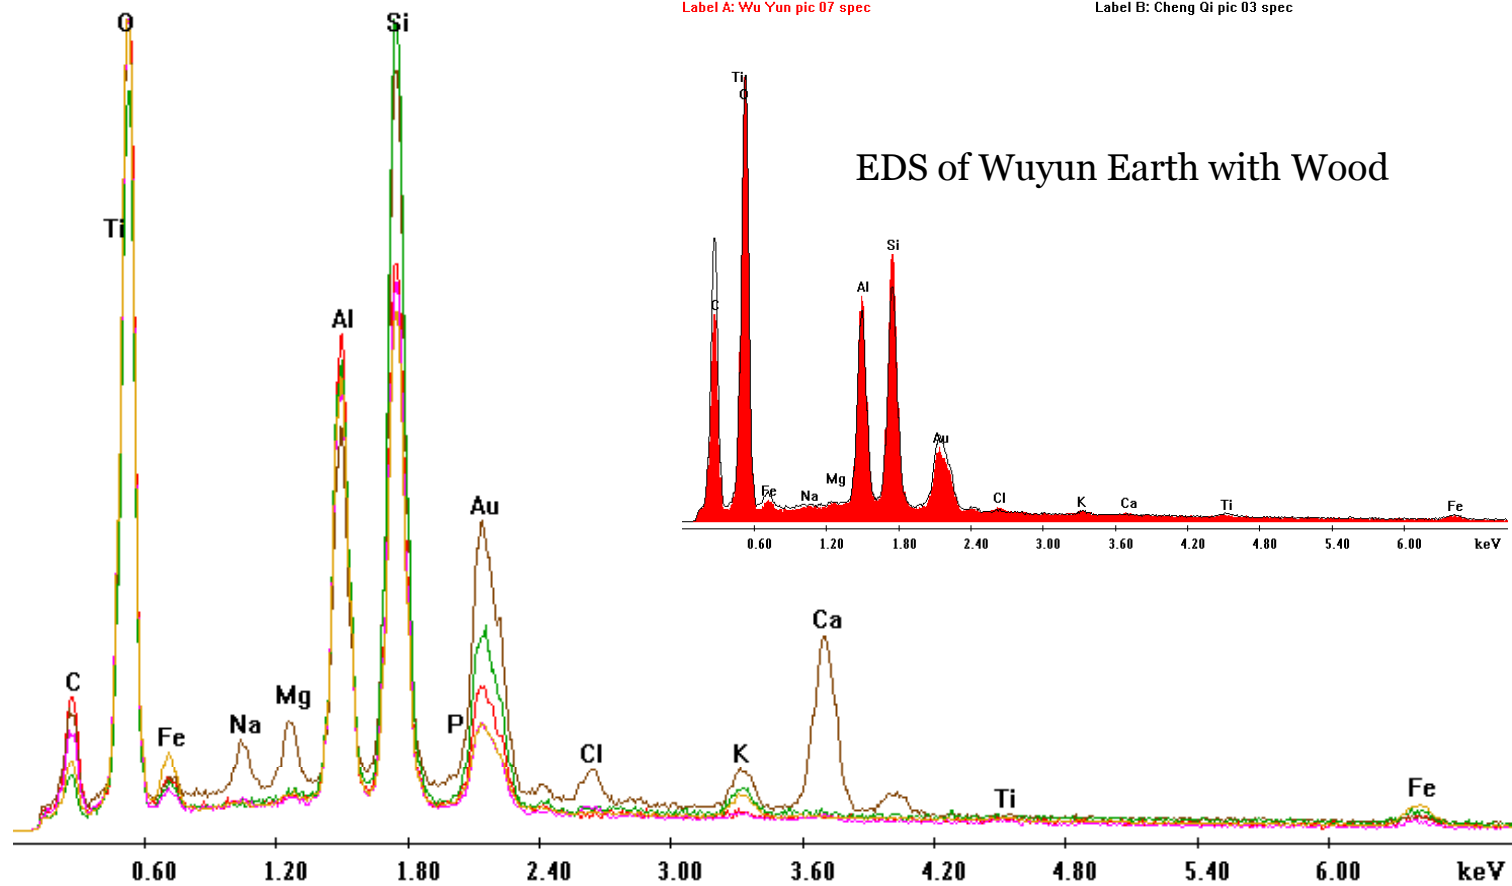
# EDS Comparison of Five Tulou RE Samples

Cheng Qi pic 08 spec   Fuxing pic 08 spec   Huanji pic 09 spec   Wu Yun pic 08 spec   Zhen Cheng pic 06 spec

Label A: Wu Yun pic 07 spec

Label B: Cheng Qi pic 03 spec

- All samples show an abundance of oxygen, silicon, and aluminum
- Zhencheng, Chengqi, and Wuyun, show an abundance in titanium
- Chengqi and Wuyun also show significant amounts of carbon, due to the presence of wood pieces
- Fuxing shows abundance of Calcium, key element in lime
- Results show that composition of rammed earth is unique to local environments of the Tulou

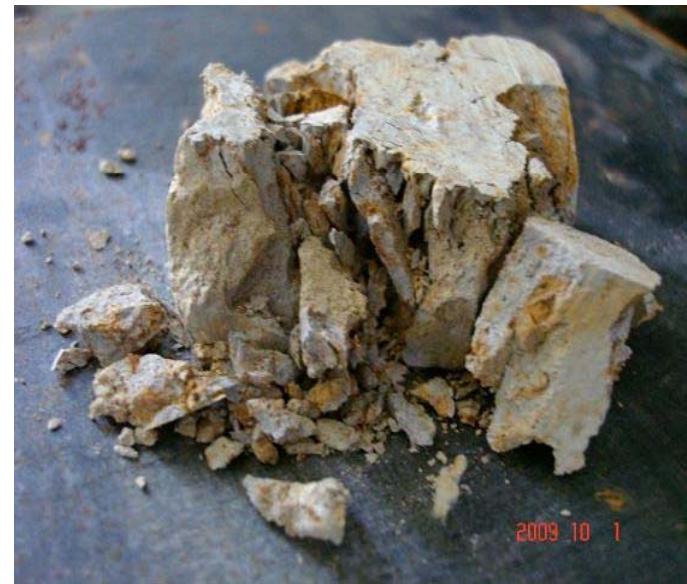
Failed rammed earth sample (XMU)

- Field collected samples include: rammed earth, reinforcing wood and bamboo, as well as structural wood from internal wooden structure.
- Wooden stick, bark, and/or bamboo strip were used for reinforcing rammed earth walls at most Tulou sites.
- RE samples very difficult to extract, thus sizes are not to ASTM standard.
- Tests performed on Instron Testing instrument at both Xiamen University and WVU.
- Stress-strain curves created to find Young's Modulus and ultimate compressive strength.

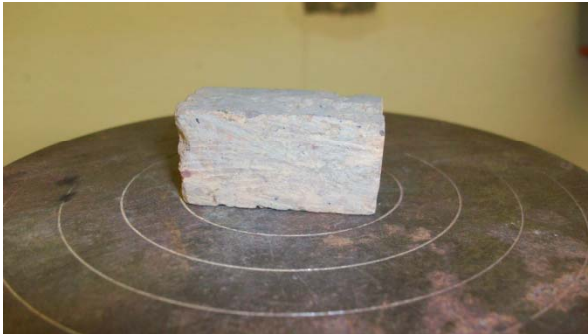
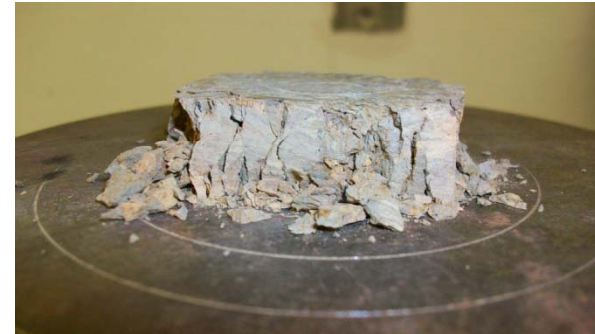
Chengqi earth sample before and after testing at WVU

Xiamen University		WVU	
<b>Tulou</b>	<b>Age (years)</b>	<b>E (psi)</b>	<b>f'c (psi)</b>	<b>E (psi)</b>	<b>f'c (psi)</b>
<b>Fuxing</b>	<b>1240</b>	<b>6318.1</b>	<b>282.4</b>	<b>X</b>	<b>X</b>
<b>Wuyun</b>	<b>500</b>	<b>1705.5</b>	<b>133.1</b>	<b>2129.3</b>	<b>278.8</b>
<b>Chengqi</b>	<b>300</b>	<b>X</b>	<b>X</b>	<b>8147.1</b>	<b>411.1</b>
<b>Zhencheng</b>	<b>100</b>	<b>3597.9</b>	<b>196.0</b>	<b>4291.4</b>	<b>125.9</b>

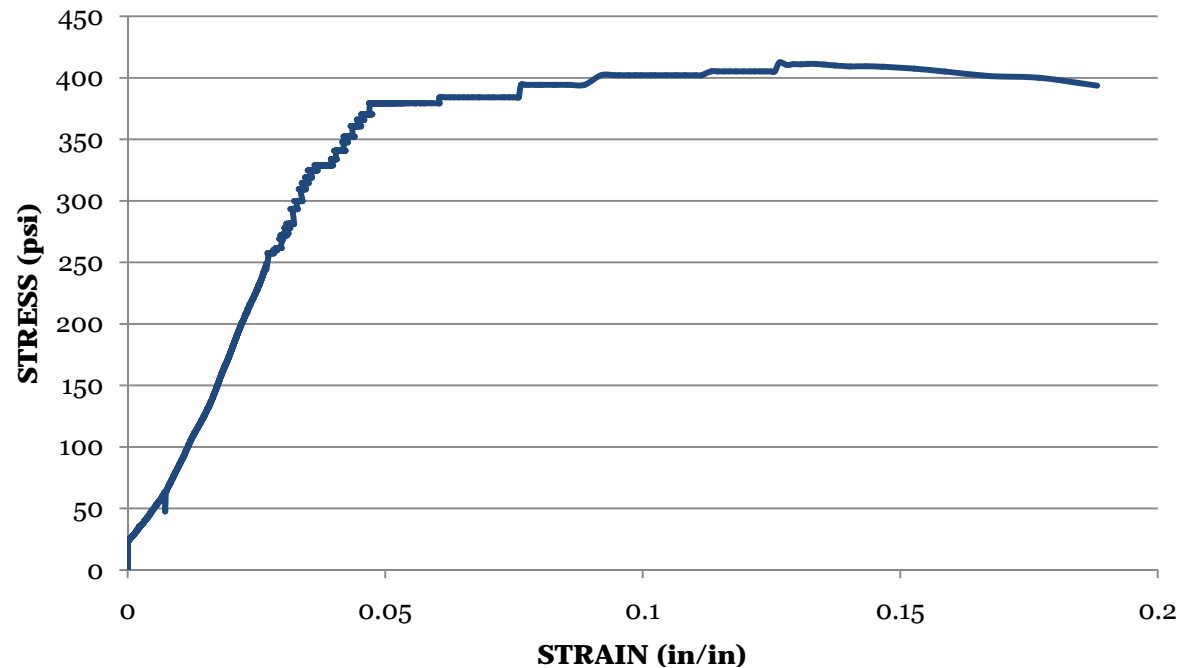
## Chengqi Earth Compression Test

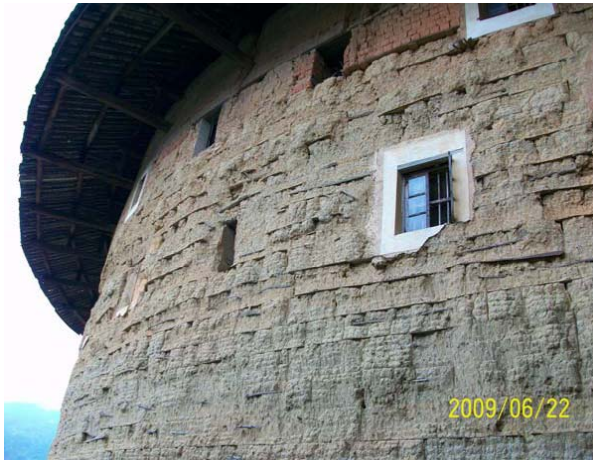
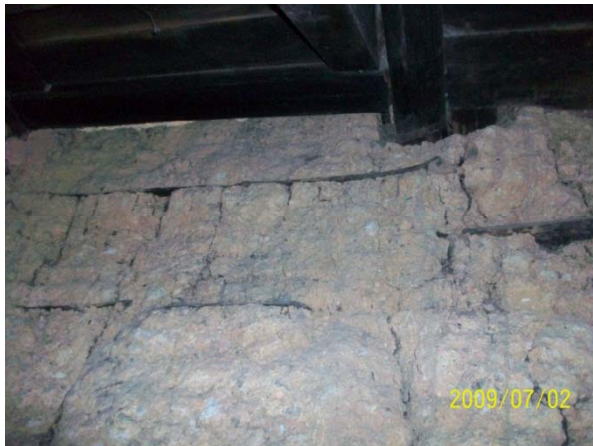
Rough rammed earth walls of Chengqi Tulou showing layer construction and wall ribs

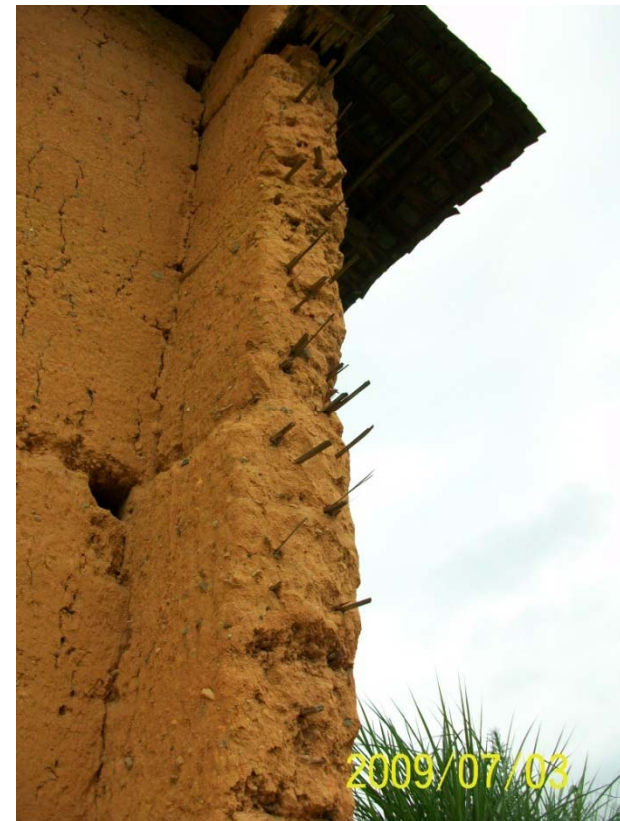
Pultruding wall ribs

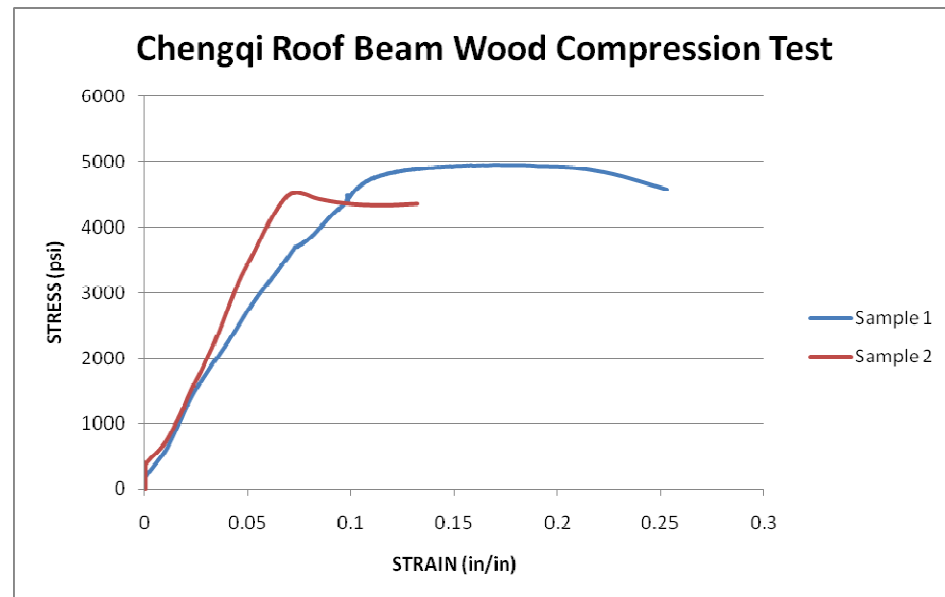
Chengqi roof beam wood sample stress/strain curve

Xiamen University		WVU	
	Tulou	Age (years)	E (psi)	f <sub>c</sub> (psi)	E (psi)	f <sub>c</sub> (psi)
Compression	Chengqi Roof Wood	300	X	X	175460.5	3990.3
	Chengqi Wood Rib	300	46799.3	3382.3	57308.3	4717.4
	Chengqi Wood Rib II	300	X	X	303363.6	4870.3
	Chengqi Bark Rib	300	X	X	52582.8	2483.6
	Fuxing Wood Rib	1240	X	X	227943.7	4376.3
	Hongkeng Bamboo	?	X	X	300023.1	11039.3
Tension	Chengqi Wood Rib	300	34736.7	1707.3	X	X
	Hongkeng Bamboo	?	463178.1	4452.4	X	X

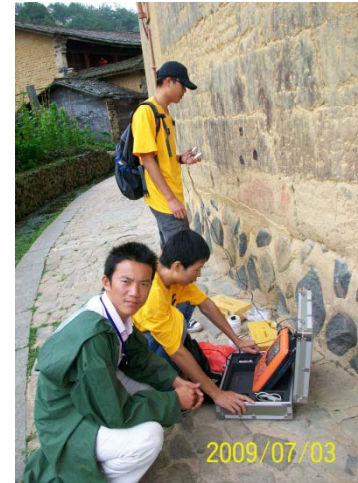
- To understand the conditions of the rammed earth walls of Hakka Tulou, without damaging the historic structures.
- Ultrasonic testing may reveal info about the strength of RE walls:
  - A combination of velocity and amplitude measurements provides more useful info by increasing the sensitivity of the ultrasonic technique to defects.
  - One can compare the velocity of a wave to the amplitude to see if there are inconsistencies, if inconsistencies exist then there is a possibility that a defect may be present.

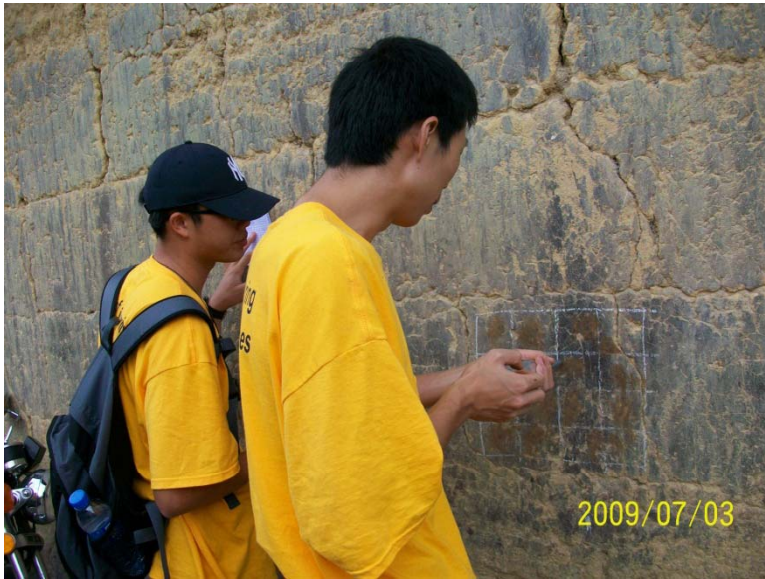
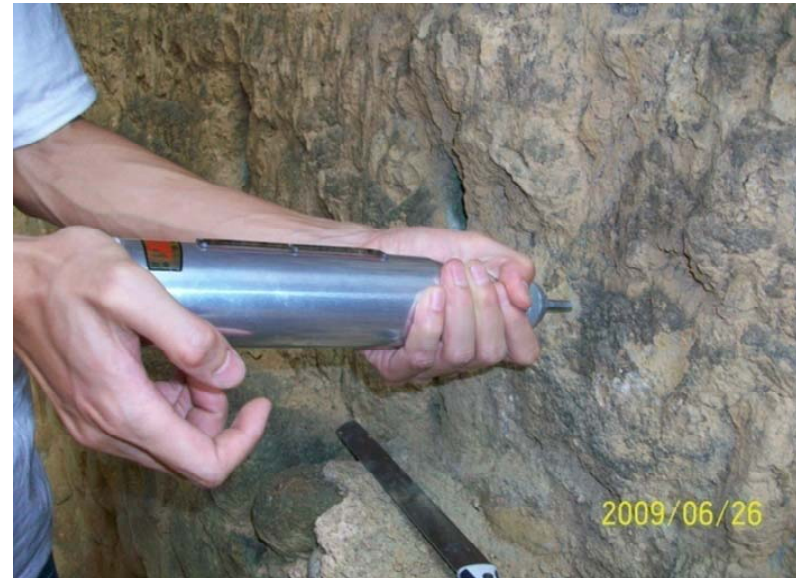
- Rebound hammer test is typically used for measuring hardness of concrete samples; measures the hardness by striking a mass on a surface and measuring rebound value (Halabe et al. 1995)

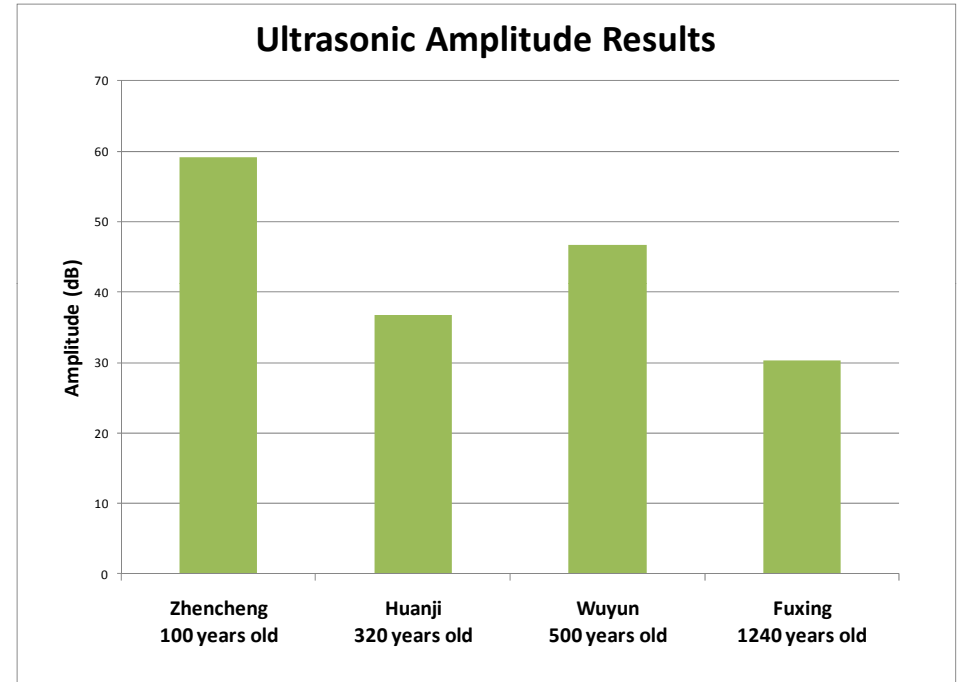
# Ultrasonic Results

Note: Fuxing Tulou data obtained on wet walls due to rain

- NDE techniques such as ultrasonic and rebound hammer were proved effective to quantitatively compare the strength of rammed earth walls.
- Infrared thermography was found not sensitive enough to detect the presence of wall ribs.
- Rebound Hammer results of Fuxing Tulou further exemplify outstanding long term strength of rammed earth

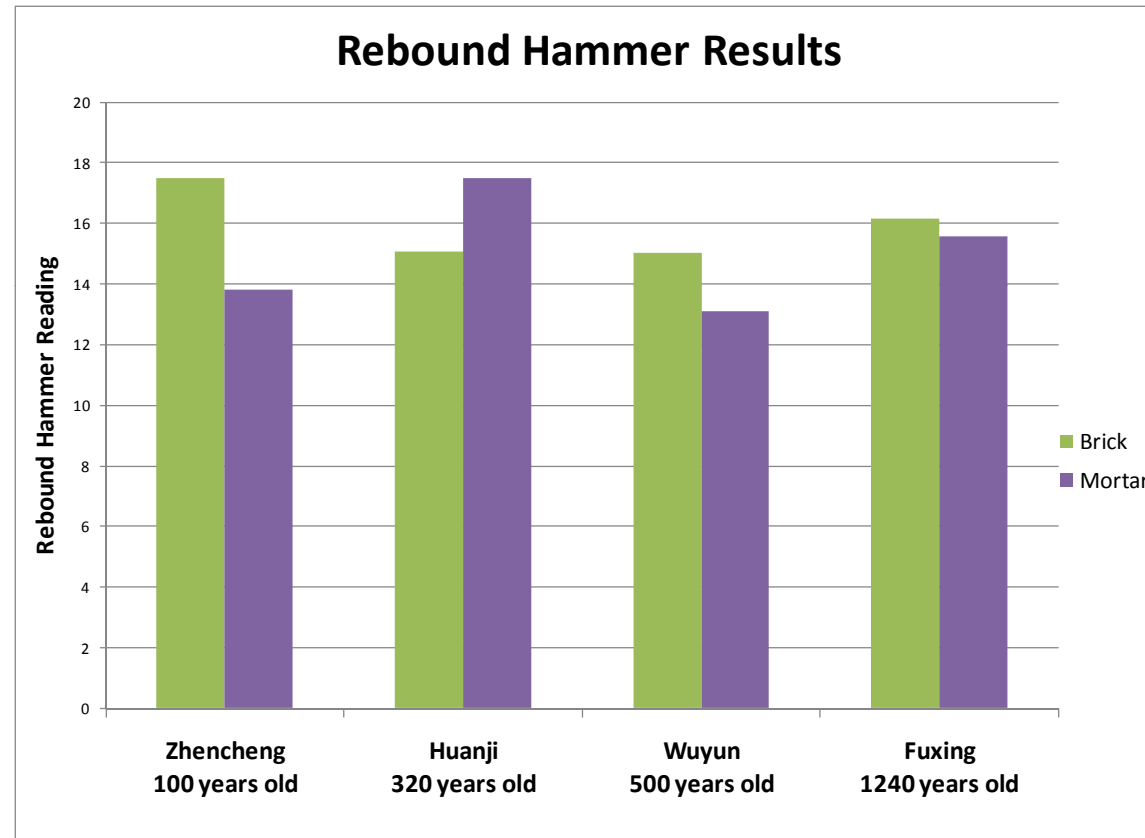
# Rebound Hammer Results

Note: Fuxing Tulou data obtained on wet walls due to rain

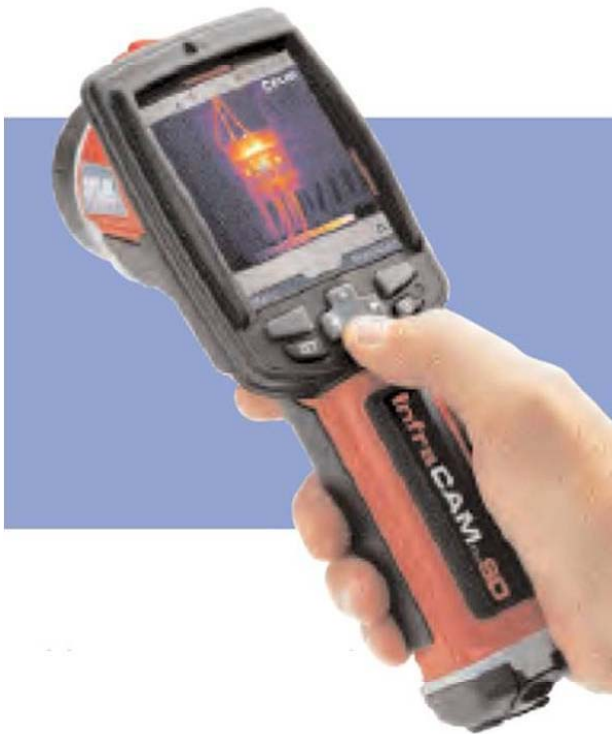
Portable Handheld IRT camera used

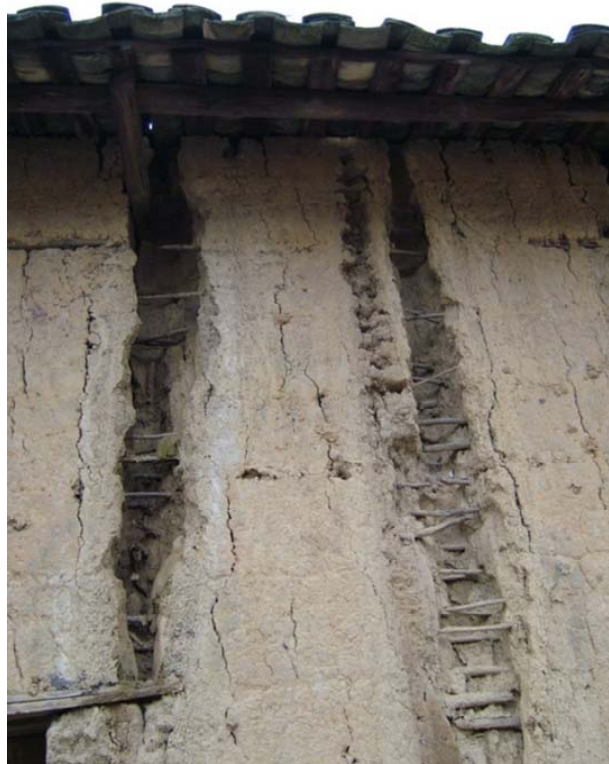
Eroded RE wall exposing wall ribs

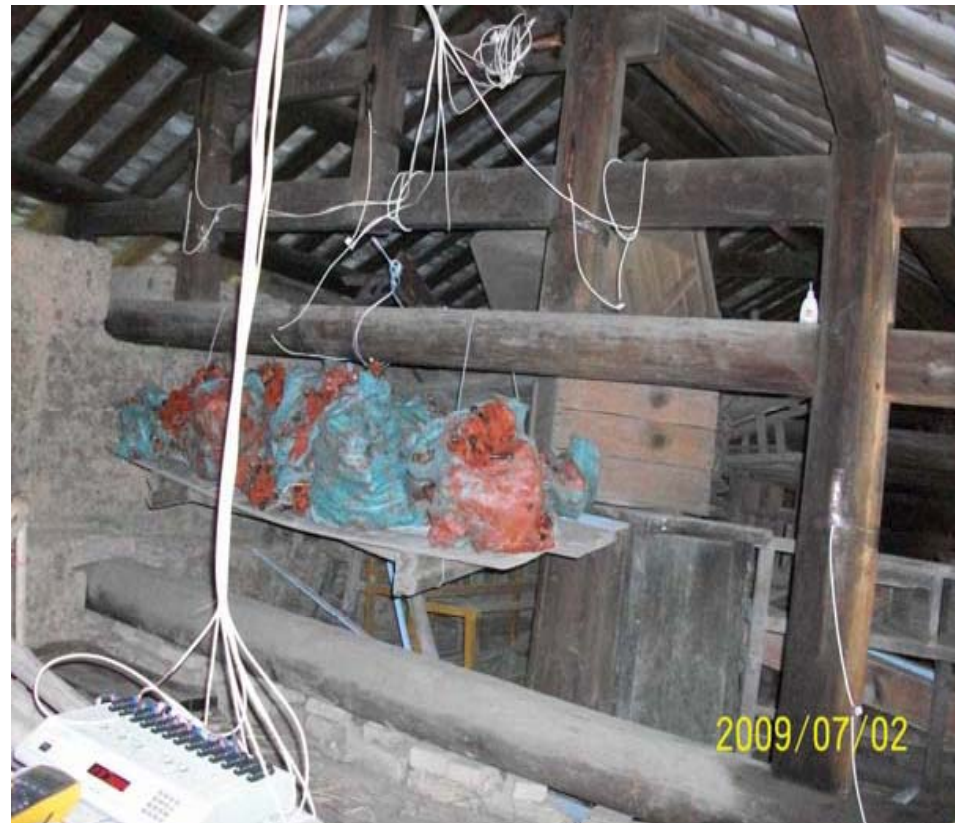
# Load Testing on Roof Truss System

- Internal wooden system is important load bearing component of Tulou.
- Loads distribute from wooden roof truss down to rammed earth walls and wooden columns.
- Two point load test up to 550 lbs in order to collect the strain data to reveal structural integrity of the system.
- Both roof and floor tests performed at Chengqi Tulou.

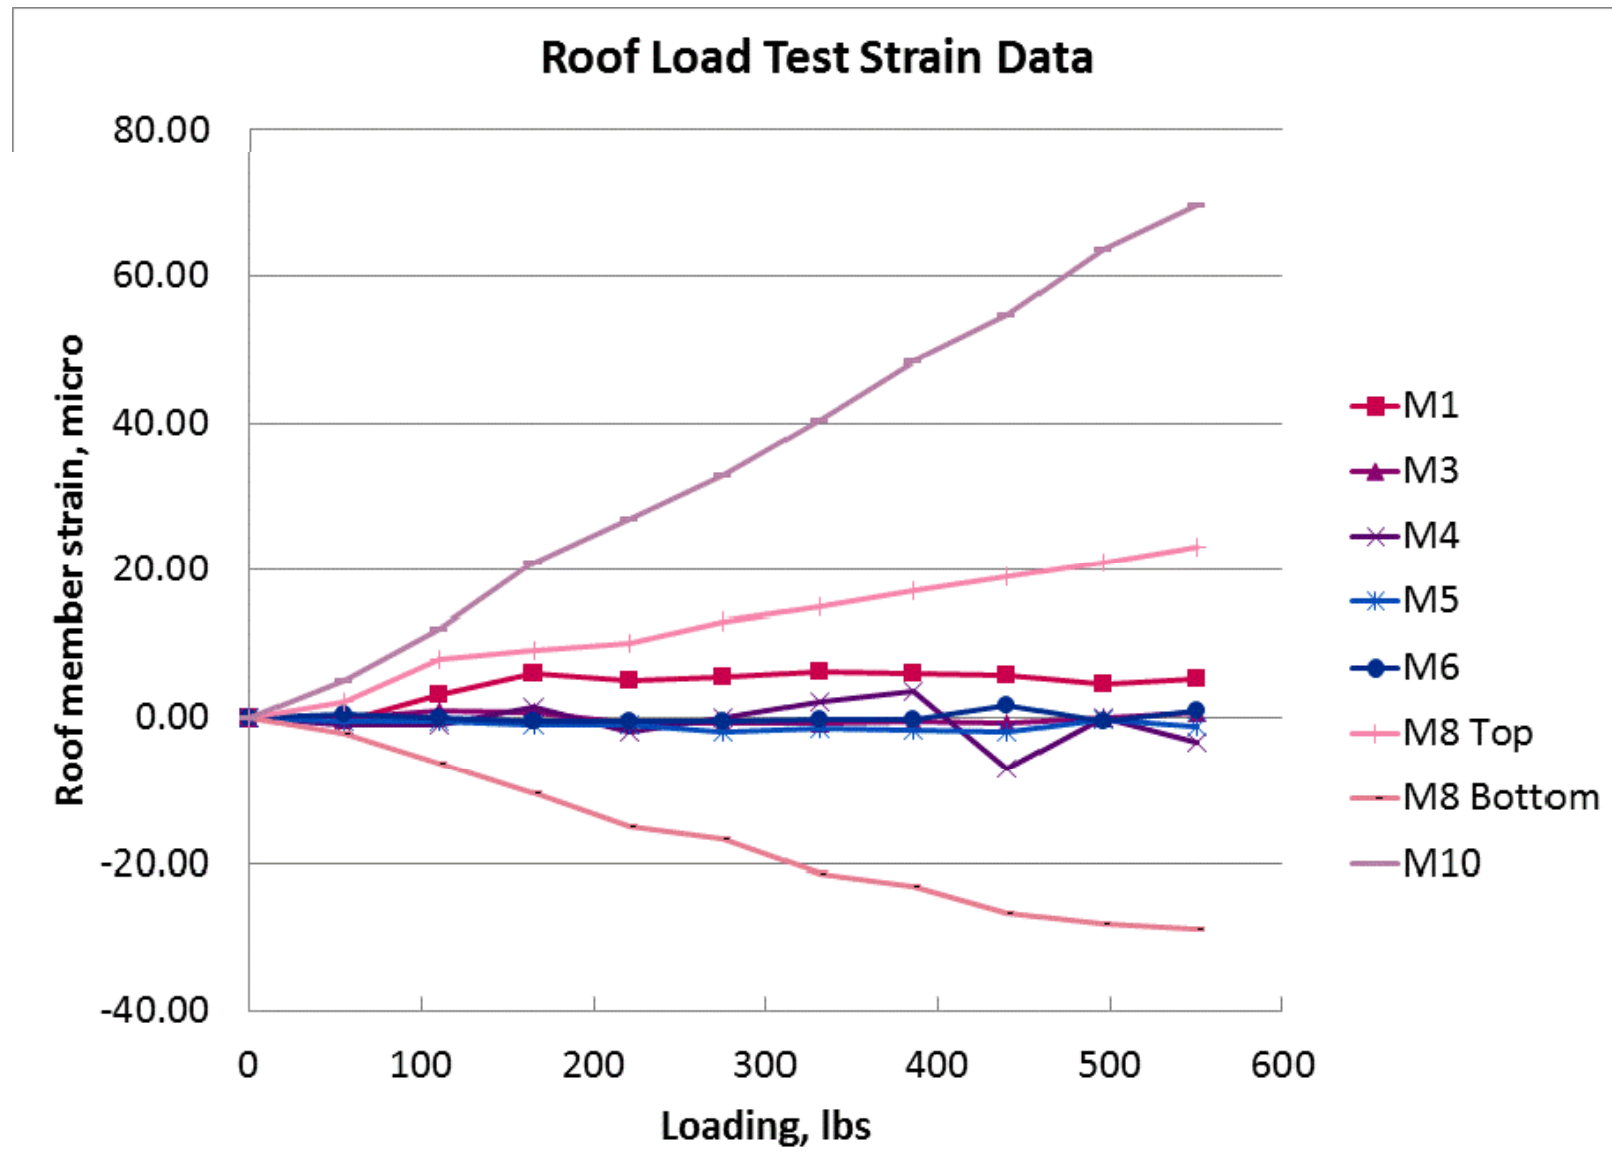
## Roof Load Test Strain Data and Model Predictions

Member	M1	M3	M4	M5	M6	M8 Top	M8 Bottom	M10
	<b>Gauge #:</b>	<b>3</b>	<b>1</b>	<b>8</b>	<b>9</b>	<b>10</b>	<b>5</b>	<b>7</b>	<b>4</b>
	<b>Load, lbs</b>	<b>μΕ</b>	<b>μΕ</b>	<b>μΕ</b>	<b>μΕ</b>	<b>μΕ</b>	<b>μΕ</b>	<b>μΕ</b>	<b>μΕ</b>
<b>Field Test Data</b>	0	0.00	0.00	0.00	0.00	0.00	0.00	0.00	0.00
	55	-0.50	0.00	-1.00	-0.50	0.40	2.00	-2.33	5.00
	110	3.00	0.83	5.00	-0.60	0.00	8.00	-6.25	12.00
	165	6.00	0.75	6.00	-1.00	-0.60	9.00	-10.33	21.00
	220	5.00	-0.67	14.00	-1.00	-0.50	10.00	-15.00	27.00
	275	5.50	-0.75	17.00	-2.00	-0.60	13.00	-16.67	33.00
	330	6.33	-0.67	22.00	-1.50	-0.33	15.00	-21.25	40.33
	385	6.00	-0.50	24.00	-1.67	-0.20	17.00	-23.00	48.50
	440	5.67	-0.67	24.00	-2.00	1.60	19.00	-26.67	54.67
	495	4.50	0.00	22.00	-0.33	-0.50	21.00	-28.00	63.50
550	5.33	0.67	19.00	-1.25	1.00	23.00	-28.67	69.67	
<b>Risa, E=1 msi</b>	550	0.48	-0.12	-0.18	-1.05	-6.02	6.82	-15.22	59.53
<b>Risa, E=0.75 msi</b>	550	0.65	-0.16	-0.24	-1.40	-8.03	9.09	-20.29	79.37

- Both systems structurally sound (no significant strain)
  - ✓ Roof Truss: 70 microstrain @ 550 lbs >>> E=0.85 msi matches
  - ✓ Floor System: 32 microstrain @ 550 lbs >>> E=1.85 msi matches
- Both systems are made of China-fir (2 msi) that offers such high strength and high decay resistance as well.
- As compared to 1) a simply supported beam and 2) a beam fixed at both ends,

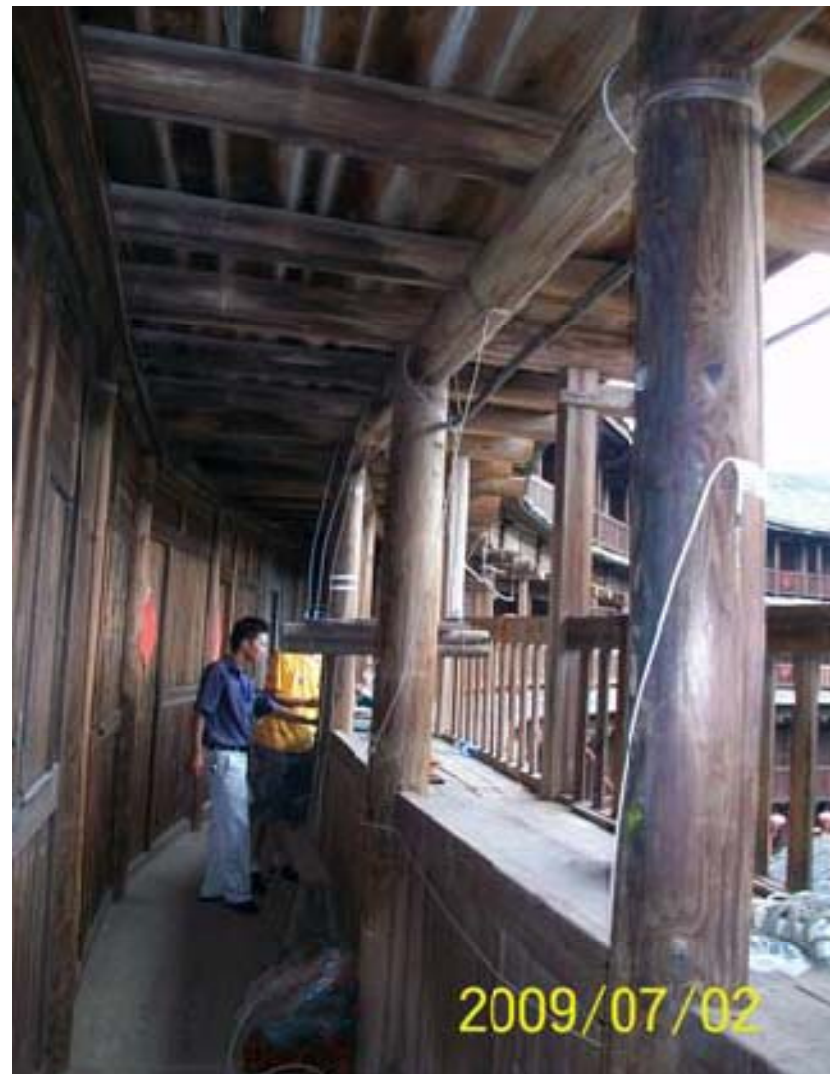
# Load Testing of Floor System

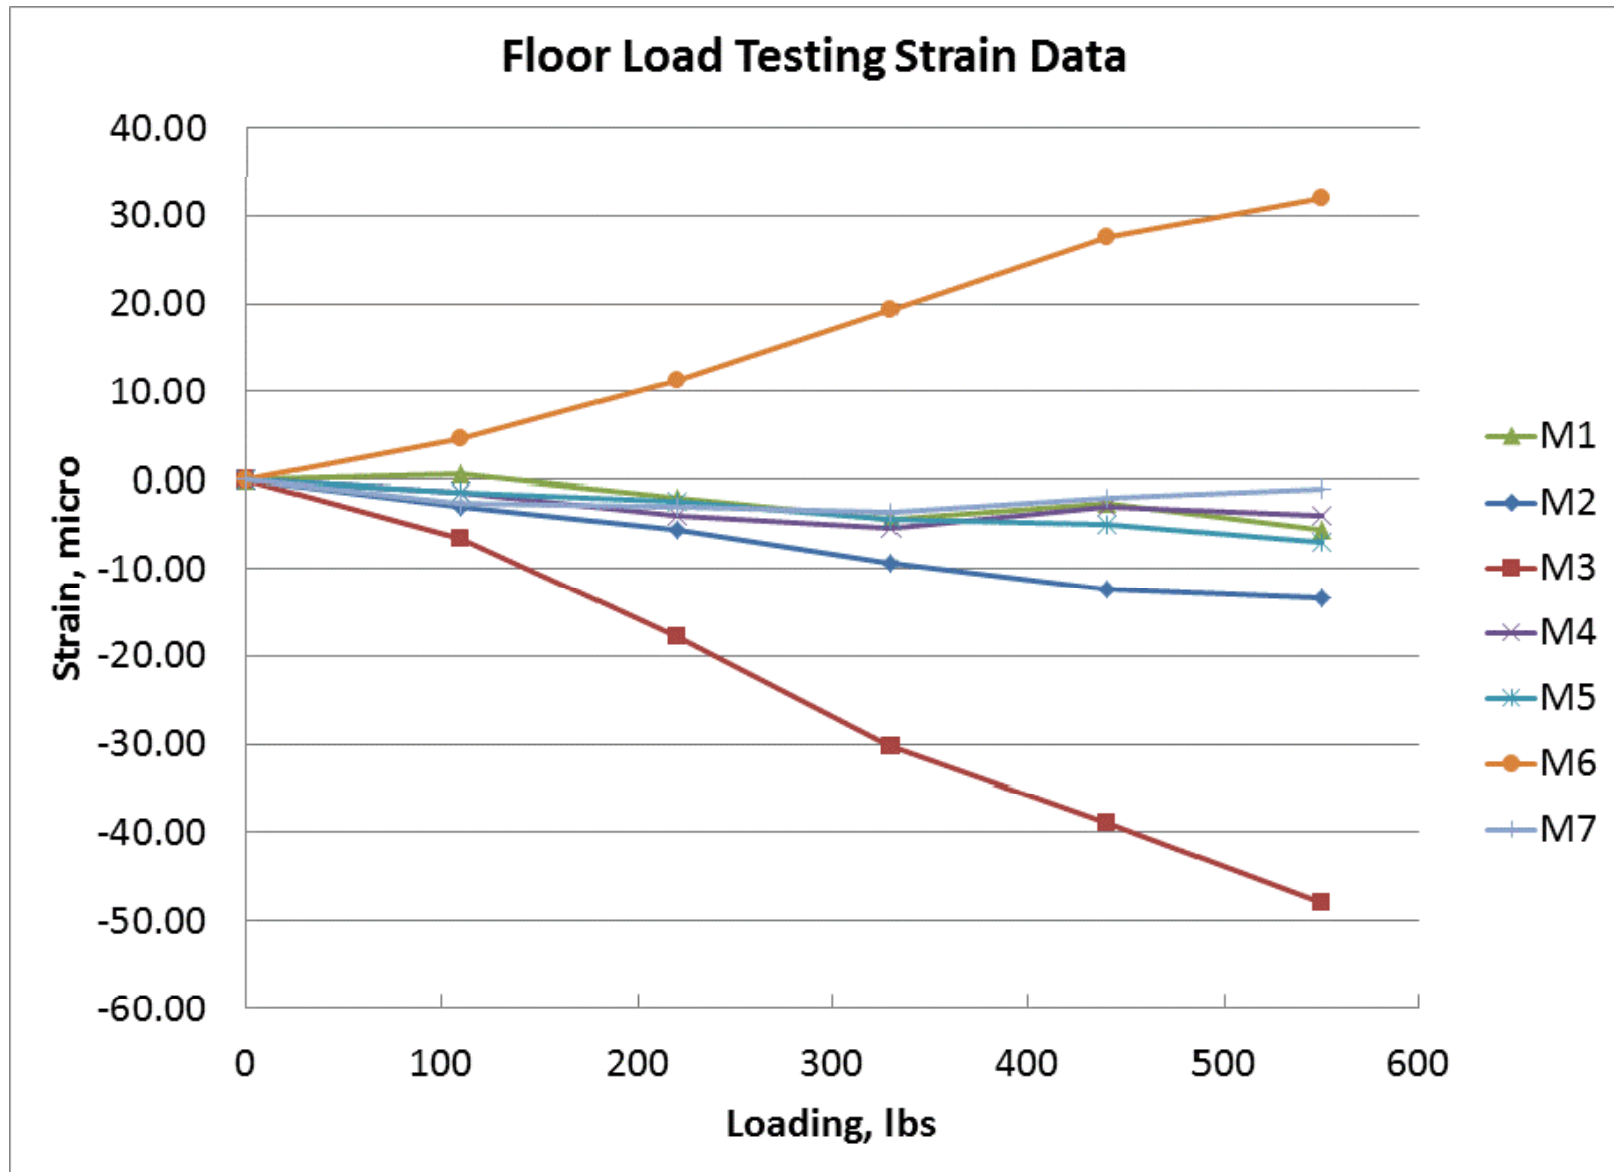
# Floor System Member Strain Data

Member	M1	M2	M3	M4	M5	M6	M7
	Gauge #:	1	3	5	8	2	4	7
	Load, lbs	$\mu\epsilon$	$\mu\epsilon$	$\mu\epsilon$	$\mu\epsilon$	$\mu\epsilon$	$\mu\epsilon$	$\mu\epsilon$
<b>Field Test Data</b>	0	0.00	0.00	0.00	0.00	0.00	0.00	0.00
	110	0.67	-3.00	-6.50	-1.33	-1.33	4.67	-2.67
	220	-2.00	-5.50	-17.75	-4.00	-2.33	11.33	-3.00
	330	-4.33	-9.50	-30.33	-5.33	-4.33	19.33	-3.67
	440	-2.50	-12.50	-39.00	-3.00	-5.00	27.50	-2.00
	550	-5.50	-13.50	-48.00	-4.00	-7.00	32.00	-1.00
<b>Risa, E=2 msi</b>	550	0.20	-2.99	-2.63	0.24	-6.78	29.69	-6.26
<b>Risa, E=1.5 msi</b>	550	0.27	-3.99	-3.50	0.32	-9.05	39.58	-8.34

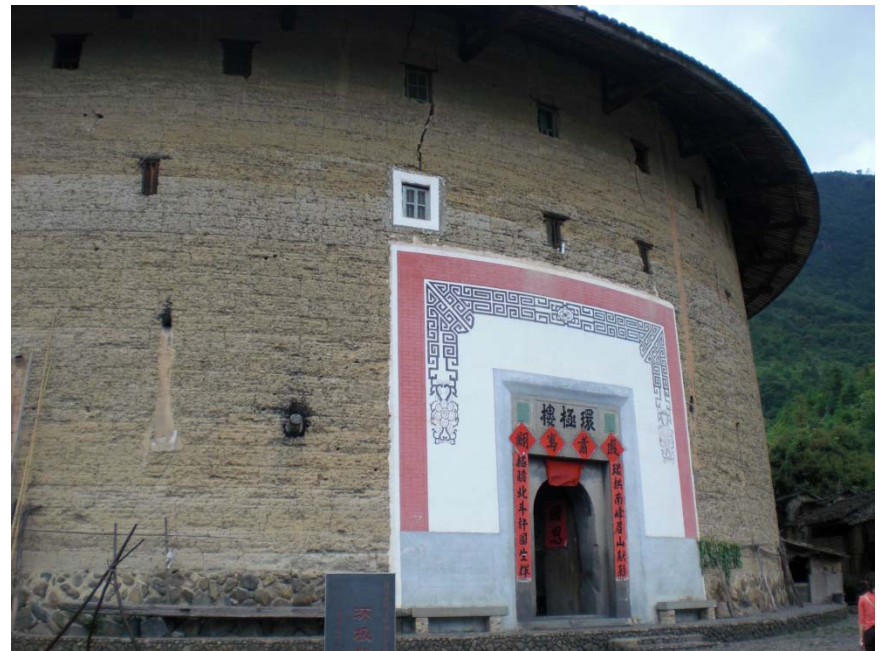
- To model the creation of the existing crack at Huanji Tulou and attempt to validate its self healing claim.
- To model the response of Huanji Tulou under a strong quake load and explain its strong resistance to earthquakes.

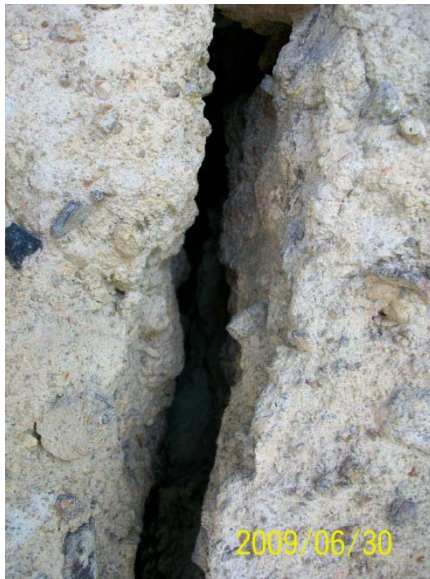
The through-the-wall thickness crack of Huanji Tulou

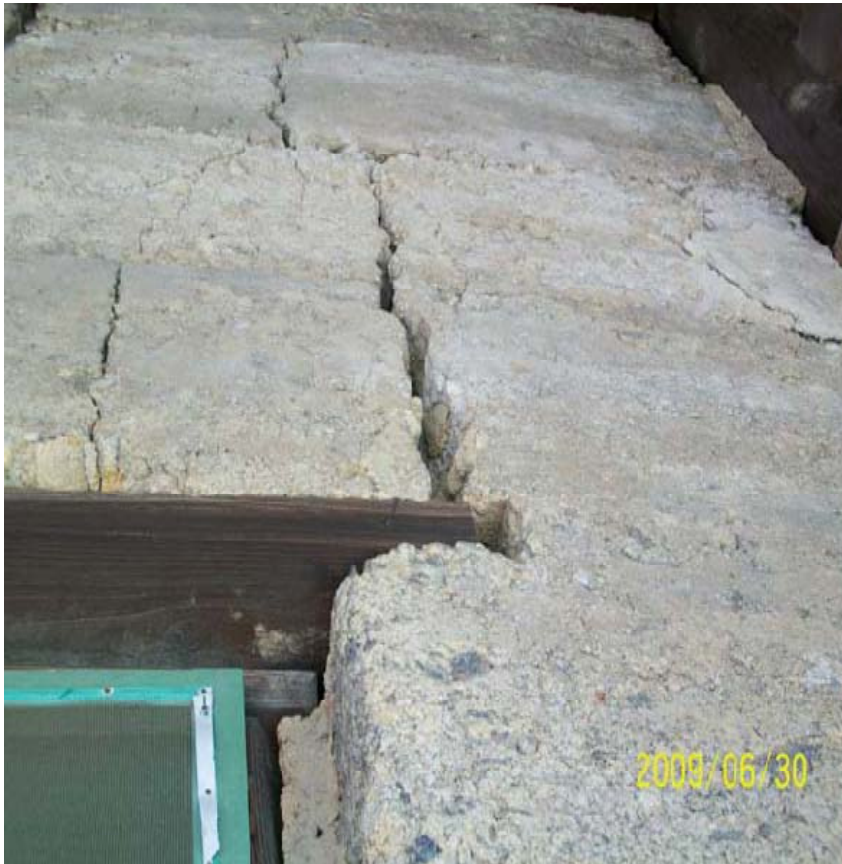
# The Cracking and Cavity at Lintel End

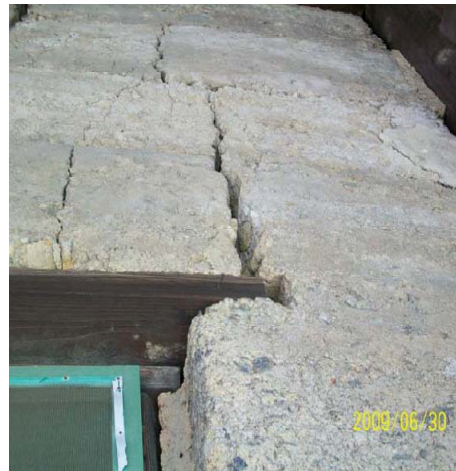
- The model shows that there is the possibility for the crack to decrease in size with decreases in temperature. However, Fujian Province has mild winters and 70 °F temperature fluxes are highly unlikely. Also, thermal expansion effect is reversal as temperature increases.
- It is argued that a thick reinforced rammed wall coupled with the internal wooden structure might contribute to a self healing effect. However, the Huanji Tulou is found without any reinforcement.
- The existence of cavity at lintel end as shown in the photo implicates that the crack has not self-healed.

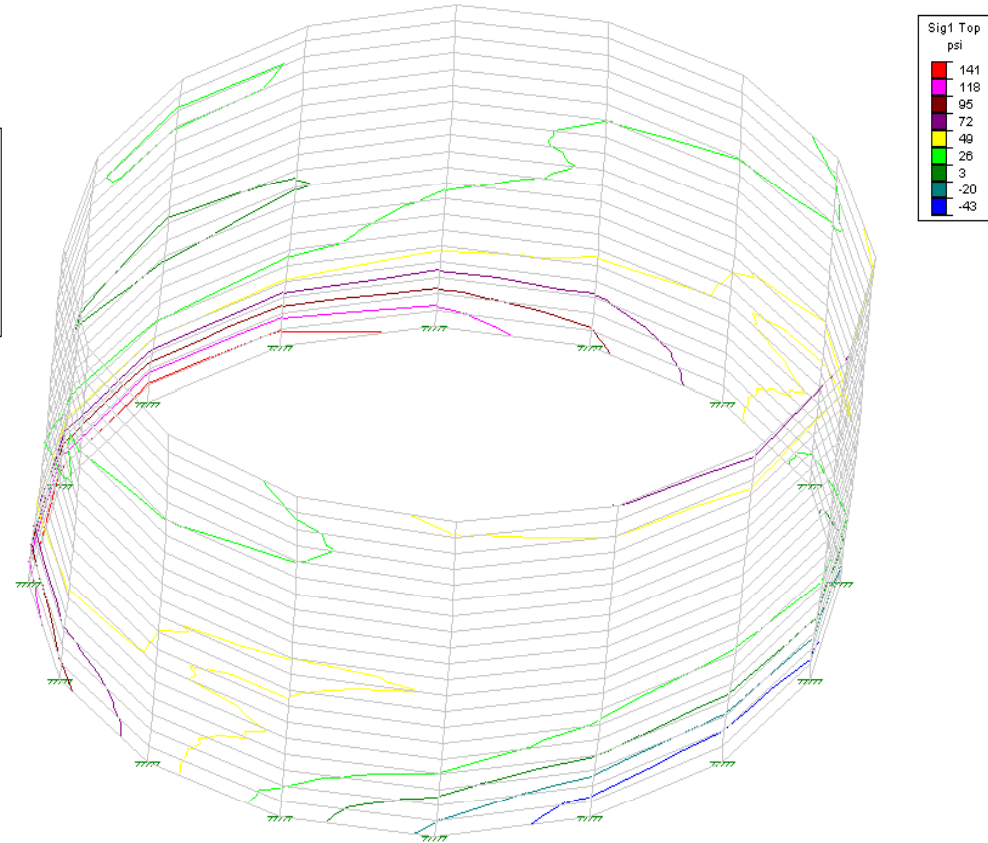
# 2D and 3D Stress Distribution of Tulou Under Earthquake Loads

Most conservative scenario:

- ✓ Weakest rammed earth
- ✓ Without wall rib reinforcement
- ✓ Without inner wooden structure

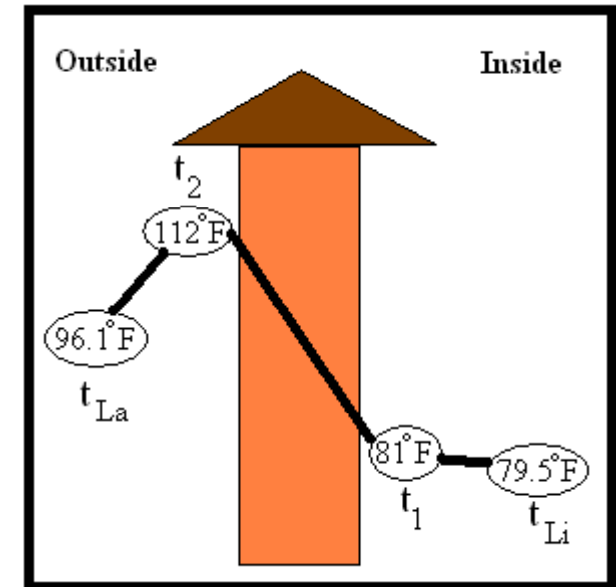
Schematic of the Chengqi Tulou Temperature Profile on a Summer Day

Temperature data (F)	Location of thermocouple						
	Court yard	Inside room	Inner wall surface	Inside inner wall	Inside outer wall	Outer wall surface	Outer yard
Time		$t_{Li}$	$t_1$			$t_2$	$t_{La}$
10:50	80.2	80.2	81	79.9	81.9	88	82.9
12:00	81.5	79.7	81	79.9	82.2	89	84
13:30	82.4	79.5	83	79.9	82.9	95	89.6
15:20	82.9	79.5	81	80.1	84.7	112	96.1
18:00	82.6	79.7	80	80.1	90.7	101	96.6

Time	Location of humidity sensor				
	Court yard	Inside room	Inside inner wall	Inside outer wall	Outer yard
10:50	74	78	82	66	71
12:00	74	80	82	65	69
13:30	69	79	82	49	60
15:20	69	79	81	32	53
18:00	69	79	81	38	46

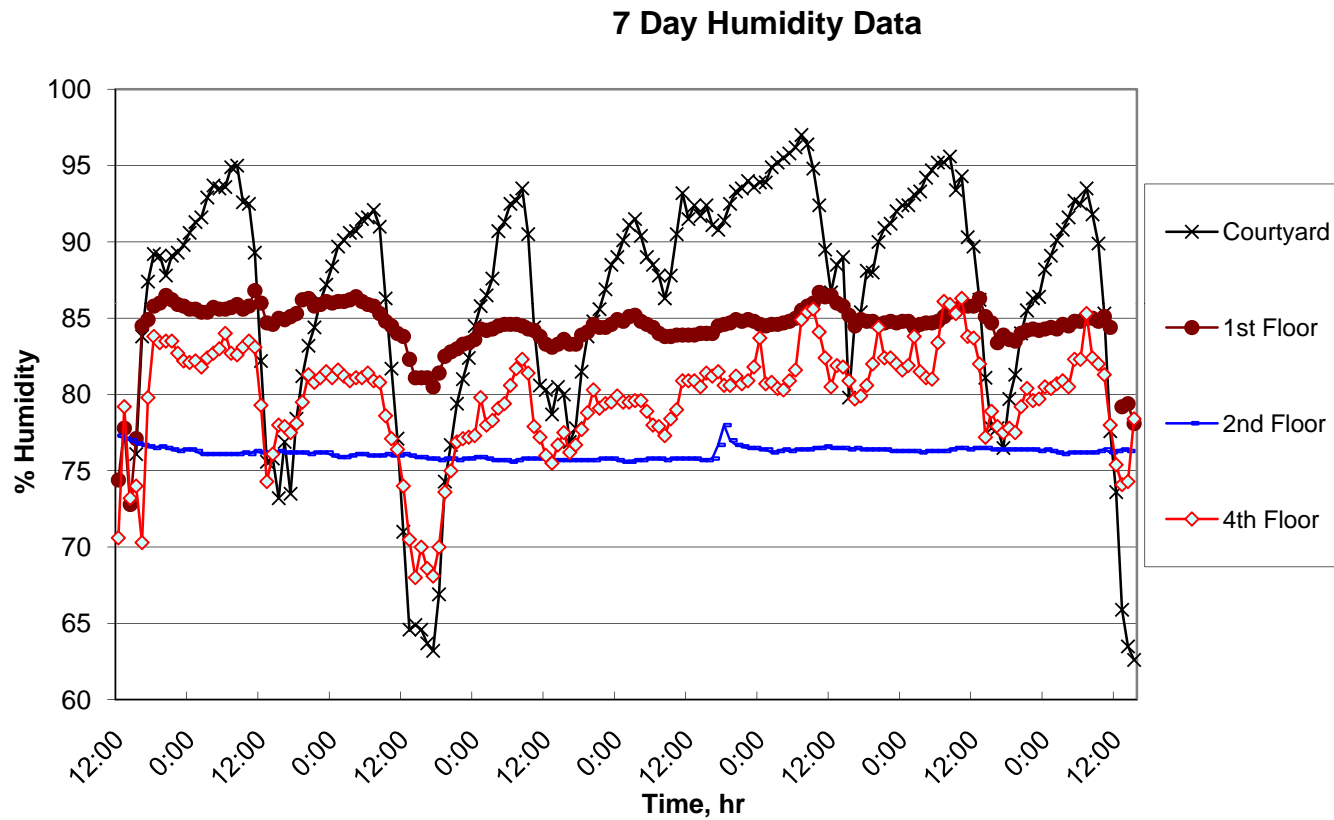
# Chengqi Tulou 7-Day Humidity Data
