Performance Observations of the Beijing area's Great Wall "Rammed Earth and Rubble Core", (unrestored sections)

David Dark

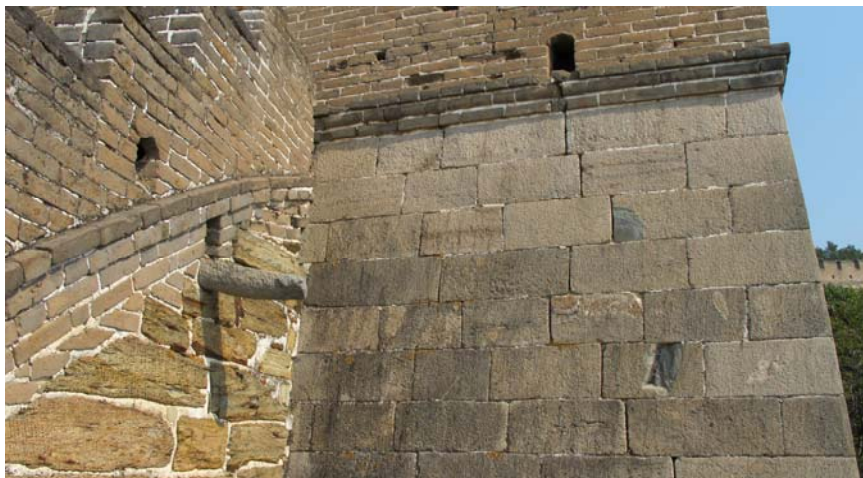
30

Quarried Stone. Water drainage spout. #8

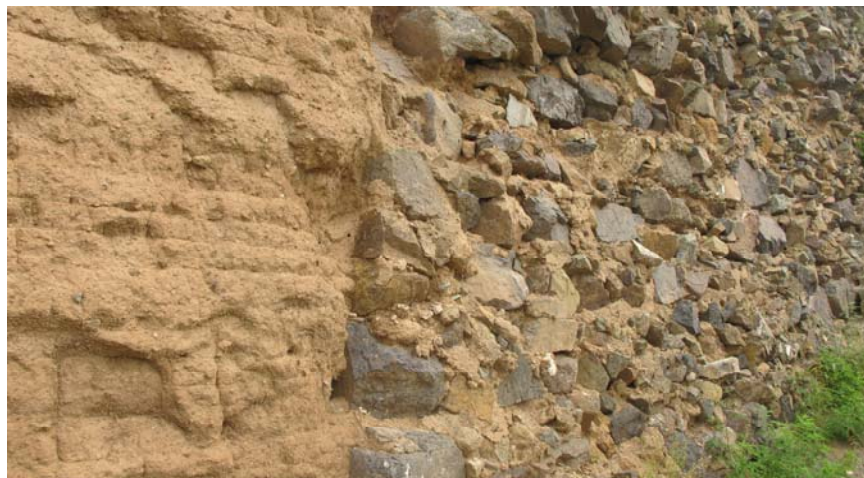
36

Rammed Earth and Rubble side by side. #5
