Performance Observations of the Beijing area's Great Wall "Rammed Earth and Rubble Core", (unrestored sections)

David Dark

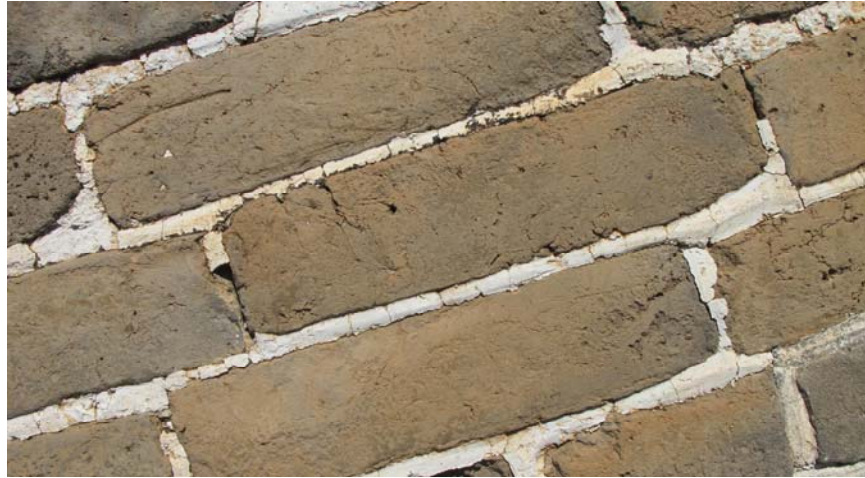
3

Figure 4. Sticky-Rice and Lime mortar.
Typical brick. #5

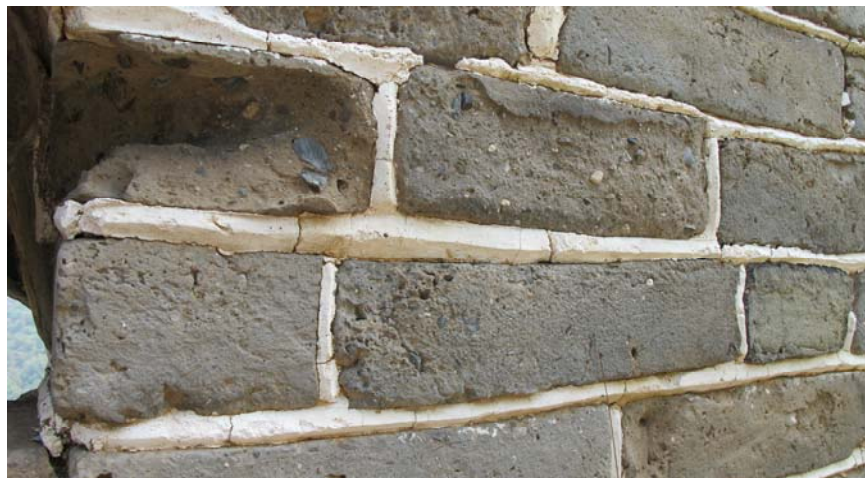
4

Sticky-Rice and Lime mortar. Typical
brick. #8

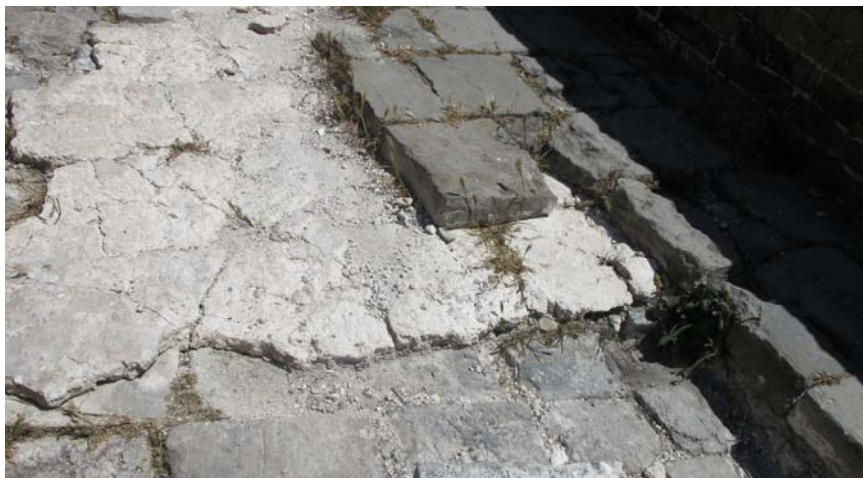
12

Figure 5. Sticky-Rice and Lime mortar
between paving. #5

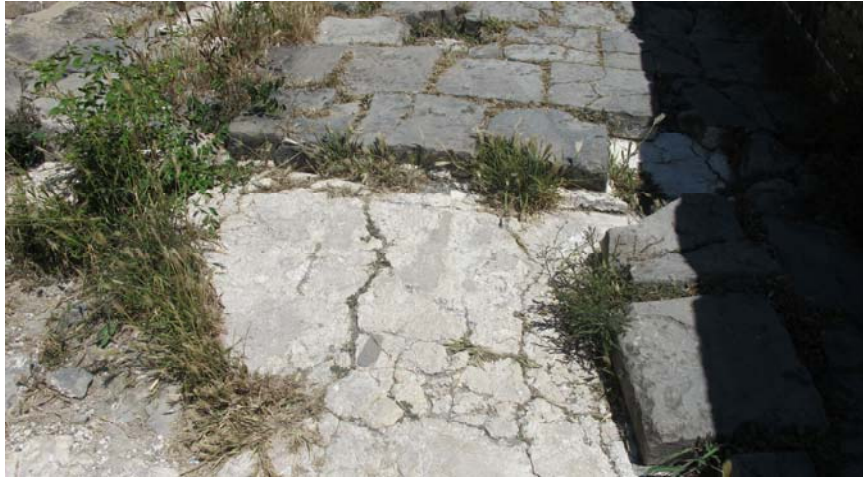
13

Sticky-Rice and Lime mortar between paving. #8

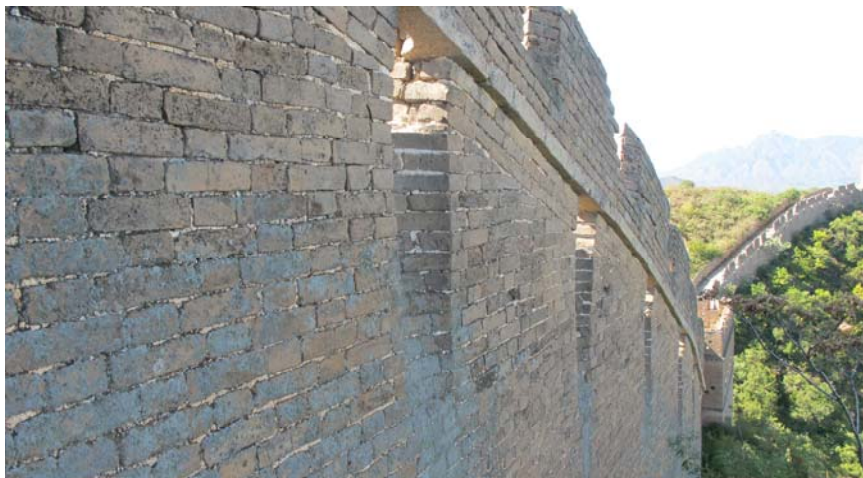
14

Drainage system. #4

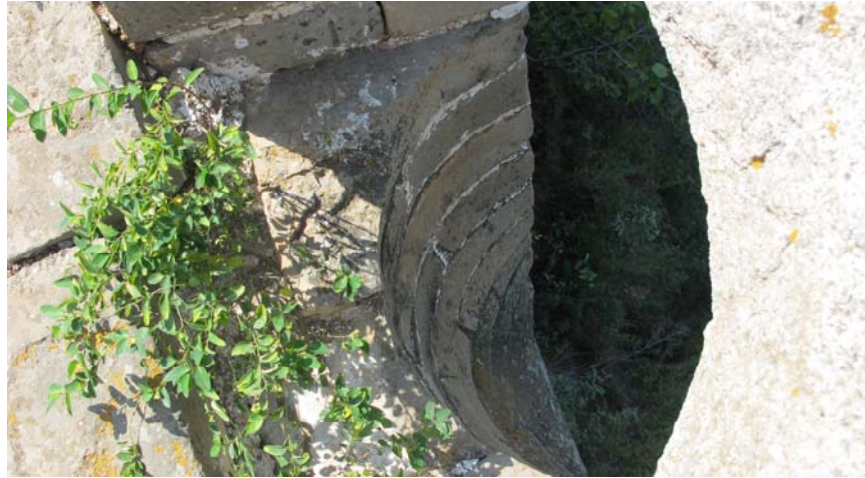
15

Drainage system. #4

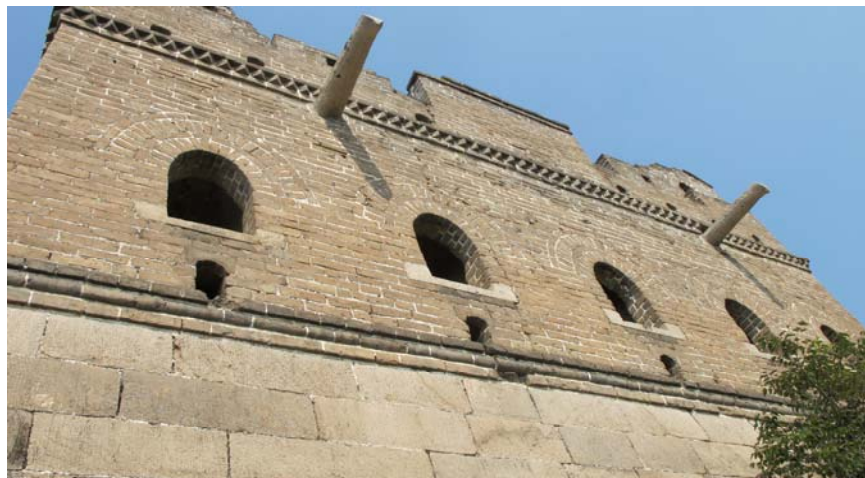
16

Water drainage spouts draining the top of a tower. #8

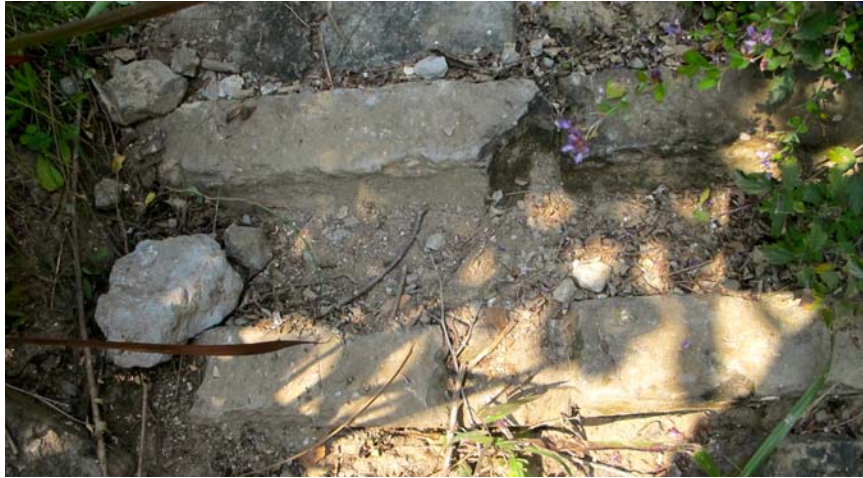
17

Drainage channel. #8

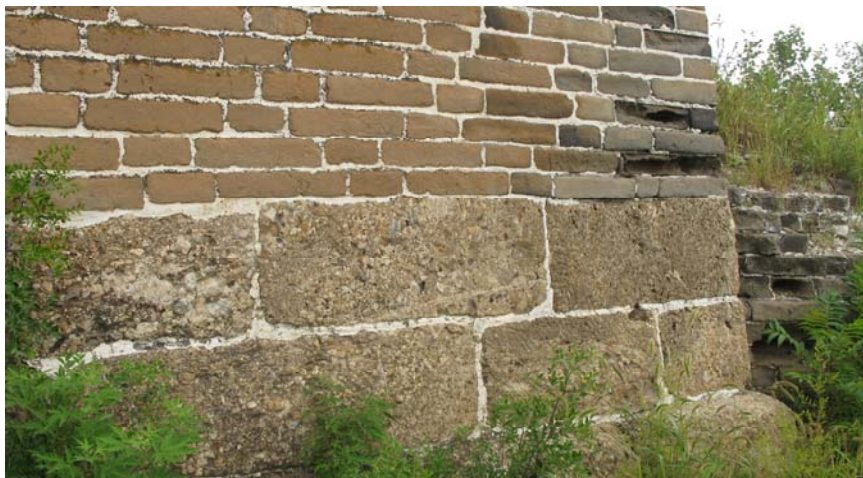
18

Figure 3. Typical brick on stone construction. Earth foundation. #5

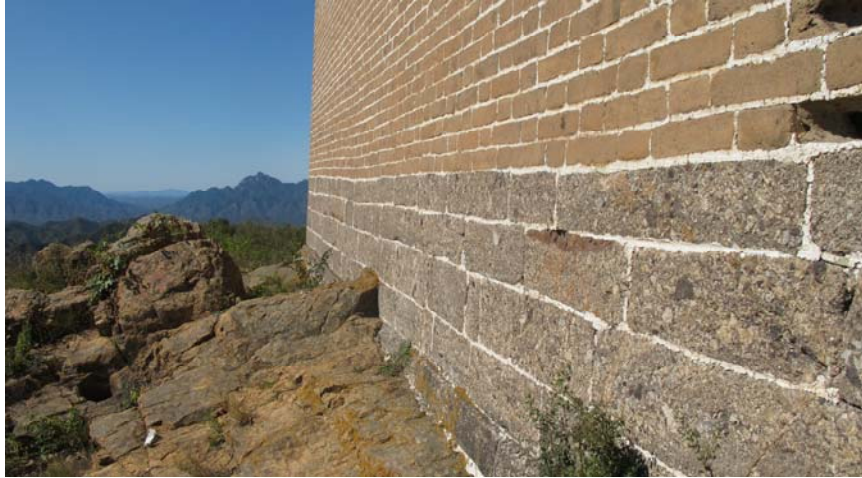
19

Typical brick on stone construction.
Bedrock foundation. #4

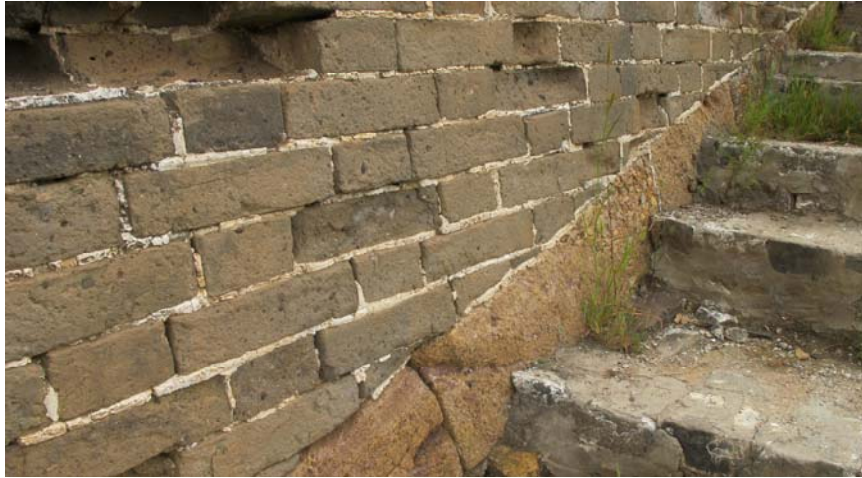
21

Quarried Stone. Single course
foundation. #5

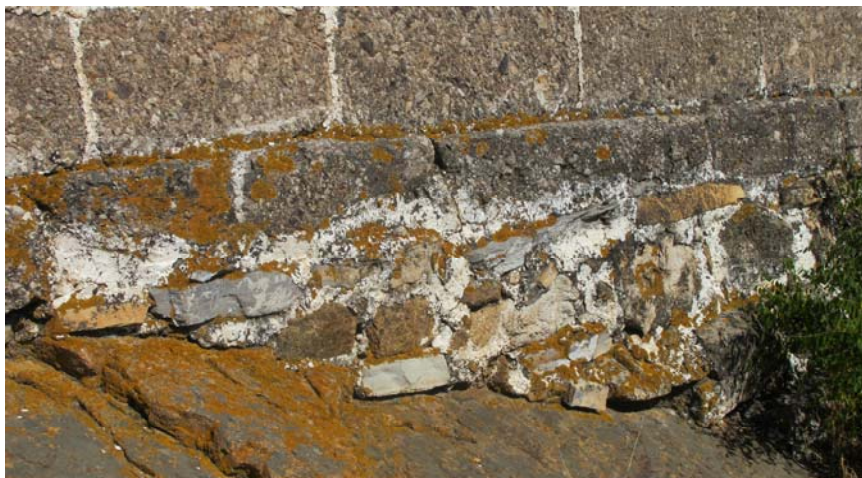
22

Mortared Rubble on bedrock. #4

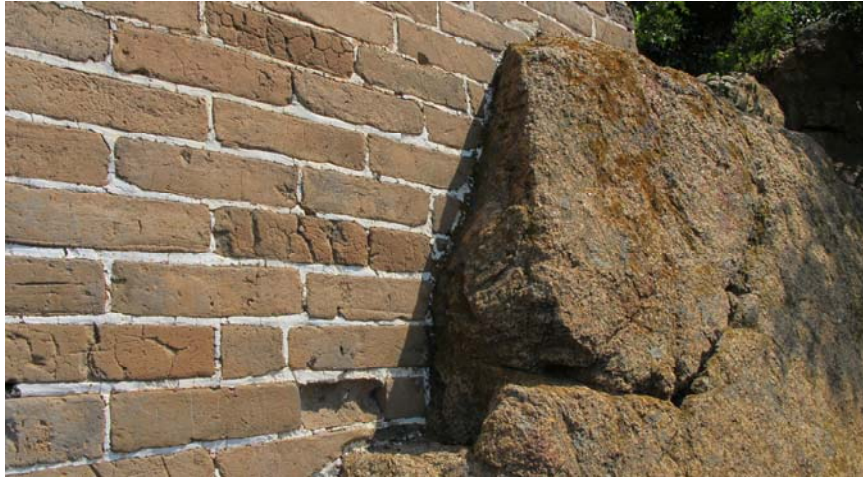
23

The exception to the rule! #4

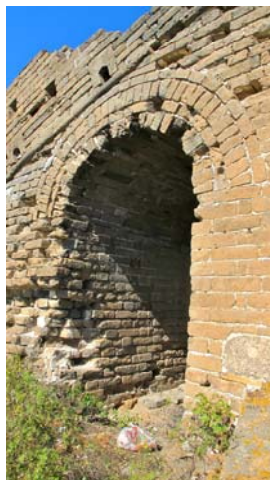
24

Another exception! #4

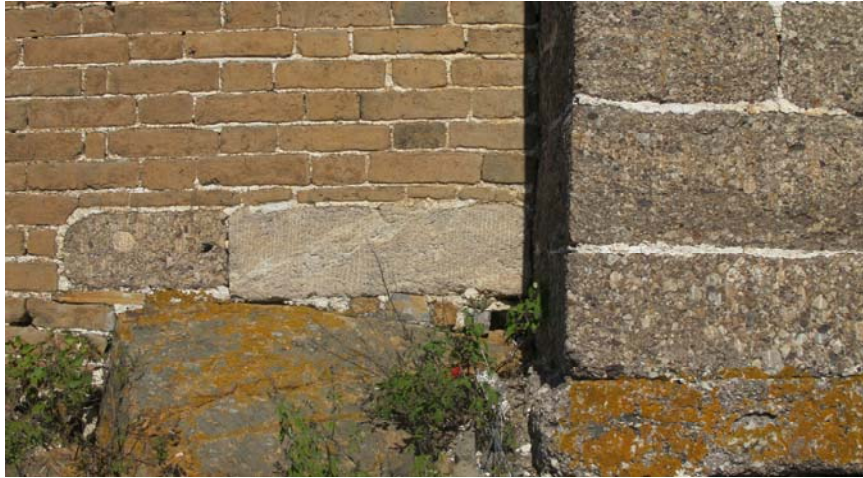
25

Quarried Stone. #4

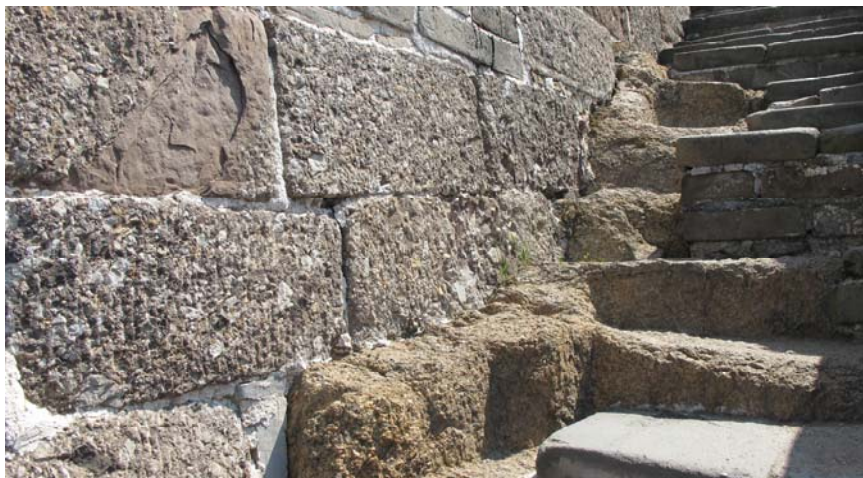
26

Quarried Stone. #4

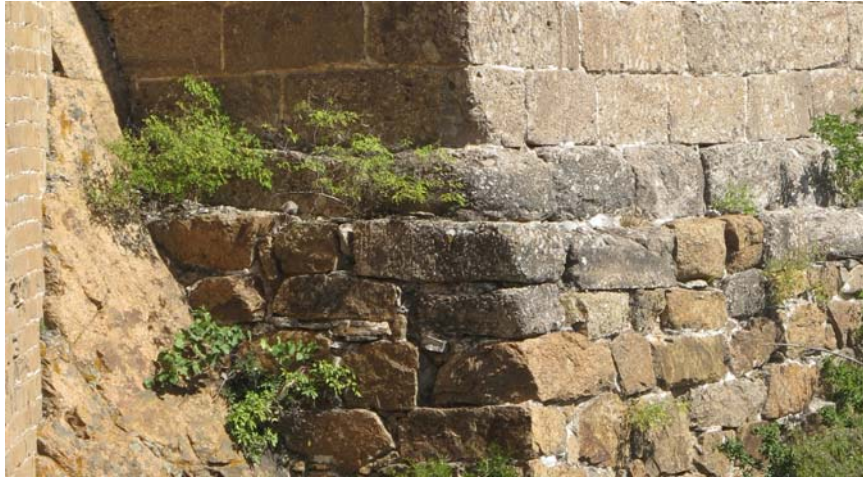
27

Quarried Stone at tower base. #4

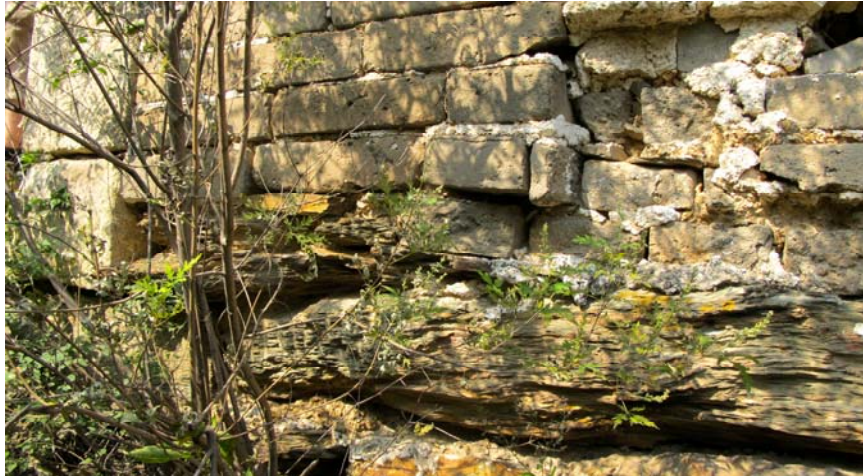
29

Quarried Stone doorpost to left. Rough cut stone bottom. #8

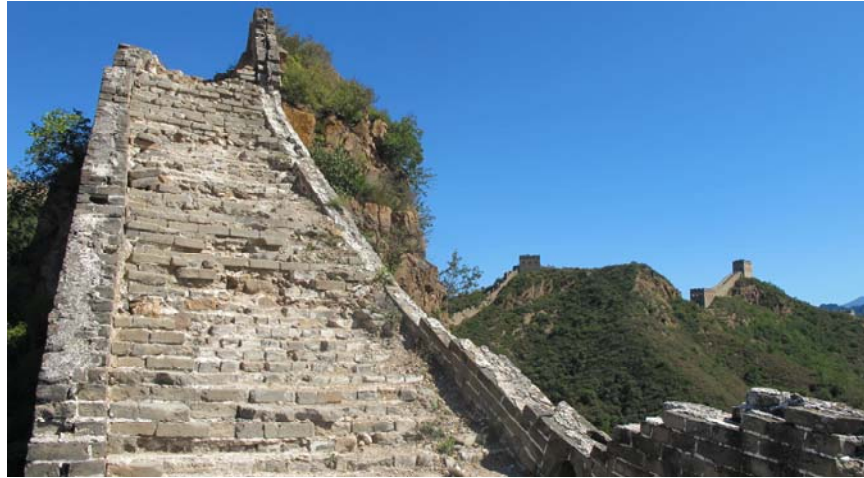
31

Figure 9. Low wall on high peak. #4

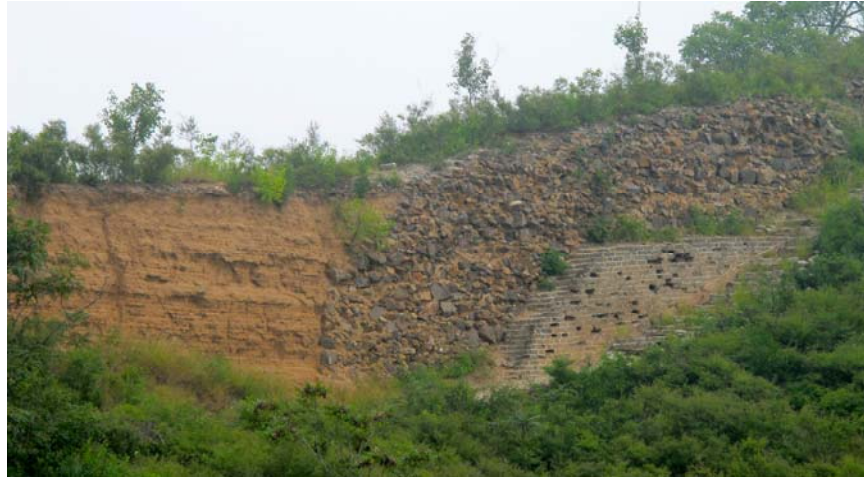
35

Figure 7. Rammed Earth and Rubble side by side. #5

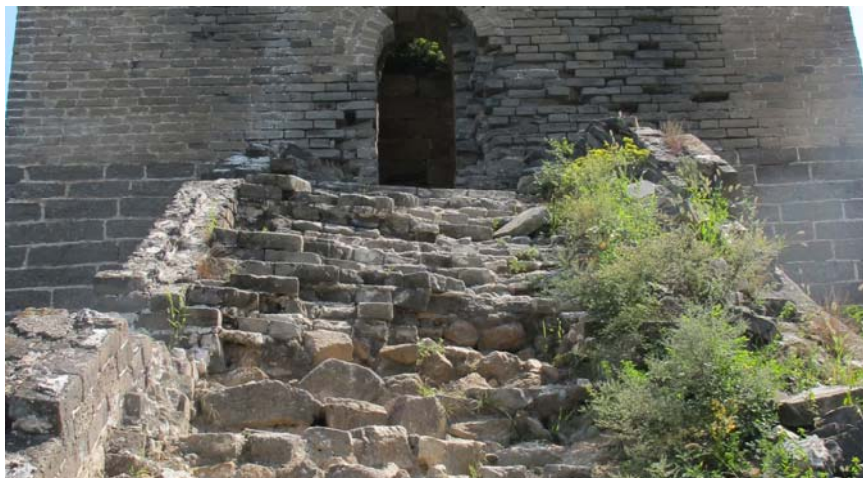
44

Rubble Core of a superior nature. #4

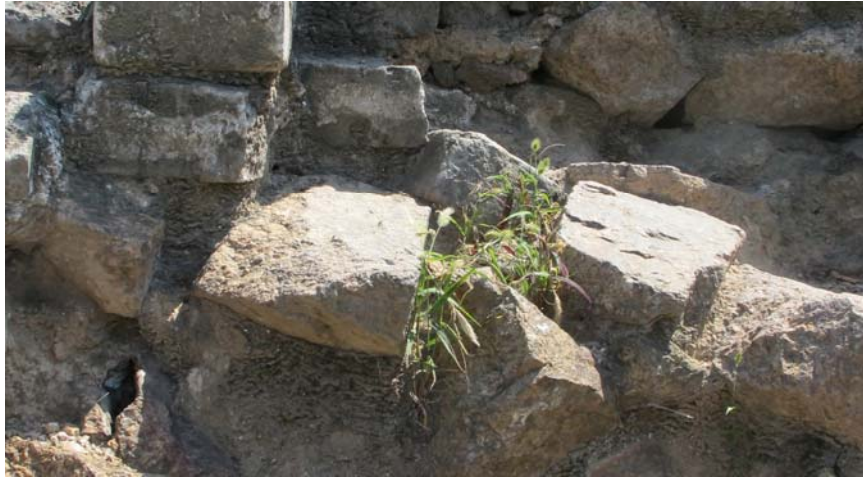
45

Rubble Core. #4

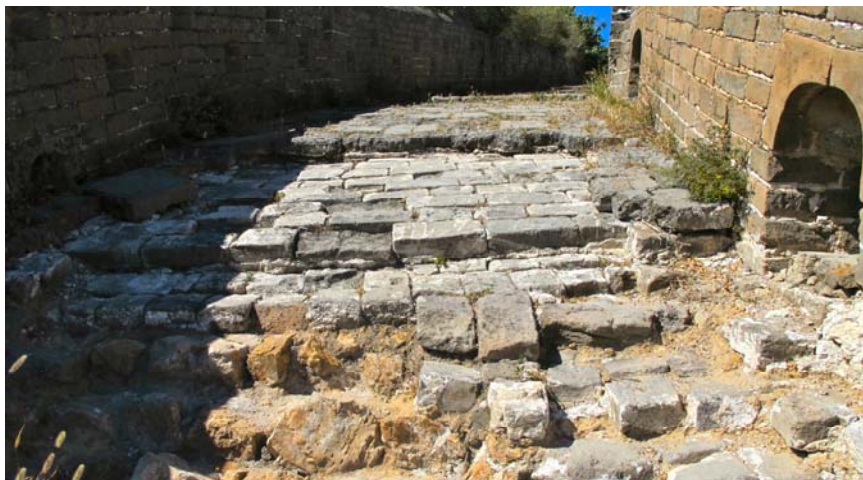
46

Pavers with Rubble Core under. #5

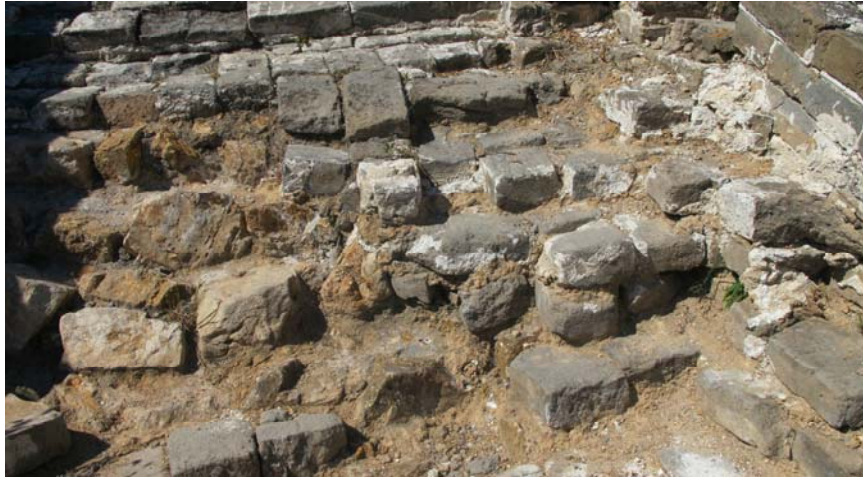
47

Rubble Core & pavers. #4

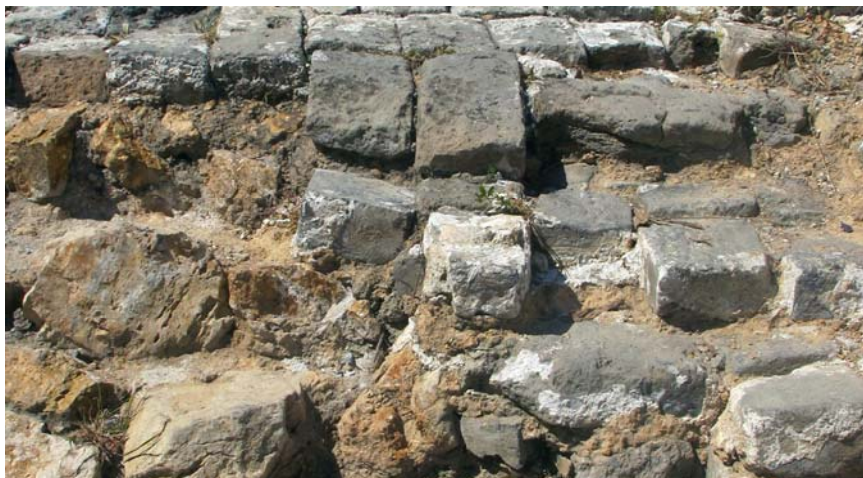
48

Rubble Core & pavers. #4

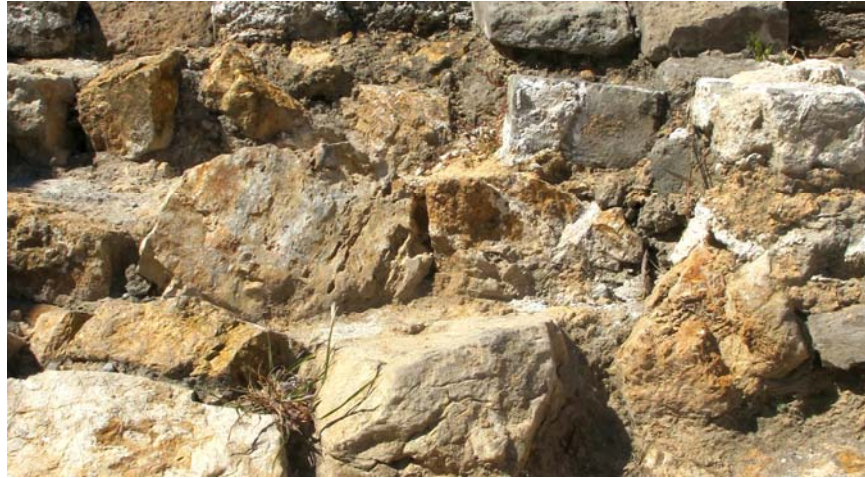
49

Rubble Core. #5

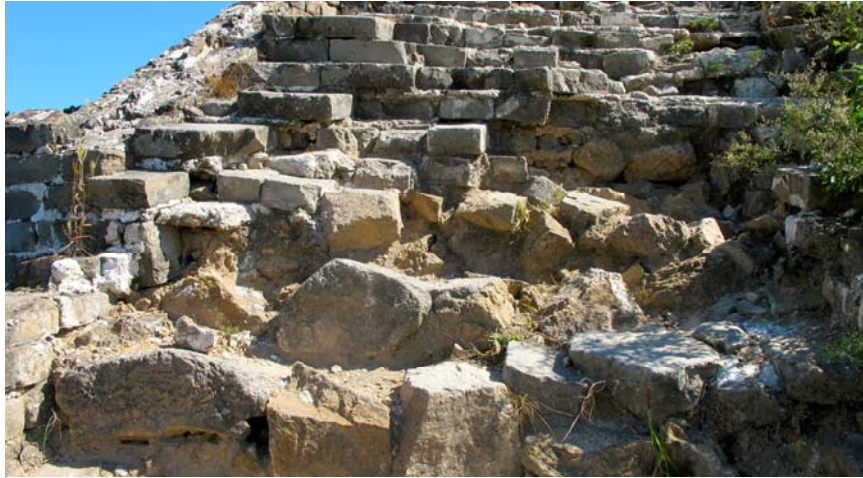
51

Rubble Core & pavers. #4

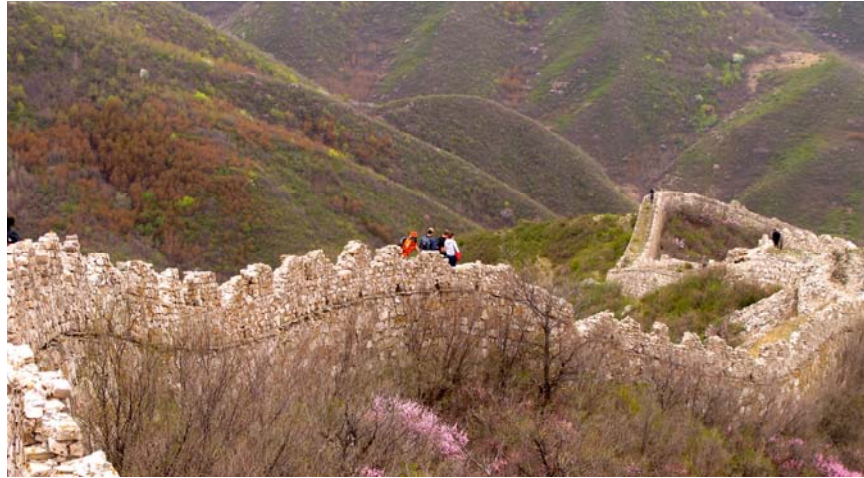
53

The serpentine nature of the Wall aids longevity. West of #14

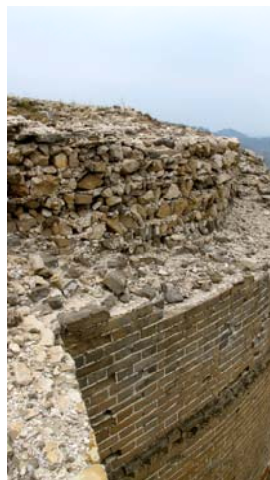
54

Rubble Core constructed in courses with mortar between. West of #14

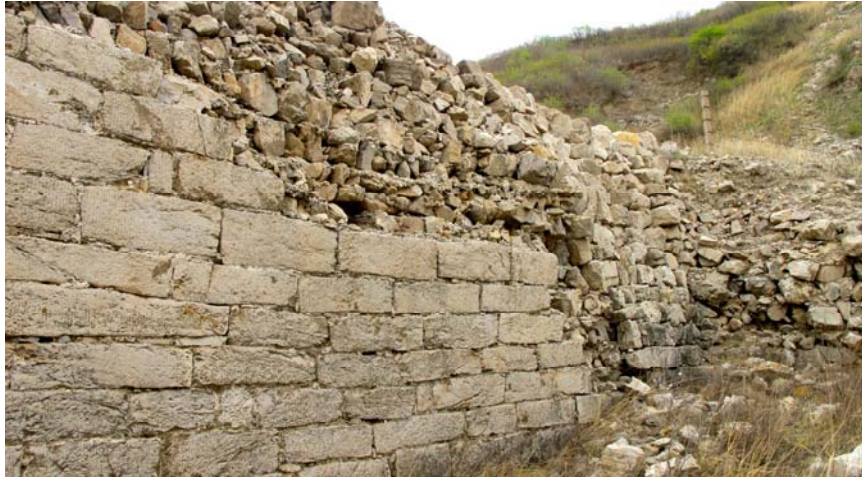
55

Rubble Core constructed in courses with mortar between. West of #14

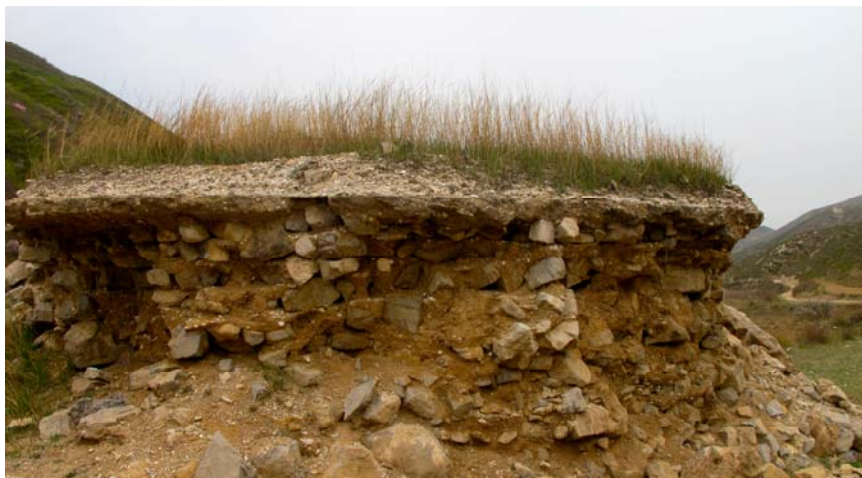
56

Rubble Core constructed in courses with earth between. West of #14

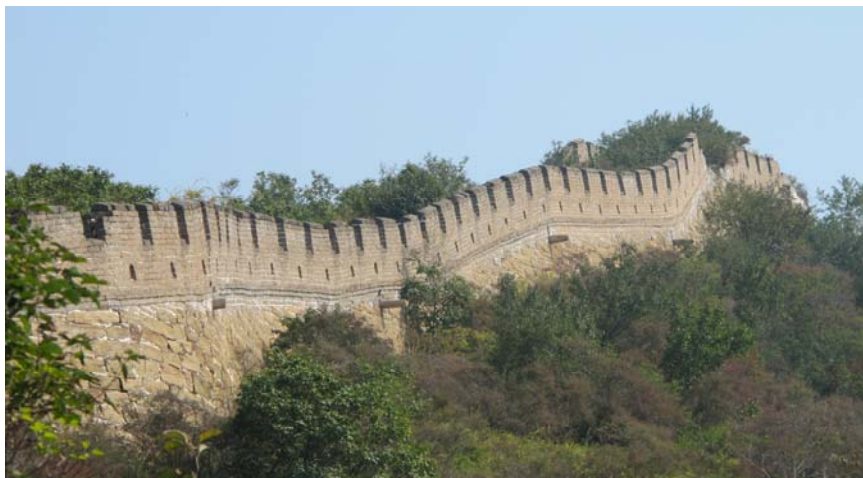
62

Drainage spouts on an inclined
section. #4

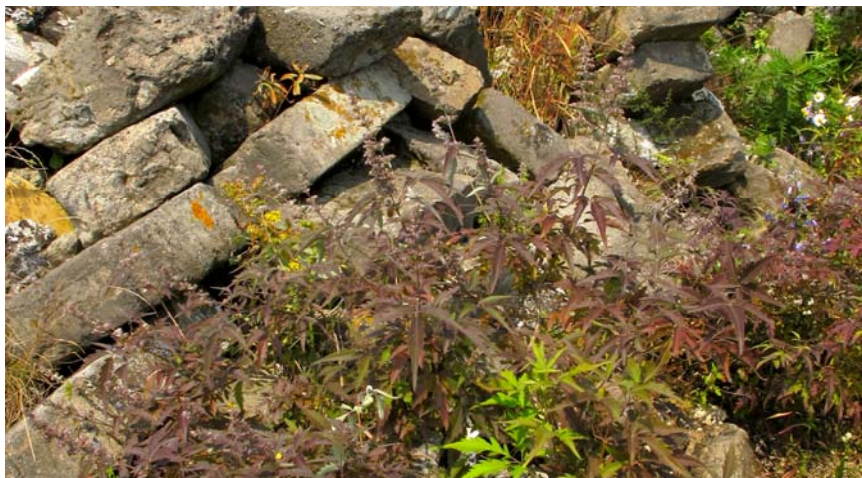
66

Chaotic, but a haven for small animals & plants. #8

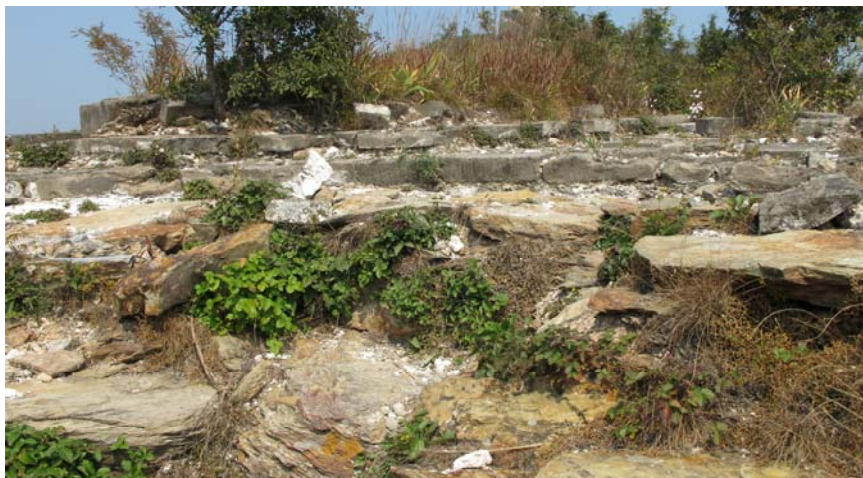
68

Large rocks in Rubble Core. #8

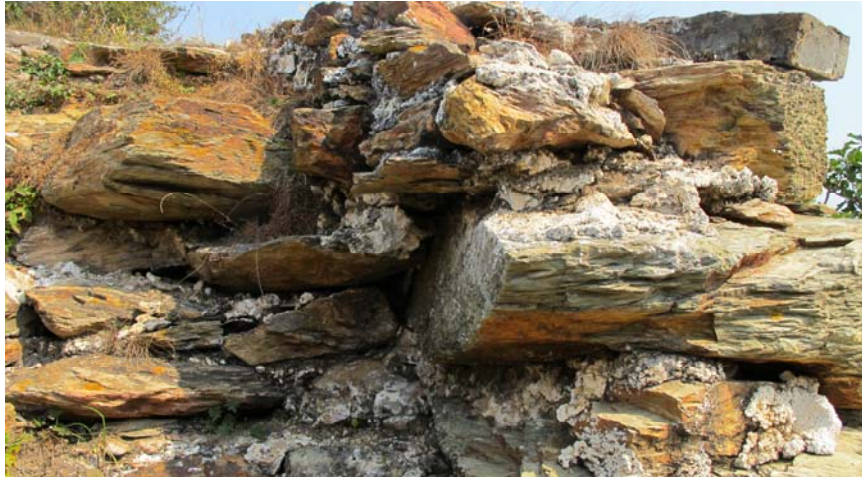
69

Outer Wall and inner Core meld and bonded together with mortar. #8
